Report Number: ED-24-74

Subject: Baker Park Pedestrian Bridge Over Oshawa Creek  
Pedestrian Structure MS-6-2017

**Re:** Emergency Bridge Inspection – Baker Park Pedestrian Bridge (Site ID: MS-6-2017)  
TSI Inc. File: 24048-1

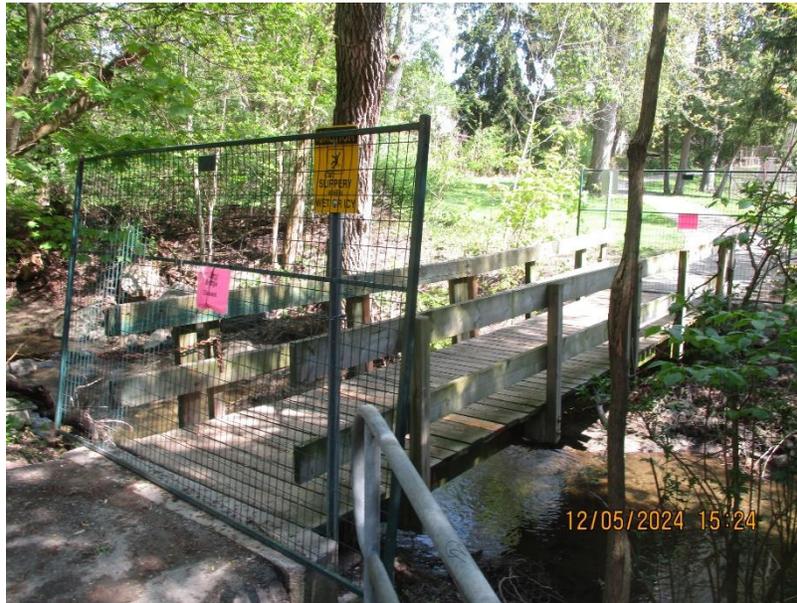
*Figure 1: Bridge Closed to the Public*

span diaphragm as previously noted in the previous section. **In discussions with the City, it has been determined that restricting the use of the bridge to pedestrians only is not feasible. As a result, it is recommended that the bridge remain closed to the public until it is replaced.**

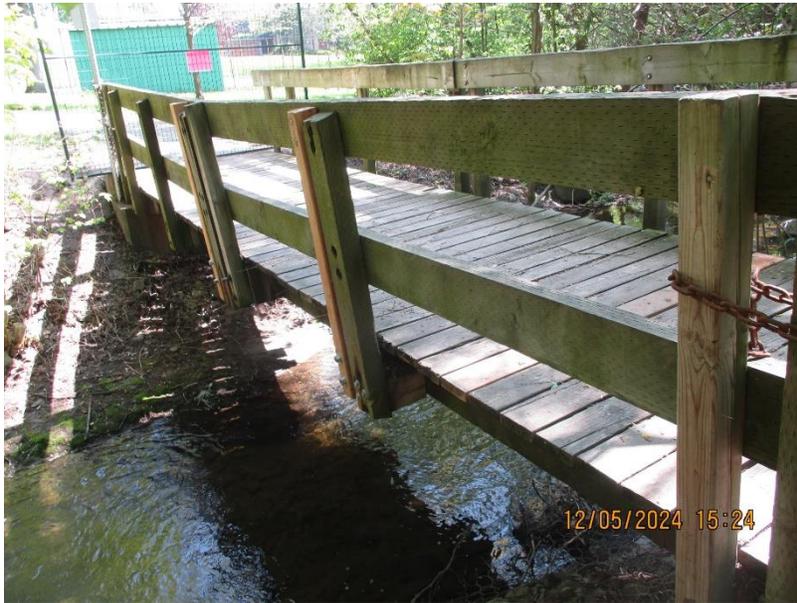
- Evidence of localized medium fire damage to the timber diaphragms and end girders were noted;
- Excessive deformation along the midspan (particularly along north side (upstream side) of the bridge was notable. Nonetheless, the bridge did not seem to be unstable under normal walking, though the bridge showed evidence of excessive vibration under jumping (dynamic loads) particularly along the north side;

*Figure 3: North Elevation-Evidence of Sag at Midspan*

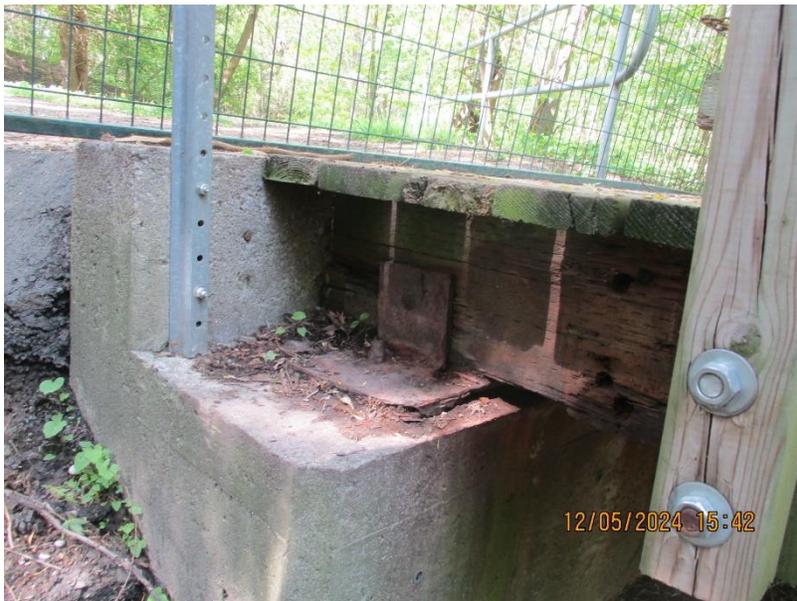
- The end timber girders evidence medium to severe decay and rot;

- The end steel bearings were found to be severely corroded;
- The bridge is missing one midspan timber diaphragm (north side) and severely corroded and failed bracing rod. The end timber diaphragms appear to experience medium to severe rot as well;

*Figure 4: End Girder (Typ.)-Evidence of Severe Decay and Rot and Severe Corrosion to Steel Base Plates*

- **The bridge must be planned to receive a new superstructure replacement within the next 1-2 years.** The design for bridge superstructure replacement shall be supported by a detailed drainage study and hydraulic analysis in accordance with the requirements of the new pedestrian bridge design standard (CSA-S7). Potential modification to the bridge elevation or alternatively implementing adequate protection system to the end bearings and girder ends may be required.

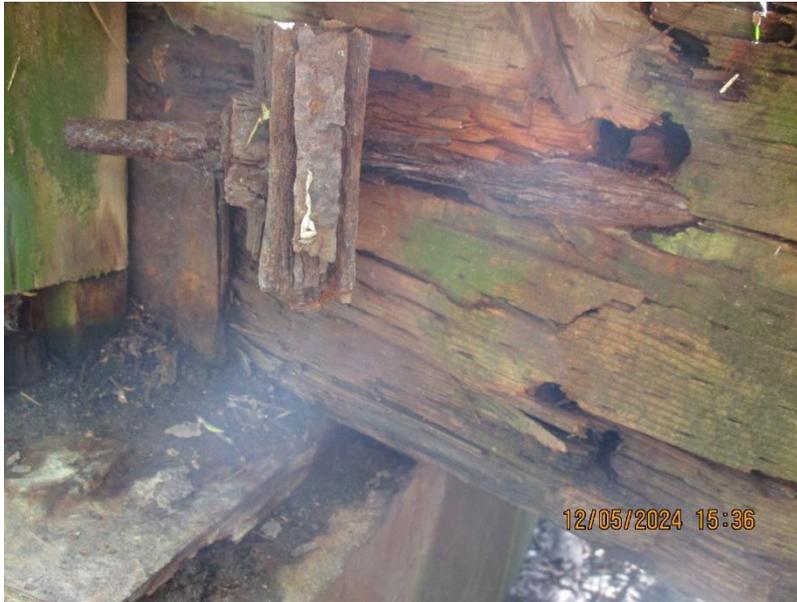
- The severity of rot on the NE and NW ends (upstream ends) are more than that of SE and SW (downstream ends) which suggest the potential prolonged exposure to moisture (Likely due to highwater level or frequent flooding events (?));

*Figure 5: Timber Girder (NE End); Evidence of Severe Rot and Decay*

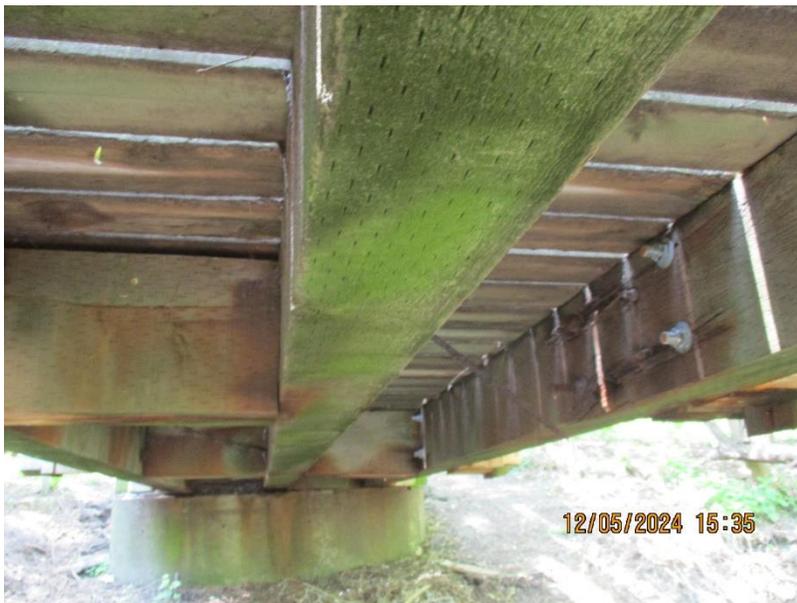
*Figure 6: Soffit (Typ.)- Evidence of Missing Midspan Diaphragm*

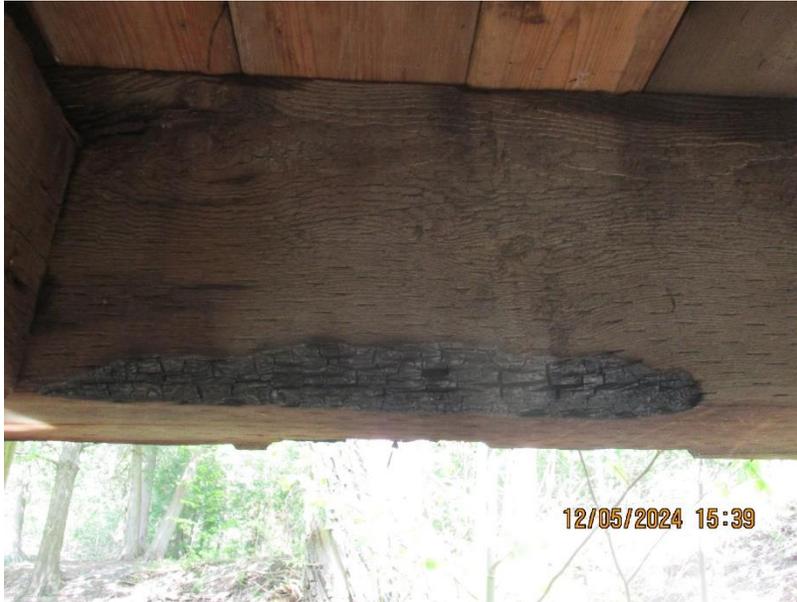
*Figure 7: Timber Diaphragm-Evidence of Fire Damage*

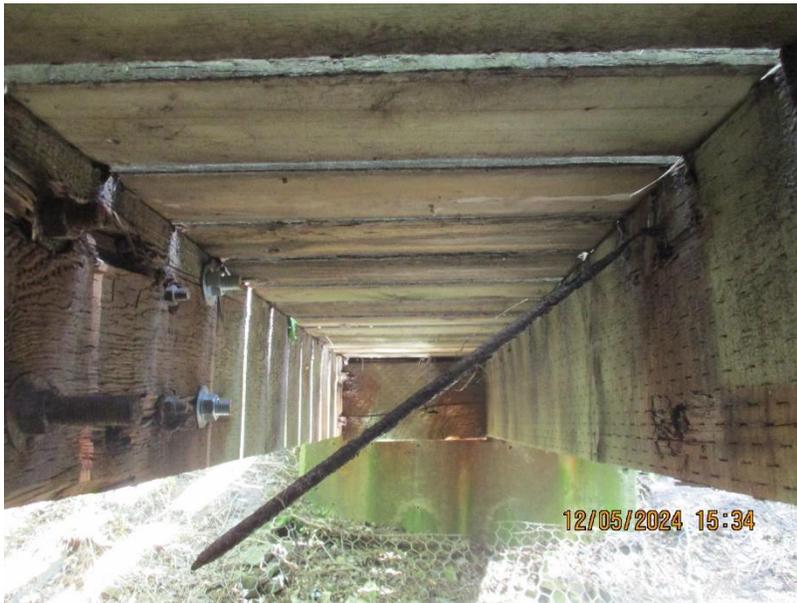
*Figure 8: Bracing Rod-Evidence of Severe Corrosion and Failure*
