Report Number: DS-22-77

Subject: Midtown Mall Pedestrian Bridge over Oshawa Creek

Attachment 2 is an excerpt of the 2021 Biennial Structural Inspection Report including the cover page prepared by T.S.I. Inc.

Structure Name: Midtown Mall Pedestrian Footbridge Over Oshawa Creek

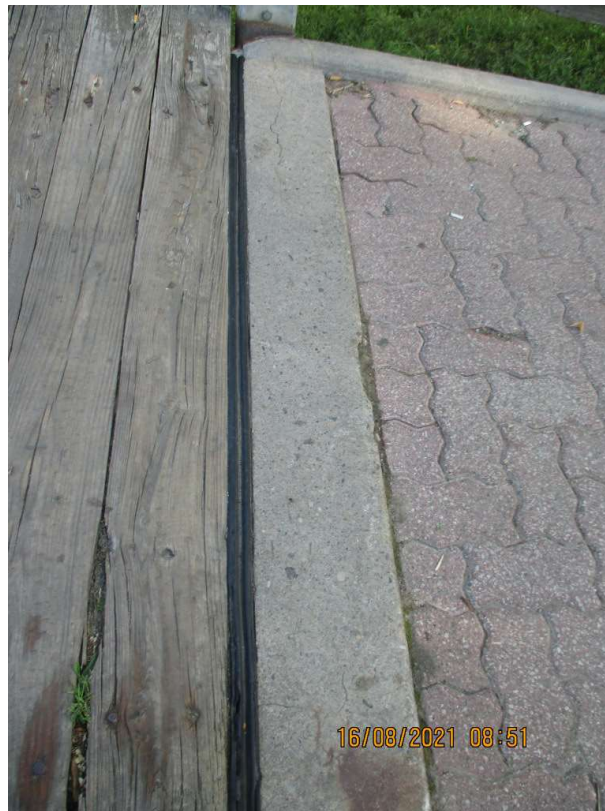
Figure 5 : East Bridge End Condition (Typ.)_Evidence of Medium to Wide Map Cracking & Rust Stain on Ballast Wall

Element Group:	Abutments				Length:	0.3			
Element Name:	Ballast Walls				Width:	0.8			
Location:	East & West Underside of Structure				Height:	0.3			
Material:	Concrete				Count (items):	4			
Element Type:	Reinforced Concrete Wall				Total Quantity:	0.9		m ²	
Environment:	Benign				Limited Inspection:				
Protection System:	None								Perform. Deficiencies
Condition Data:	Units	Excellent	Good	Fair	Poor*				
	m ²		0.9			00			
Comments:	<ul style="list-style-type: none"> Evidence of spalls patched with asphalt and wide cracks on west and wide cracks and rust stain on east ballast wall was noted. 								
Recommended Work:	<input checked="" type="checkbox"/>	Rehab		Replace	Maintenance Needs:			00	
	<input checked="" type="checkbox"/>	1-5 years		6-10 years	Urgent		1 year	2 years	
<ul style="list-style-type: none"> To conduct concrete repair to ballast walls.

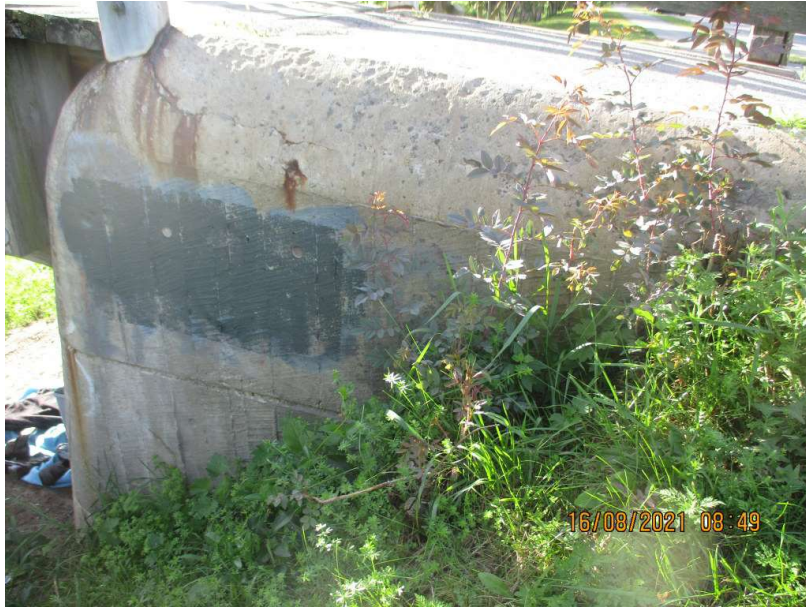
Figure 9 : NW Wingwall_Evidence of Wide Cracks & Rust Stain around Barrier Connection to Wingwall

Element Group:	Abutments				Length:	2.3			
Element Name:	Wingwalls				Width:	0.3			
Location:	NE, NW, SW & SE Side of Structure				Height:	1.7			
Material:	Cast-in-Place Concrete				Count (items):	4.0			
Element Type:	Reinforced Concrete Walls				Total Quantity:	15.6		m ²	
Environment:	Benign				Limited Inspection:				
Protection System:	None								Perform. Deficiencies
Condition Data:	Units	Excellent	Good	Fair	Poor*				
	m ²		8.6	5.0	2.0	00			
Comments:	<ul style="list-style-type: none"> Evidence of wide cracks and delamination was noted on abutments around barriers connection bases. 								
Recommended Work:	<input checked="" type="checkbox"/>	Rehab		Replace	Maintenance Needs:			00	
	<input checked="" type="checkbox"/>	1-5 years		6-10 years	Urgent		1 year	2 years	
<ul style="list-style-type: none"> To conduct concrete repair to wingwalls.

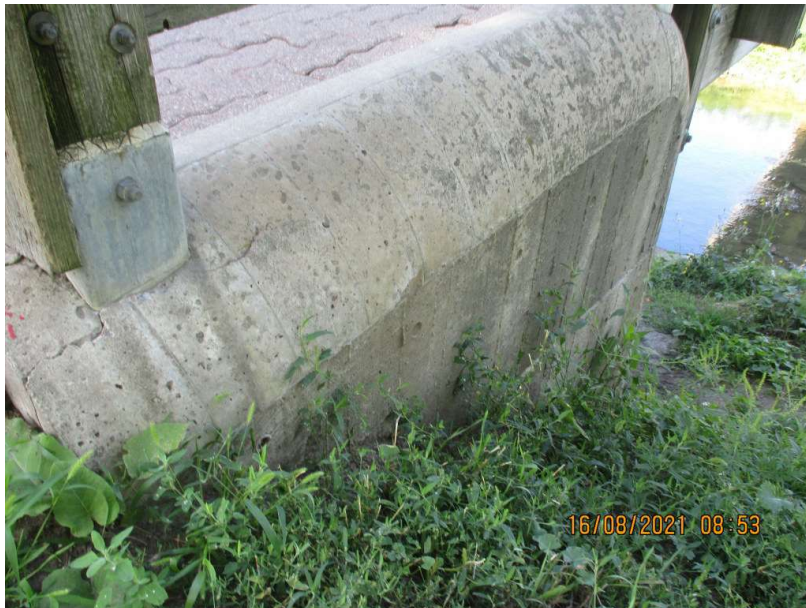
Figure 10 : NE Wingwall_Evidence of Wide Cracks around Barrier Connection

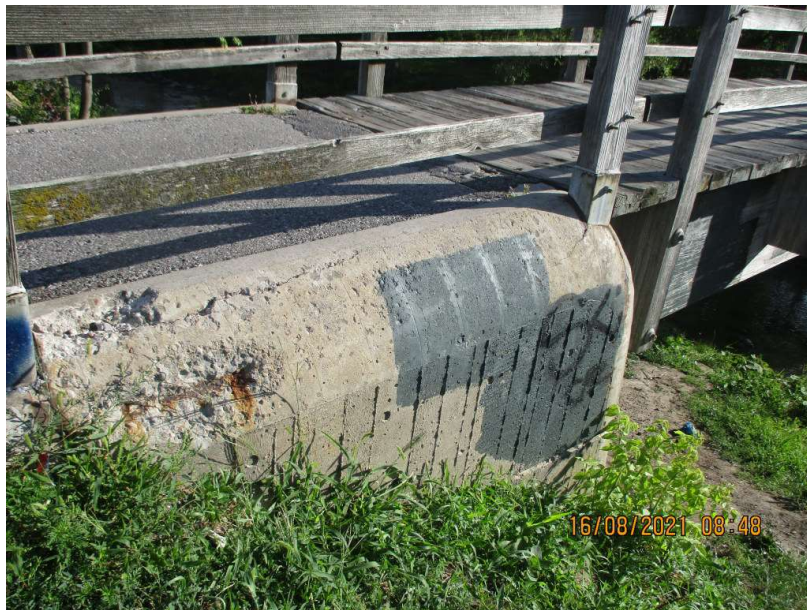
Figure 11 : SW Wingwall_Evidence of Medium Spall, Wide Longitudinal Crack & Rust Stain

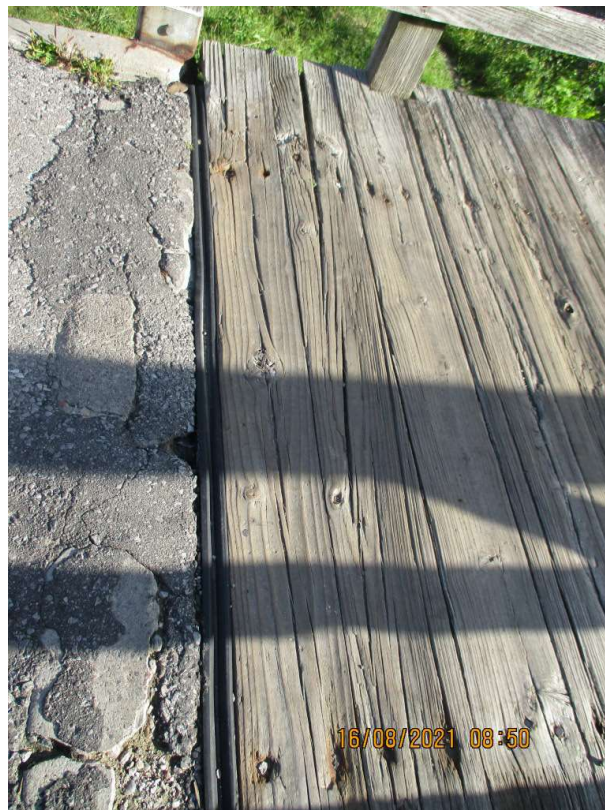
Figure 12 : West Bridge End Condition (Typ.)_Evidence of Spall & Wide Cracks on Exposed Surface of Ballast Wall

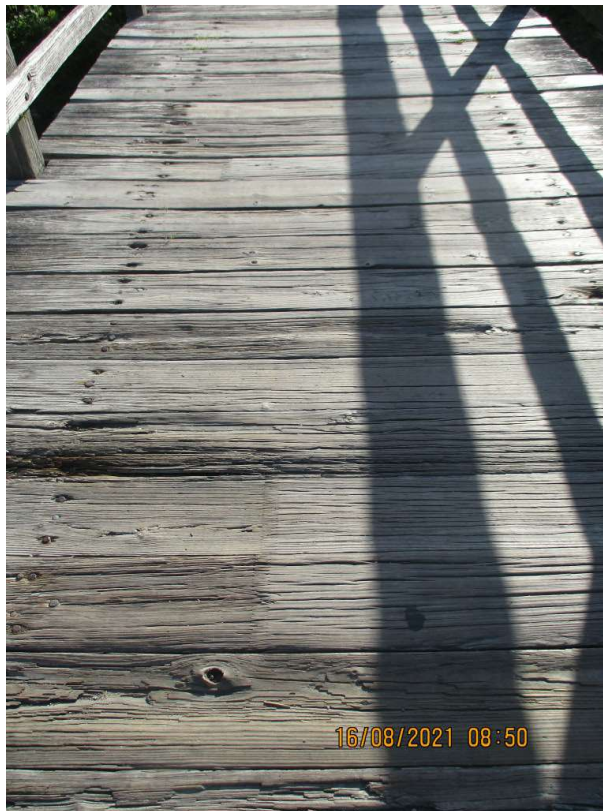
Figure 13 : Deck Top Condition (Typ.)_Evidence of Severe Weathering and Wear & Tear

Element Group:	Decks				Length:	23.40			
Element Name:	Deck Top				Width:	2.20			
Location:	Top of Deck				Height:				
Material:	Timber				Count (items):				
Element Type:	Transverse Timber Planks				Total Quantity:	51.50		m ²	
Environment:	Severe				Limited Inspection:				
Protection System:	None								Perform. Deficiencies
Condition Data:	Units	Excellent	Good	Fair	Poor*				
	m ²		22.50	25.00	4.00	00			
Comments:	• Evidence of severe weathering, medium to severe split and check, and localized medium rot was noted.								
Recommended Work:	<input checked="" type="checkbox"/>	Rehab		Replace	Maintenance Needs:		00		
	<input checked="" type="checkbox"/>	1-5 years		6-10 years	Urgent	1 year	2 years		
• To replace deck top.

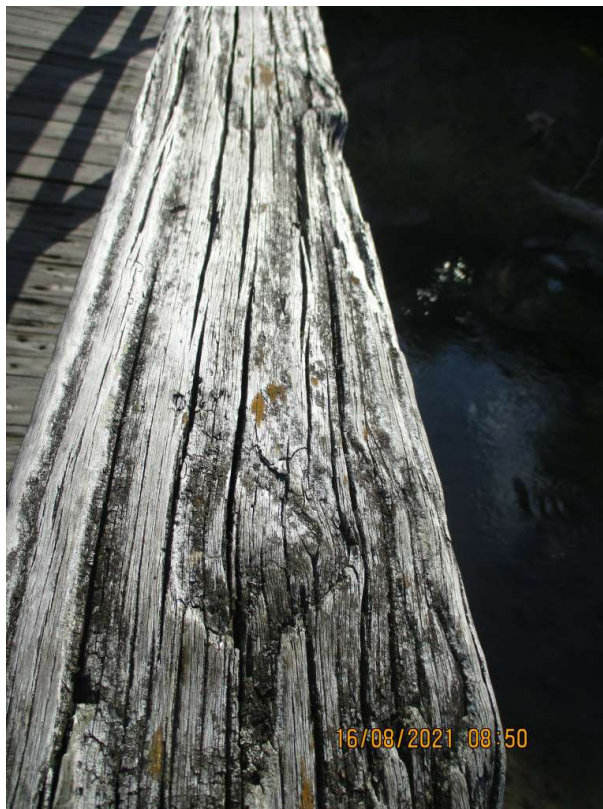
Figure 14 : South Bridge Barrier Top Face_Evidence of Severe Weathering

Element Group:	Barriers		Length:	23.40			
Element Name:	Railing Systems		Width:	0.04			
Location:	North & South Side of Structure		Height:	0.09			
Material:	Wood		Count (items):	2.00			
Element Type:	Timber Railing		Total Quantity:	46.80		m	
Environment:	Severe		Limited Inspection:				
Protection System:	None					Perform. Deficiencies	
Condition Data:	Units	Excellent	Good	Fair	Poor*		
	m		15.80	30.0	1.0	00	
Comments:	<ul style="list-style-type: none"> Evidence of medium to severe weathering and medium split and checks was noted. Barrier system was noted substandard. 						
Recommended Work:	<input checked="" type="checkbox"/>	Rehab		Replace	Maintenance Needs:		00
	<input checked="" type="checkbox"/>	1-5 years		6-10 years	Urgent	1 year	2 years
<ul style="list-style-type: none"> To replace bridge barrier.

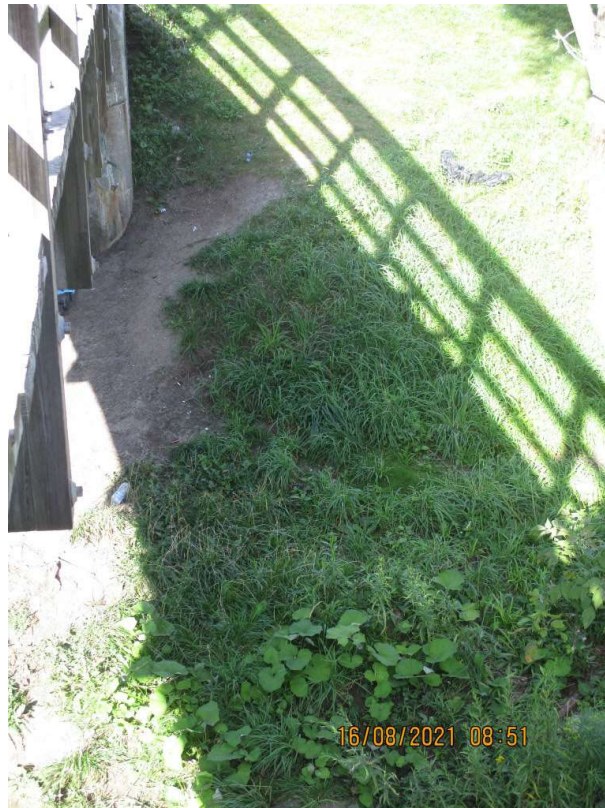
Figure 18 : NW Embankment_Evidence of Medium Erosion

Element Group:	Embankments and Streams				Length:				
Element Name:	Embankments				Width:				
Location:	NE, NW, SE & SW of Structure				Height:				
Material:	Gravel				Count (items):	4			
Element Type:	Embankment				Total Quantity:	4.0		Each	
Environment:	Moderate				Limited Inspection:				
Protection System:	Vegetation								Perform. Deficiencies
Condition Data:	Units	Excellent	Good	Fair	Poor*				
	Each			4.0		00			
Comments:	<ul style="list-style-type: none"> • Evidence of medium erosion on all embankment was noted. 								
Recommended Work:	Rehab		Replace	Maintenance Needs:		13			
	1-5 years		6-10 years	Urgent	<input checked="" type="checkbox"/>	1 year		2 years	
<ul style="list-style-type: none"> • To implement erosion control measures on all the embankments.

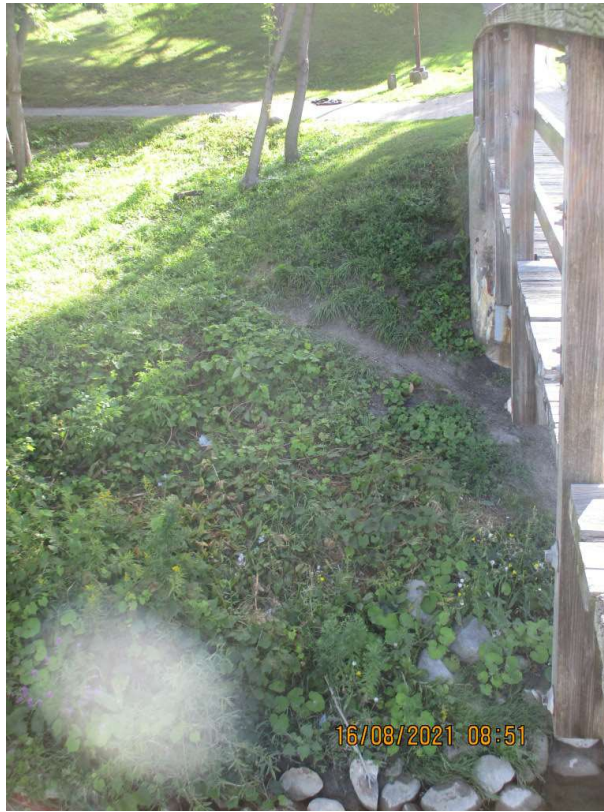
Figure 19 : NE Embankment_Evidence of Medium Erosion

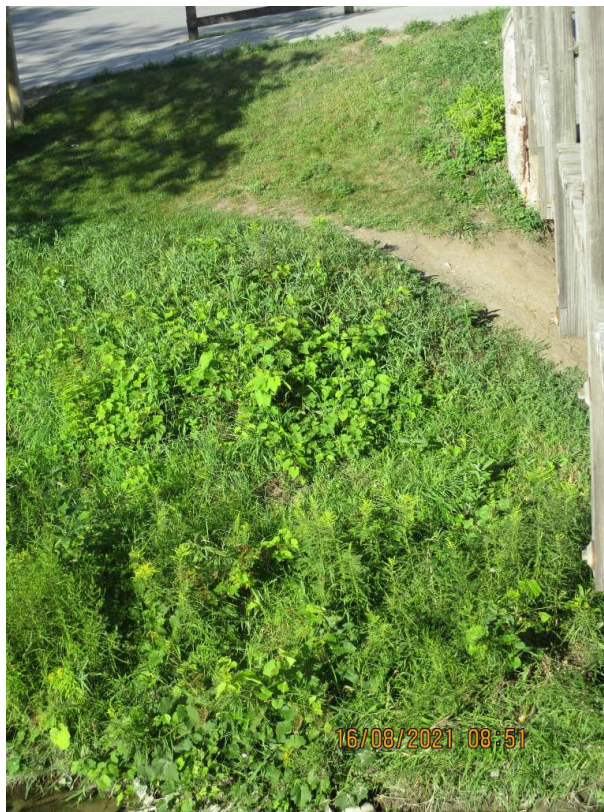
Figure 20 : SE Embankment_Evidence of Medium Erosion

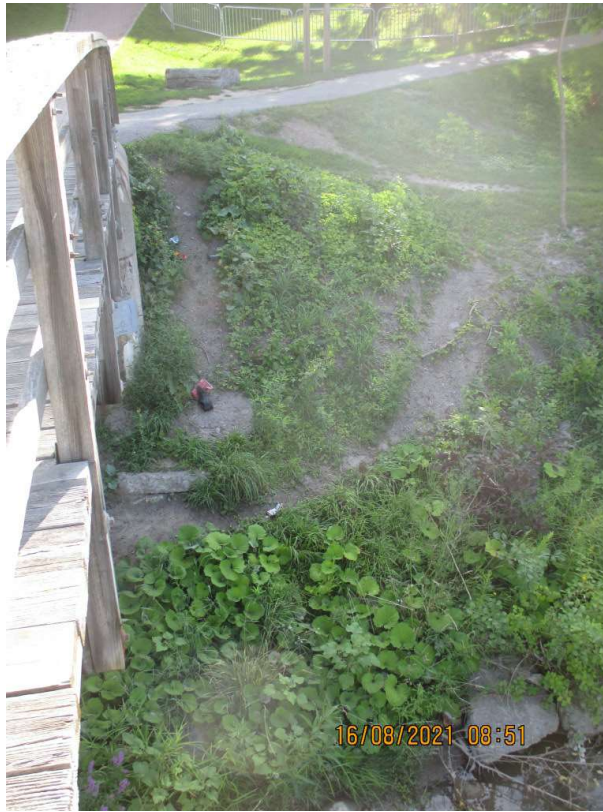
Figure 21 : SE Embankment_Evidence of Medium Erosion

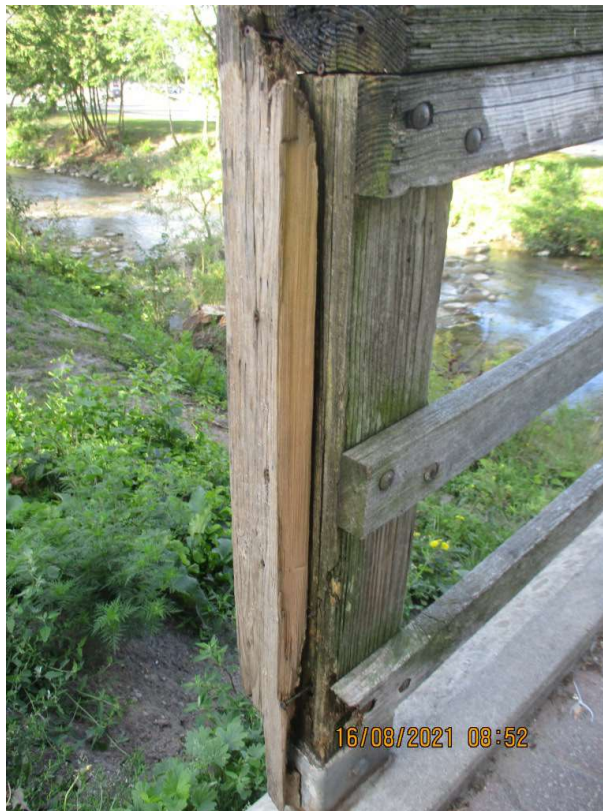
Figure 23 : SE Corner of Barrier_Evidence of Section Loss

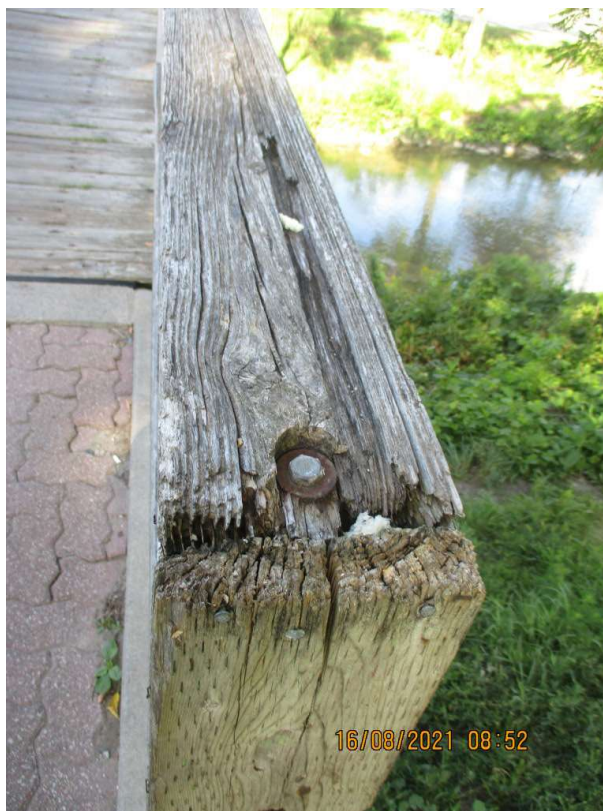
Figure 24 : NE Coener of Barrier_Evidence of Severe Rot

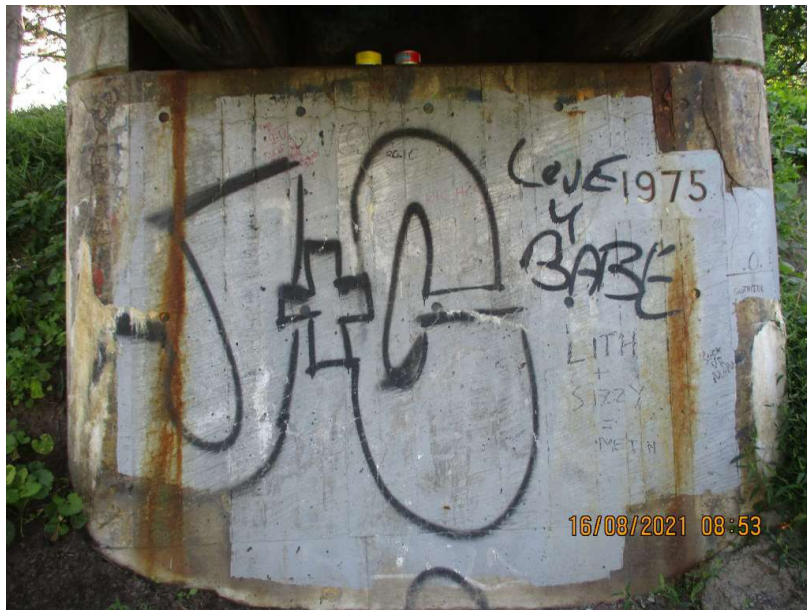
Figure 25 : East Abutment (Typ.)_ Evidence of Wide Transverse Cracks

Element Group:	Abutments		Length:	0.3			
Element Name:	Abutment Walls		Width:	2.0			
Location:	East & West Underside of Structure		Height:	1.3			
Material:	Concrete		Count (items):	2			
Element Type:	Reinforced Concrete Walls		Total Quantity:	6.2		m ²	
Environment:	Benign		Limited Inspection:				
Protection System:	None					Perform. Deficiencies	
Condition Data:	Units	Excellent	Good	Fair	Poor*		
	m ²		2.0	2.20	2.00	00	
Comments:	<ul style="list-style-type: none"> Evidence of wide cracks and delamination on east abutment, and severe spall with exposed rusted rebar, wide cracks and delamination on west abutment was noted. 						
Recommended Work:	<input checked="" type="checkbox"/>	Rehab		Replace	Maintenance Needs:		00
	<input checked="" type="checkbox"/>	1-5 years		6-10 years	Urgent	1 year	2 years
<ul style="list-style-type: none"> To conduct concrete repair to abutments.

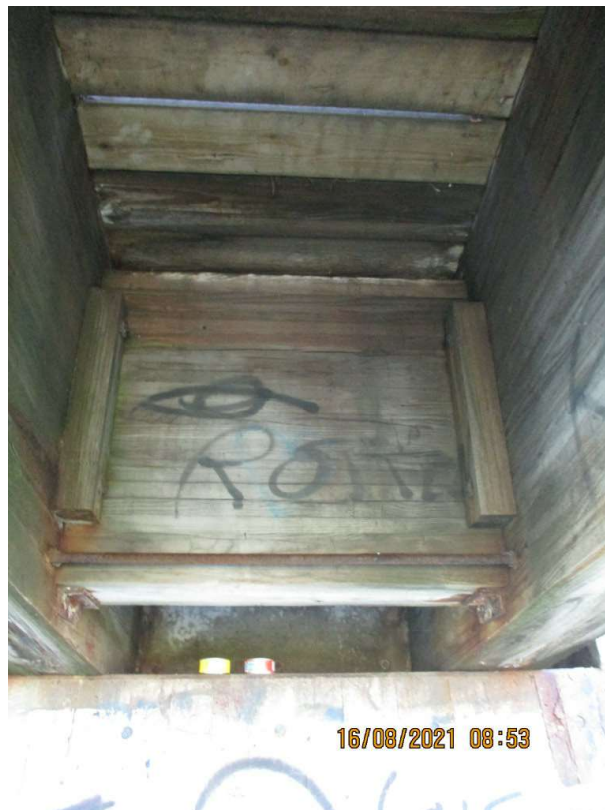
Figure 26 : Timber Diaphragm (Typ.)_ Evidence of Severe Corrosion on Connections

Element Group:	Beams/Main Longitudinal Element (MLE'S)		Length:				
Element Name:	Diaphragms		Width:				
Location:	Underside of Structure		Height:				
Material:	Wood		Count (items):	5.0			
Element Type:	Timber Diaphragm		Total Quantity:	5.0		Each	
Environment:	Benign		Limited Inspection:				
Protection System:	None					Perform. Deficiencies	
Condition Data:	Units	Excellent	Good	Fair	Poor*		
	Each			3.0	2.0	00	
Comments:	<ul style="list-style-type: none"> Evidence of minor rot on timber diaphragms, and severe corrosion on steel connections was noted. 						
Recommended Work:	<input checked="" type="checkbox"/>	Rehab		Replace	Maintenance Needs:		00
	<input checked="" type="checkbox"/>	1-5 years		6-10 years	Urgent	1 year	2 years
<ul style="list-style-type: none"> To replace diaphragm corroded connections.

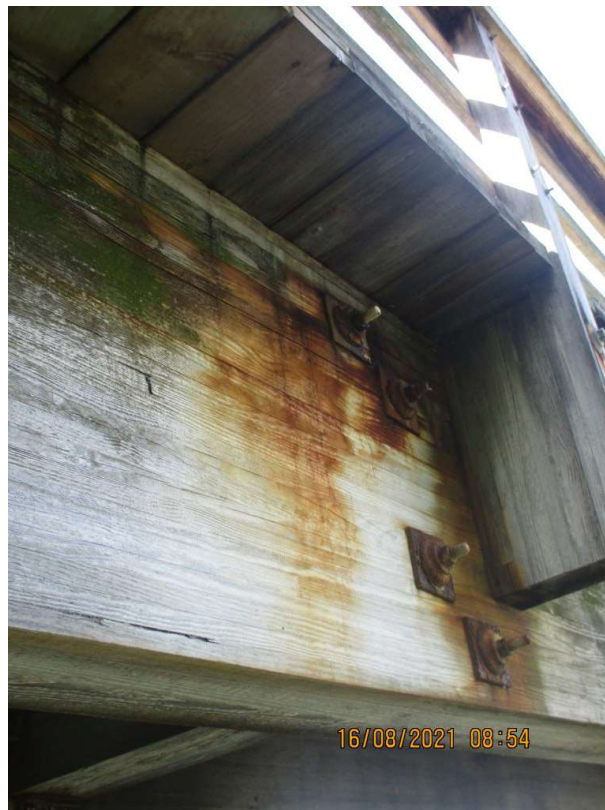
Figure 28 : Post Tensioning Rod Ends_Evidence of Medium to Severe Corrosion

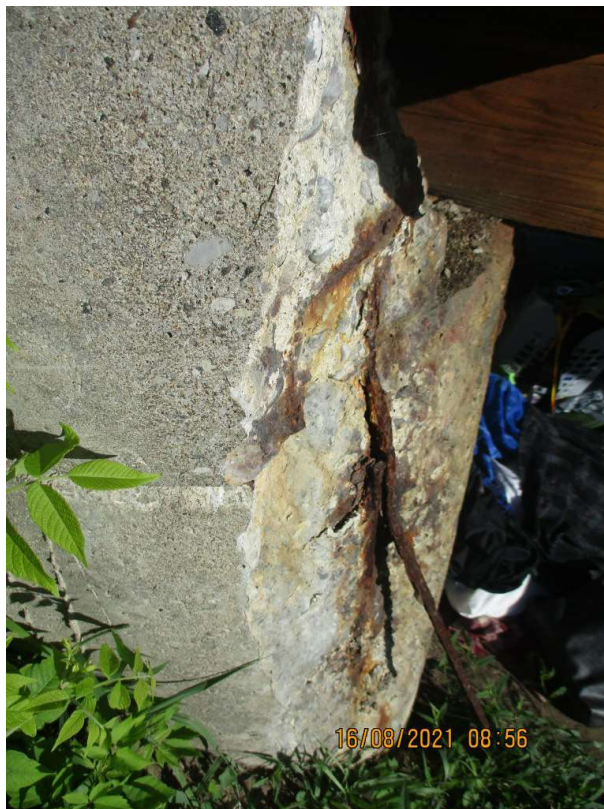
Figure 30 : West Abutment_Evidence of Severe Spall with Exposed Rusted Rebar

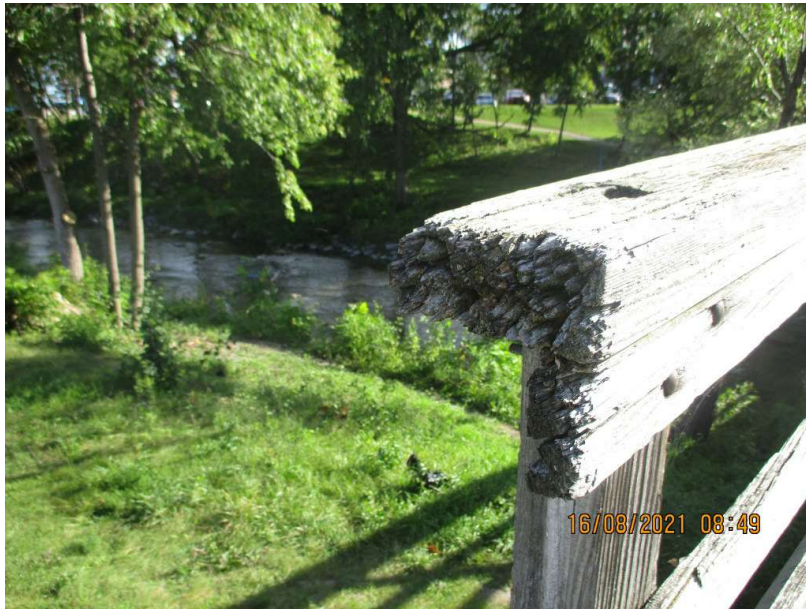
Figure 31 : Approach Barrier_Evidence of Medium Rot
