Report Number: DS-22-51

Subject: Results of Staff Investigation regarding a Water Drainage Issue
at 903 Black Cherry Drive

Item: DS-22-51
Attachment 2

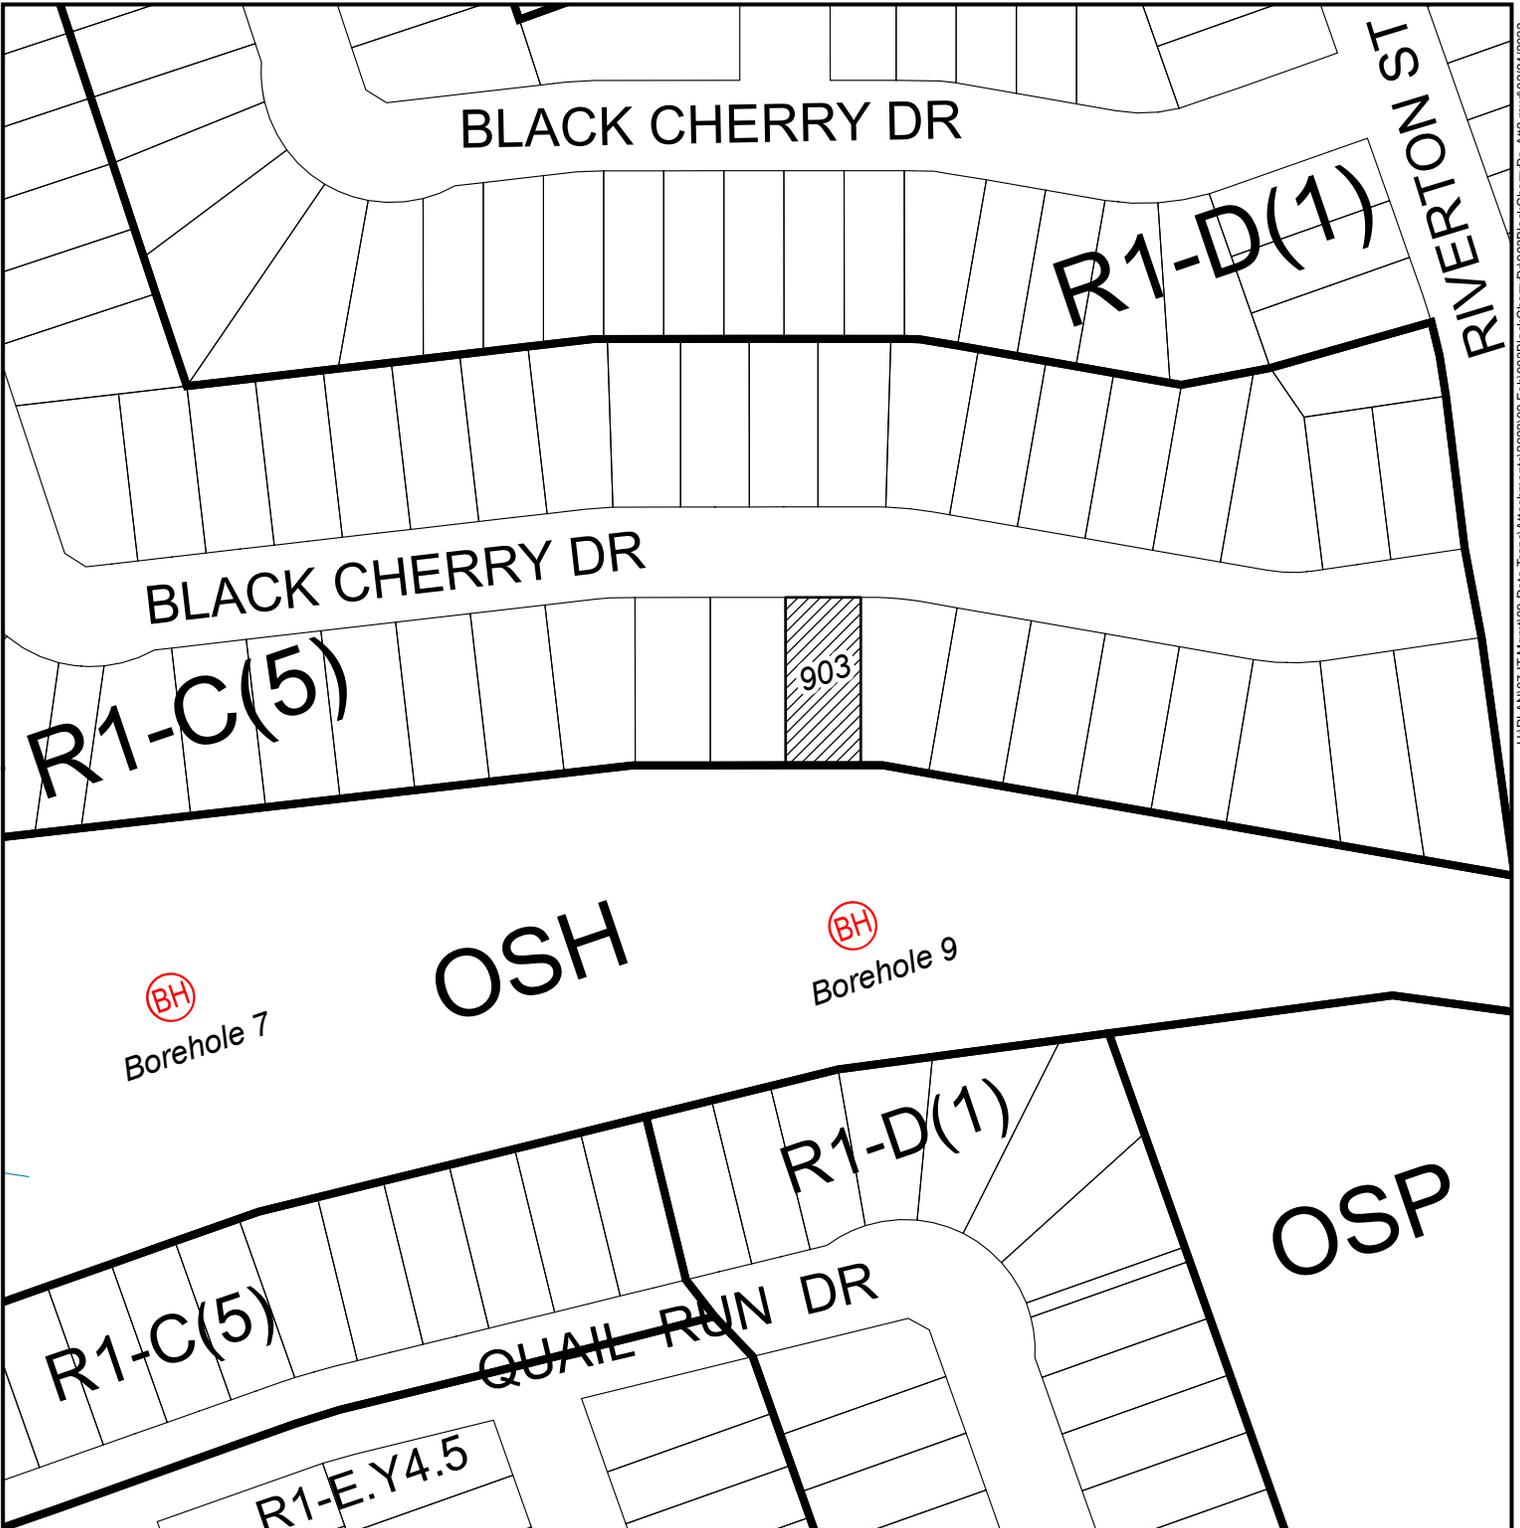
- The general area surrounding 903 Black Cherry Drive was a drumlinized till plain consisting of glacial tills and containing layers of water bearing sand;
- Shallow groundwater conditions were noted in 24 of the 72 boreholes ranging in depth from 0.3 metres (1 foot) to 6.1 metres (20 feet); and,
- The shallowest water level was detected in Boreholes 7 and 9, both of which are in the Open Space Block 89 in Plan 40M-2264 in proximity to 903 Black Cherry Dr. (see Attachment 2).

The Geotechnical Investigation dated May 10, 1995 prepared by Golder Associates Ltd. indicates the location of boreholes (see Attachment 2). As noted in the Geotechnical Report, Boreholes 7 and 9 had the shallowest groundwater table. When considering the

underlying soil condition is water bearing sand, it is staff's opinion that groundwater and not surface water is the likely cause of the issues experienced by the pool.
