Economic and Development Services Committee – April 17, 2023

Application for Demolition of 195 Simcoe Street North under Section 34, Part IV of the Ontario Heritage Act (File: 12-04-0319) (Ward 4)

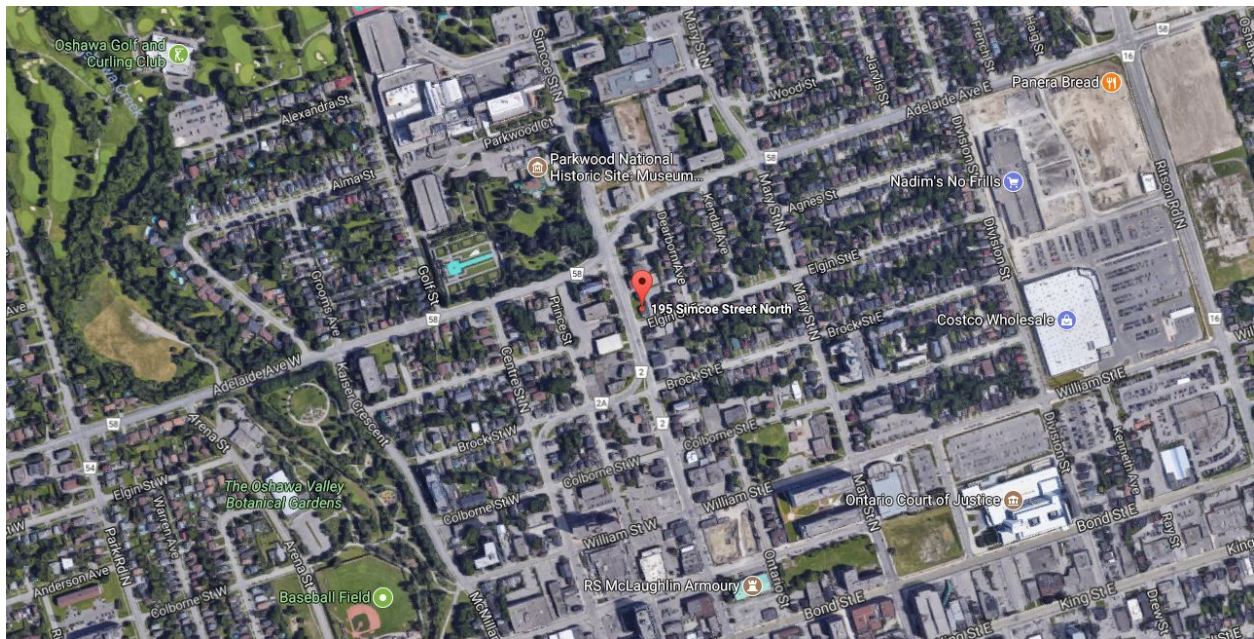
Location of 195 Simcoe Street North, Google Map August 2017

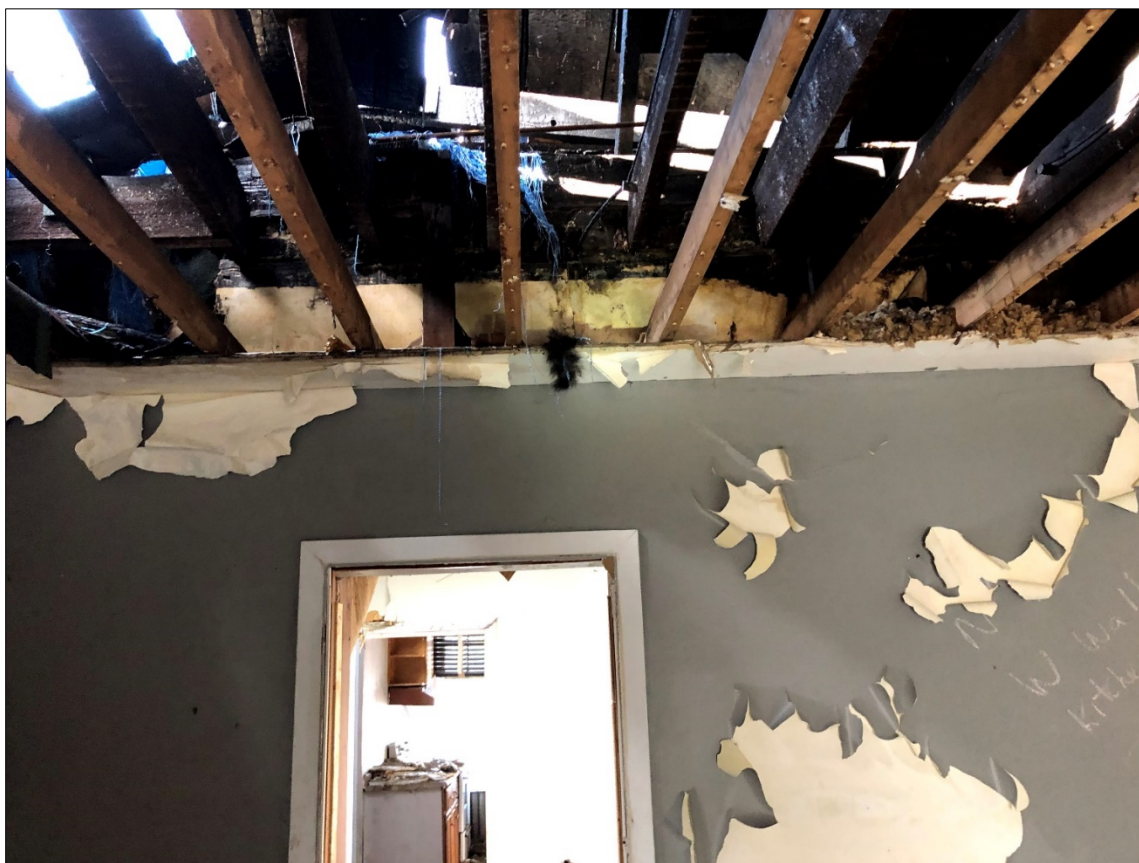
Figure 2: View of deteriorated roof and collapsed second level ceiling

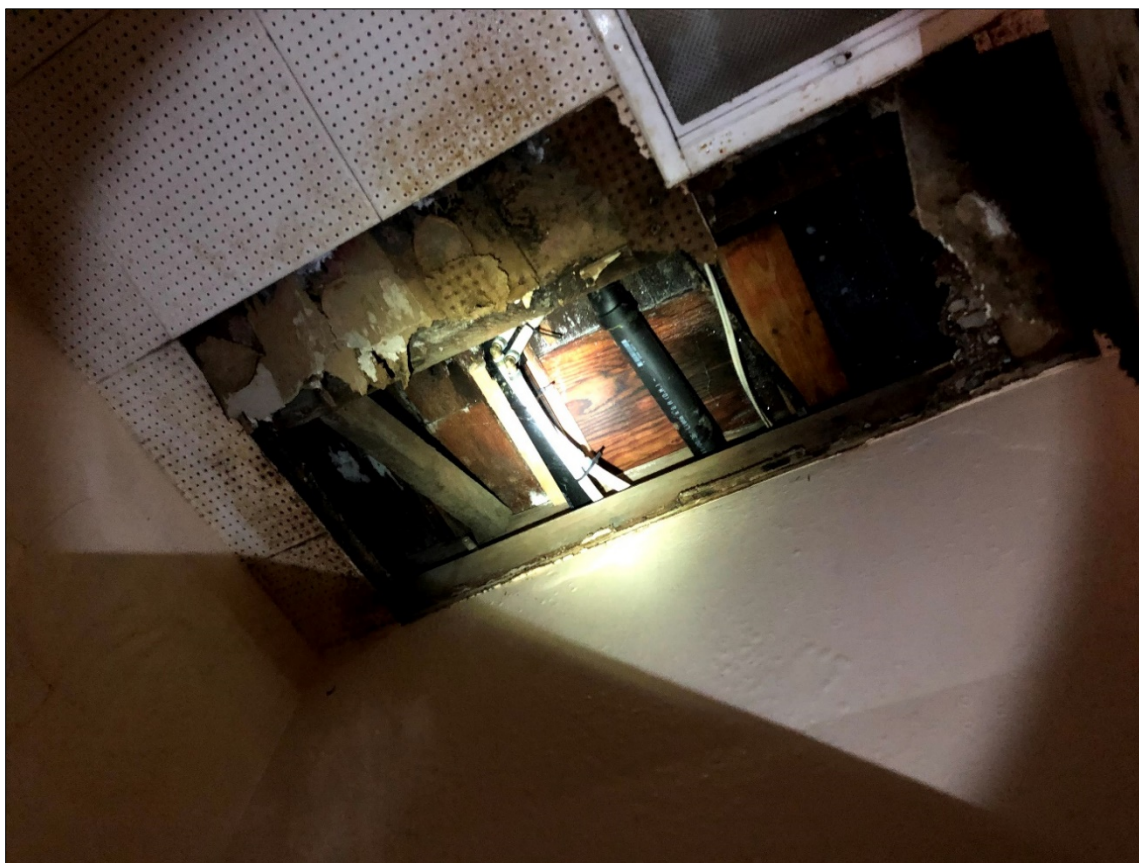
Figure 4: View of collapsing main level ceiling and water and mould damage in ceiling void

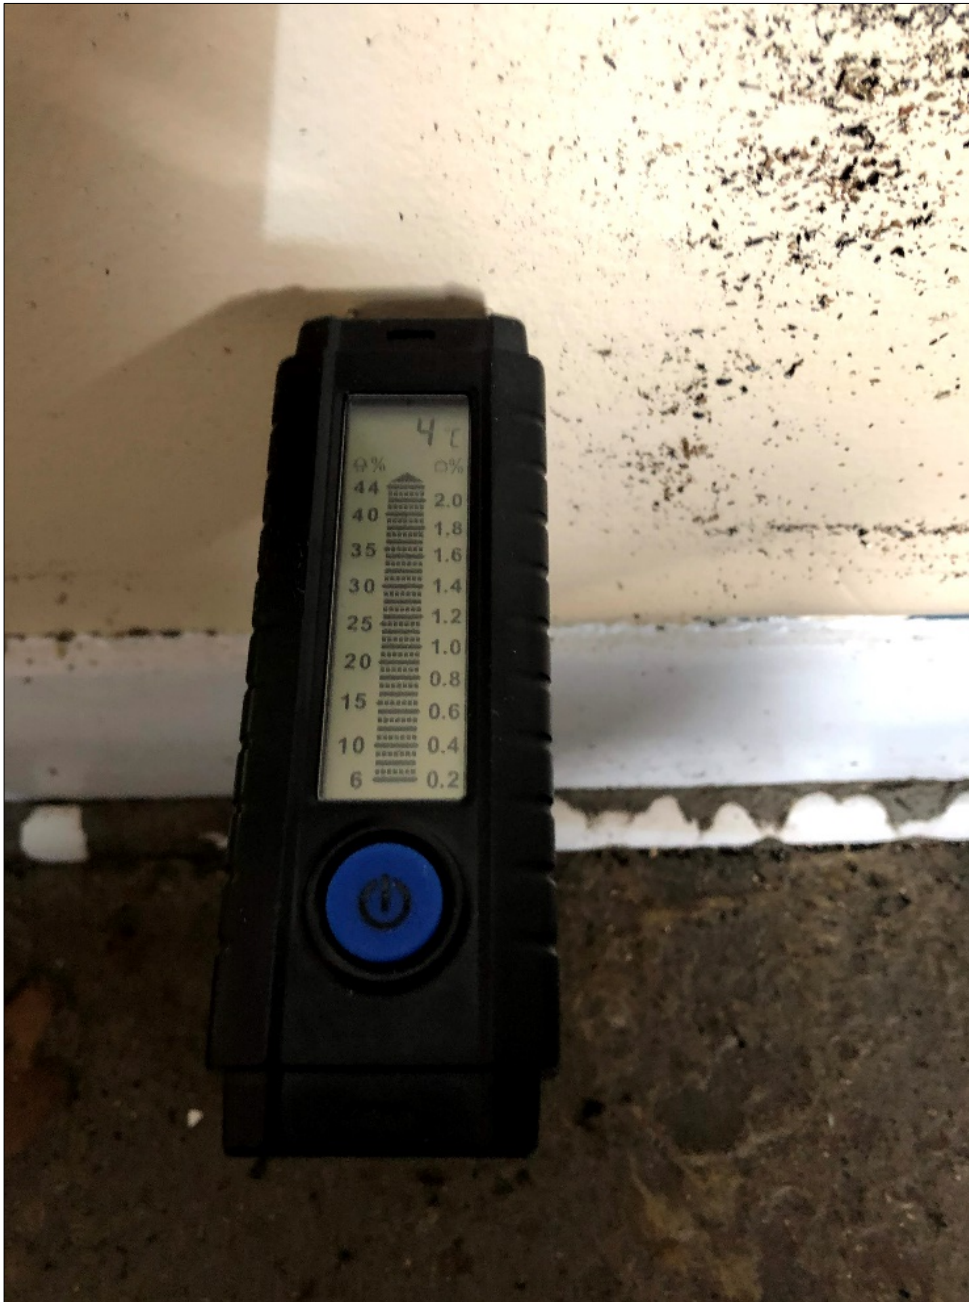
Figure 6: View of moisture meter confirming elevated moisture readings from wall finishes

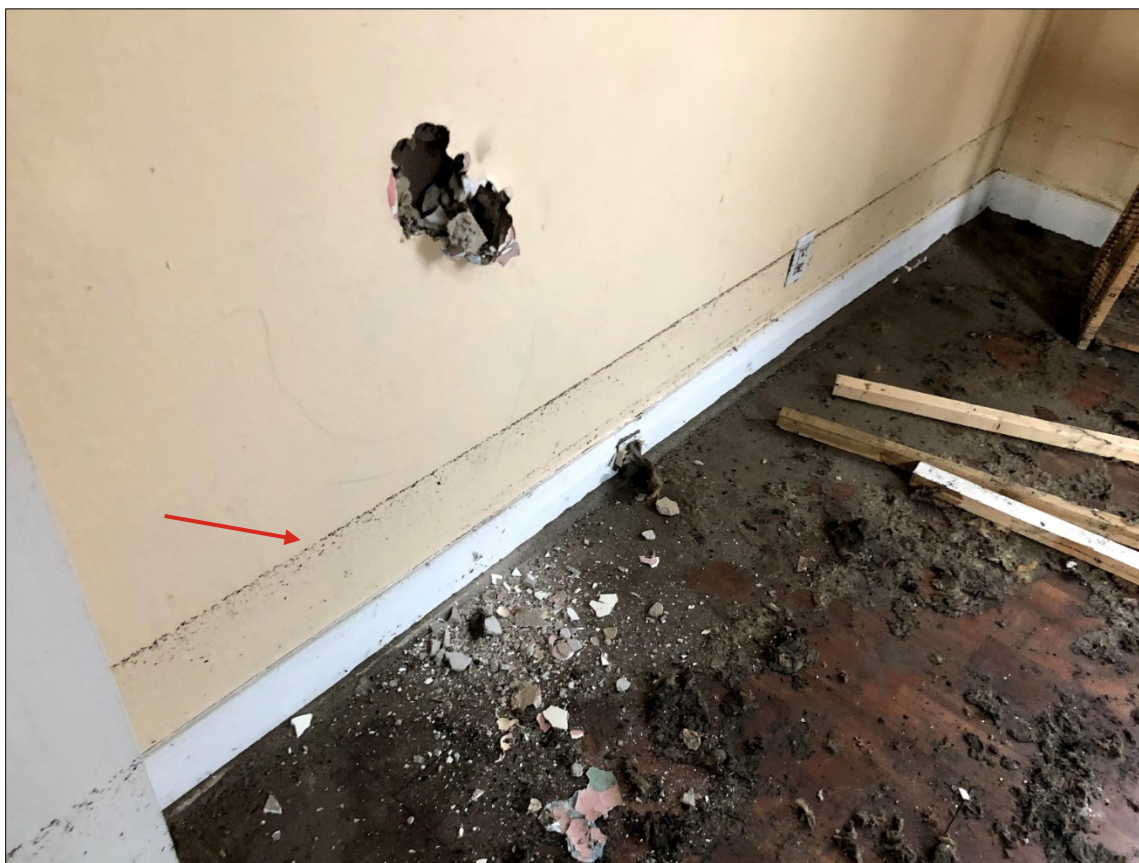
Figure 8: View of water staining line throughout main level and smoke impacted wall finishes in northeast bedroom (Sample S-4)

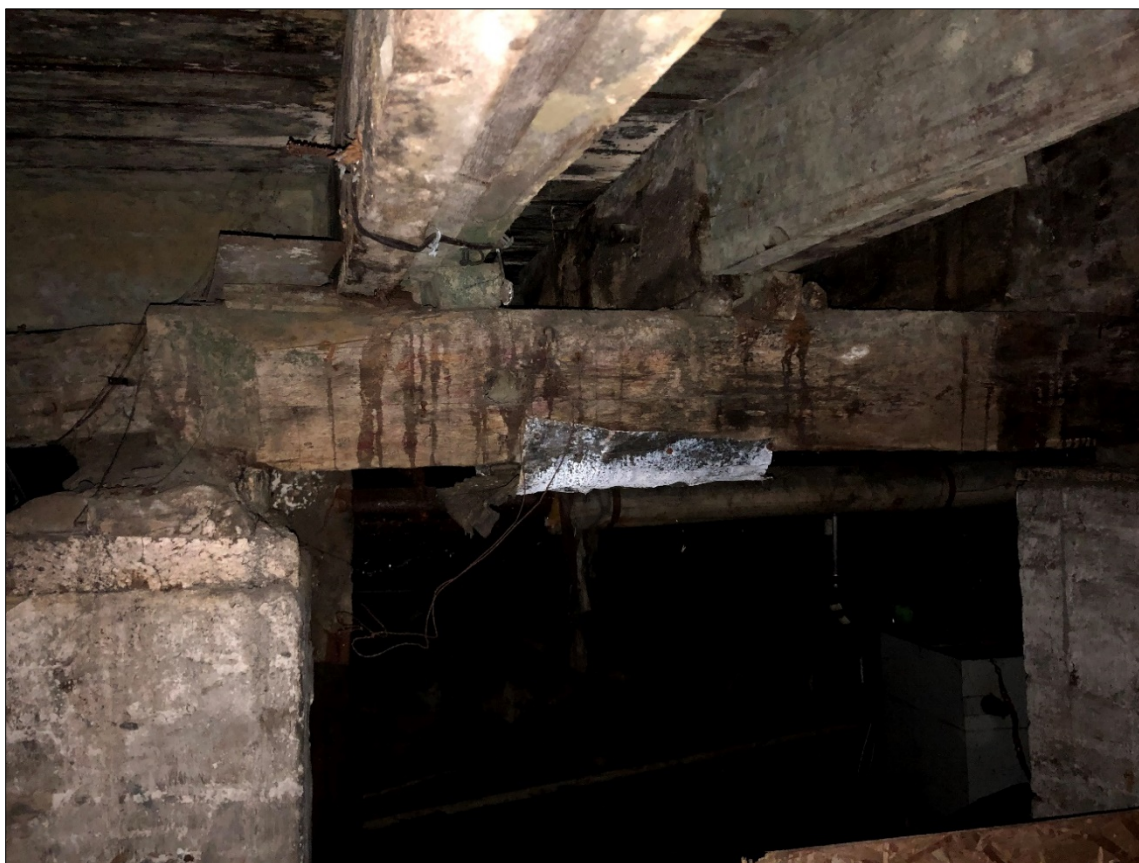
Figure 10: View of wood rot and mould impacts on basement structural members

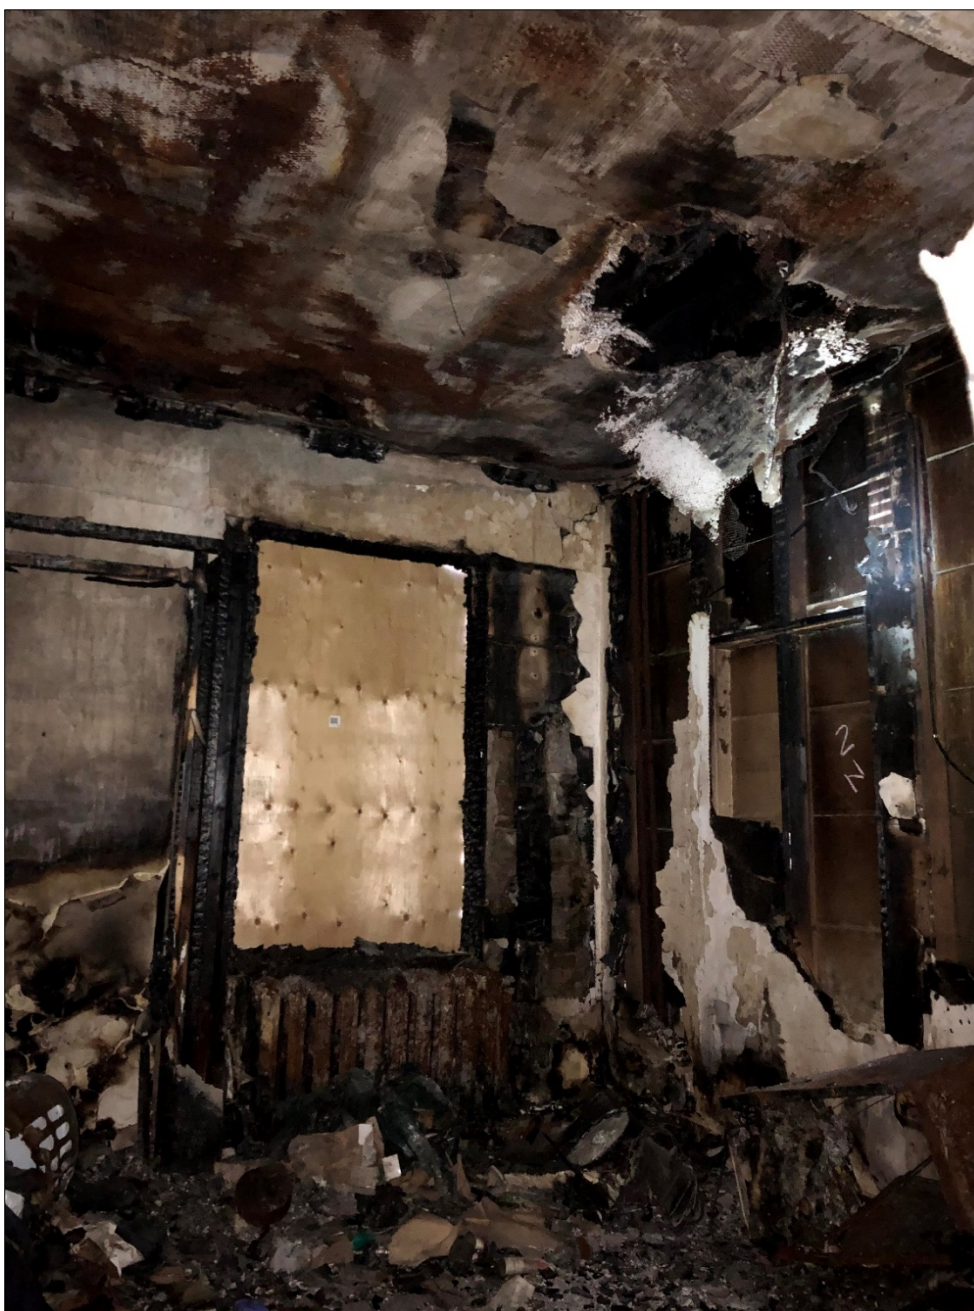
Figure 11: View of structurally damaged main level southwest bedroom wall (Sample S-1)

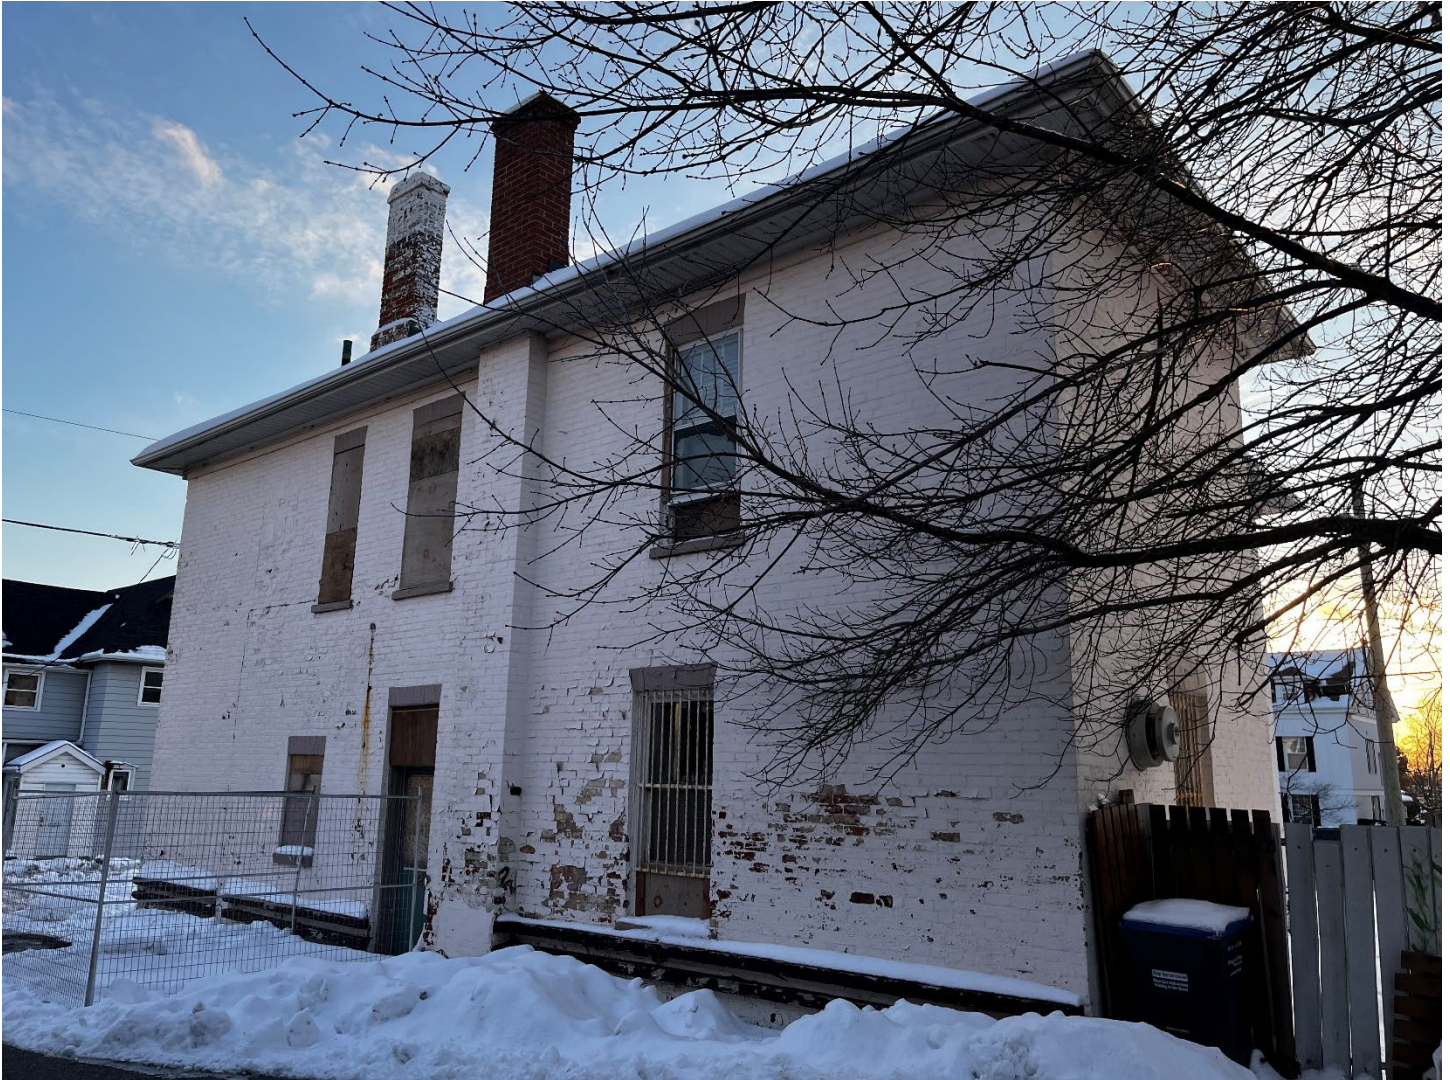
Figure 5 - Rear of building, showing damaged brick, replaced or removed original windows.

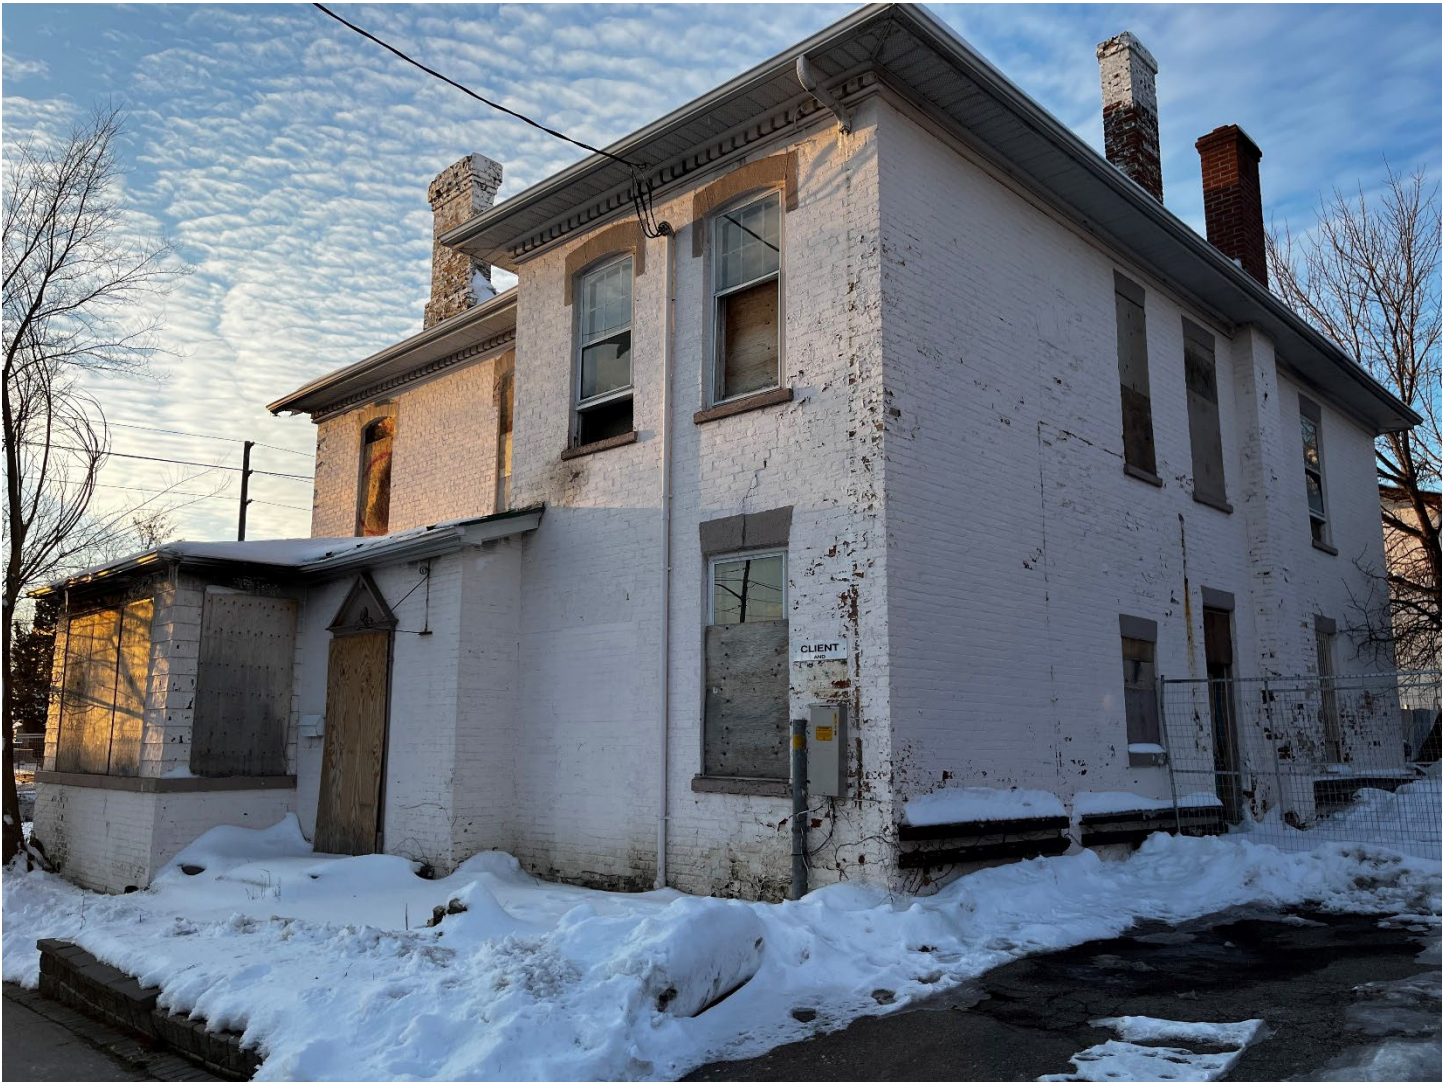
Figure 6 - Rear and South Side of building, showing deterioration of brick, replaced and removed windows, and a portion of the fire damaged section of the building. The enclosed sunroom and door was a later modification.

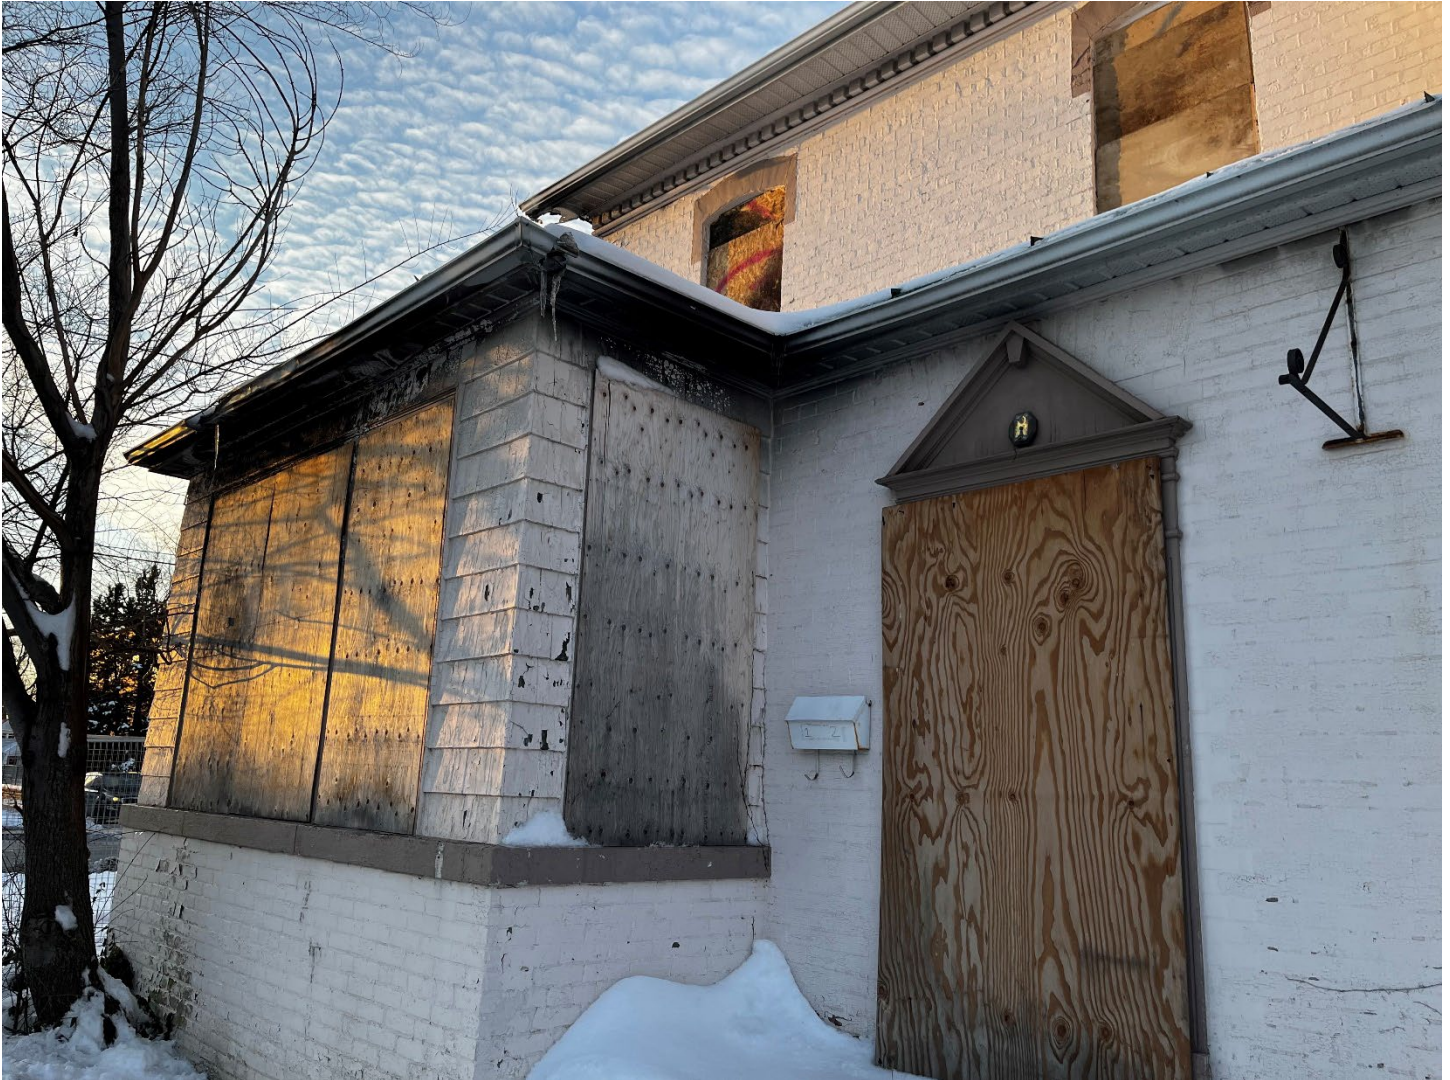
Figure 7 - Fire damage shown around the sunroom

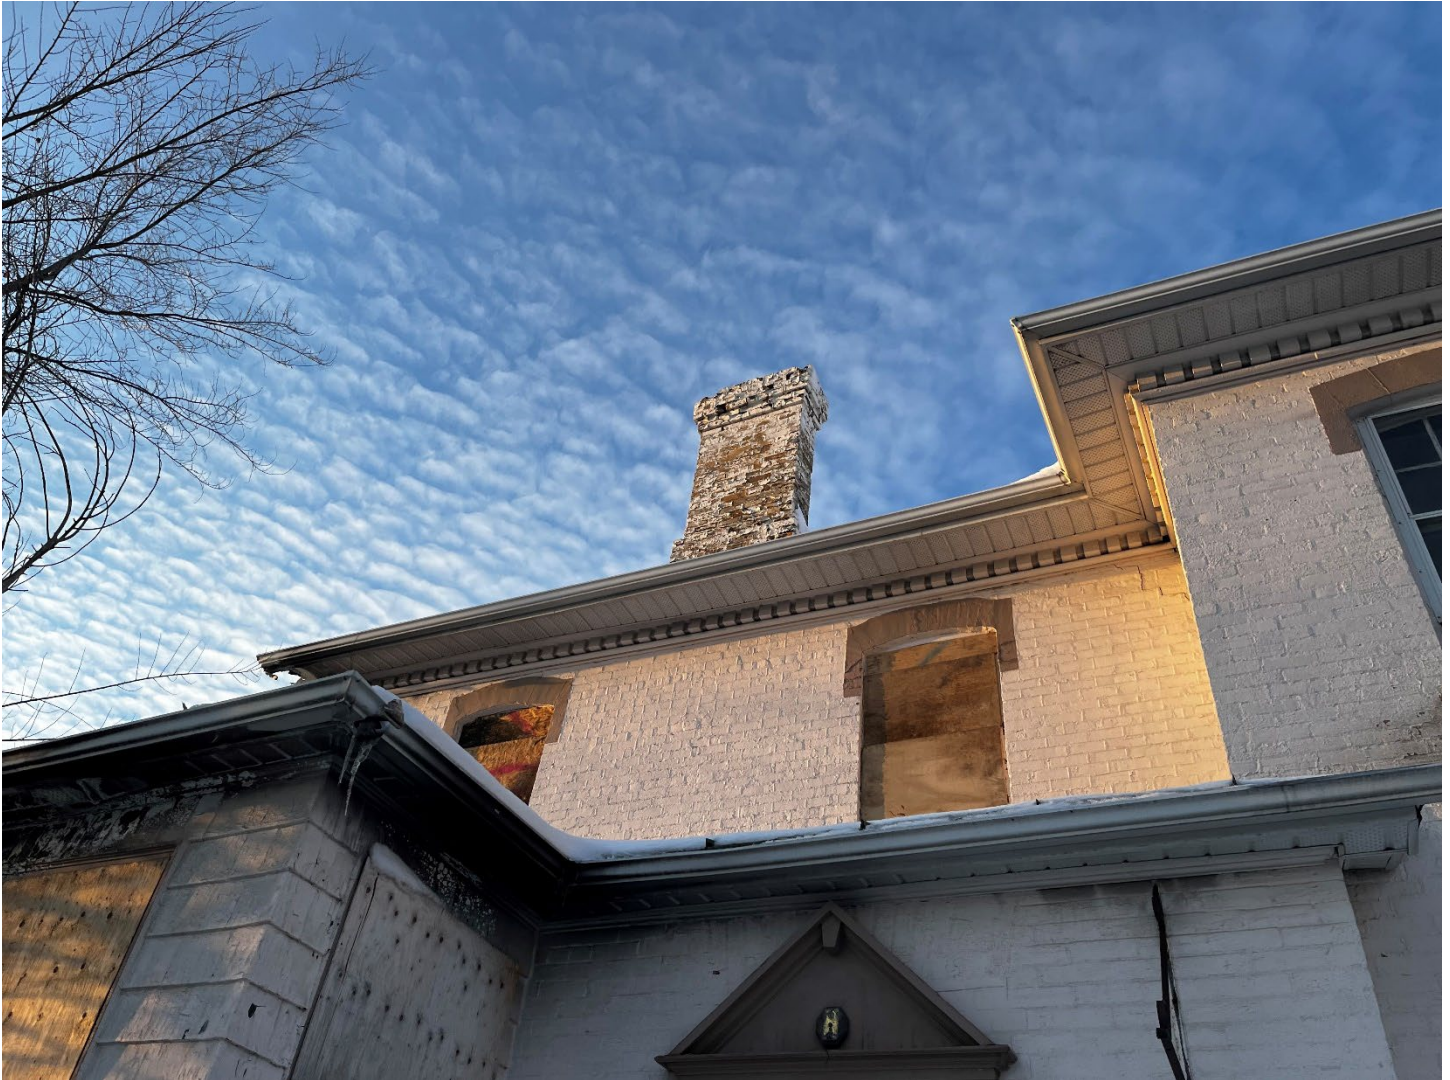
Figure 8 - Deteriorating chimney with potential for restoration

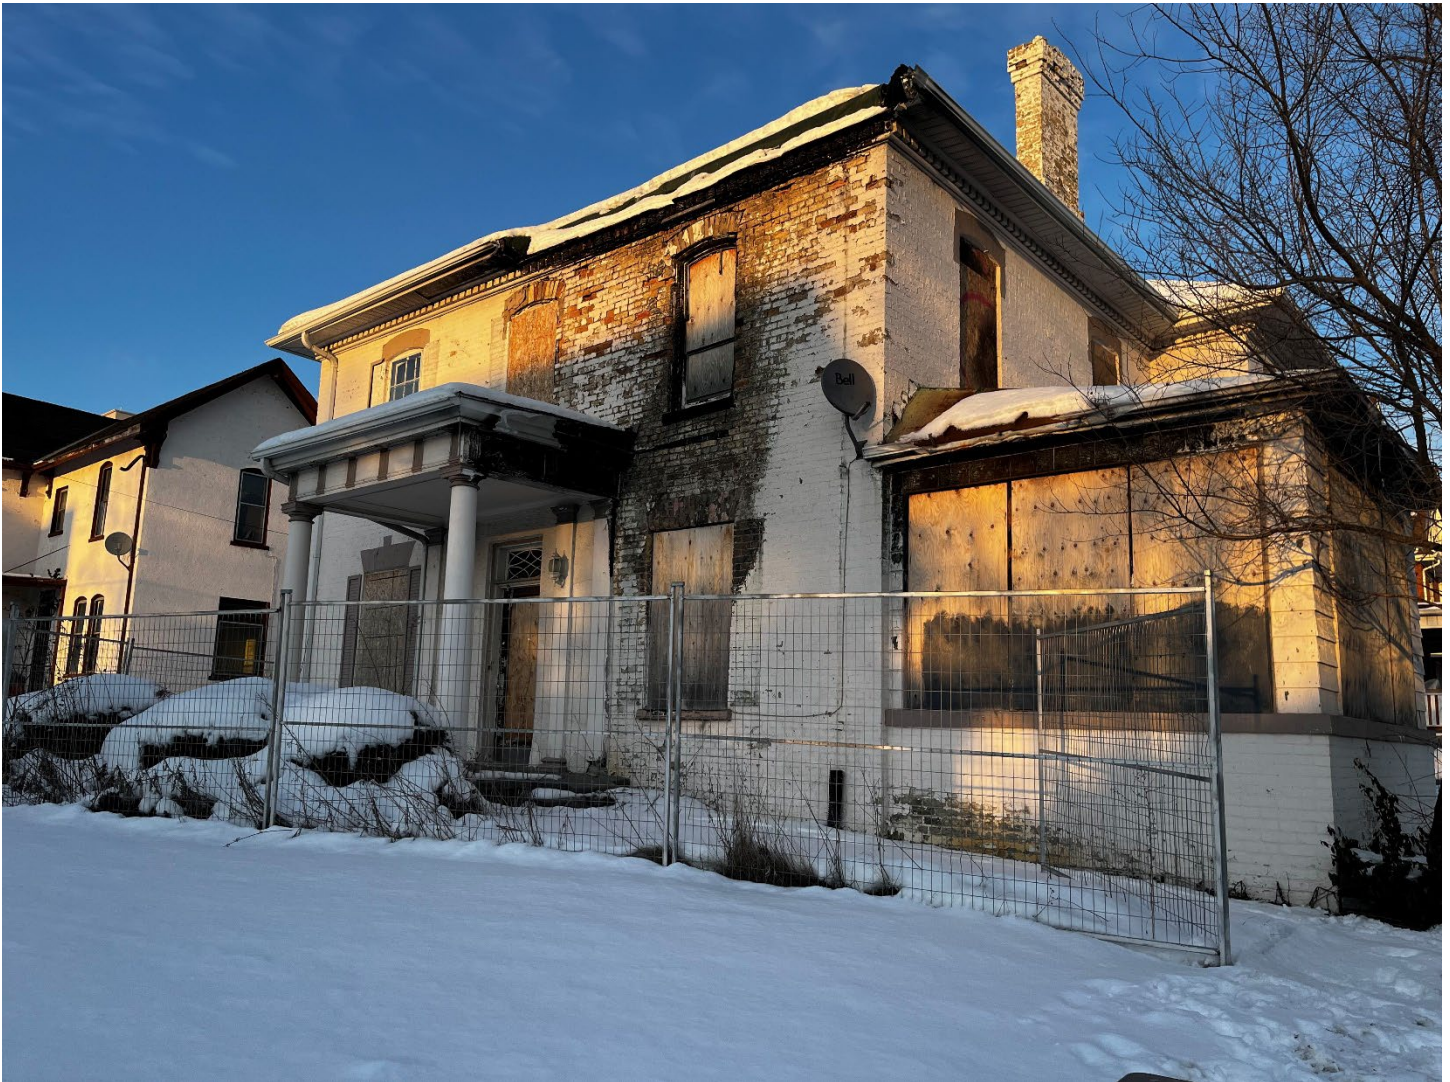
Figure 9 - Front of the building showing extreme fire damage and paint burning off the front.

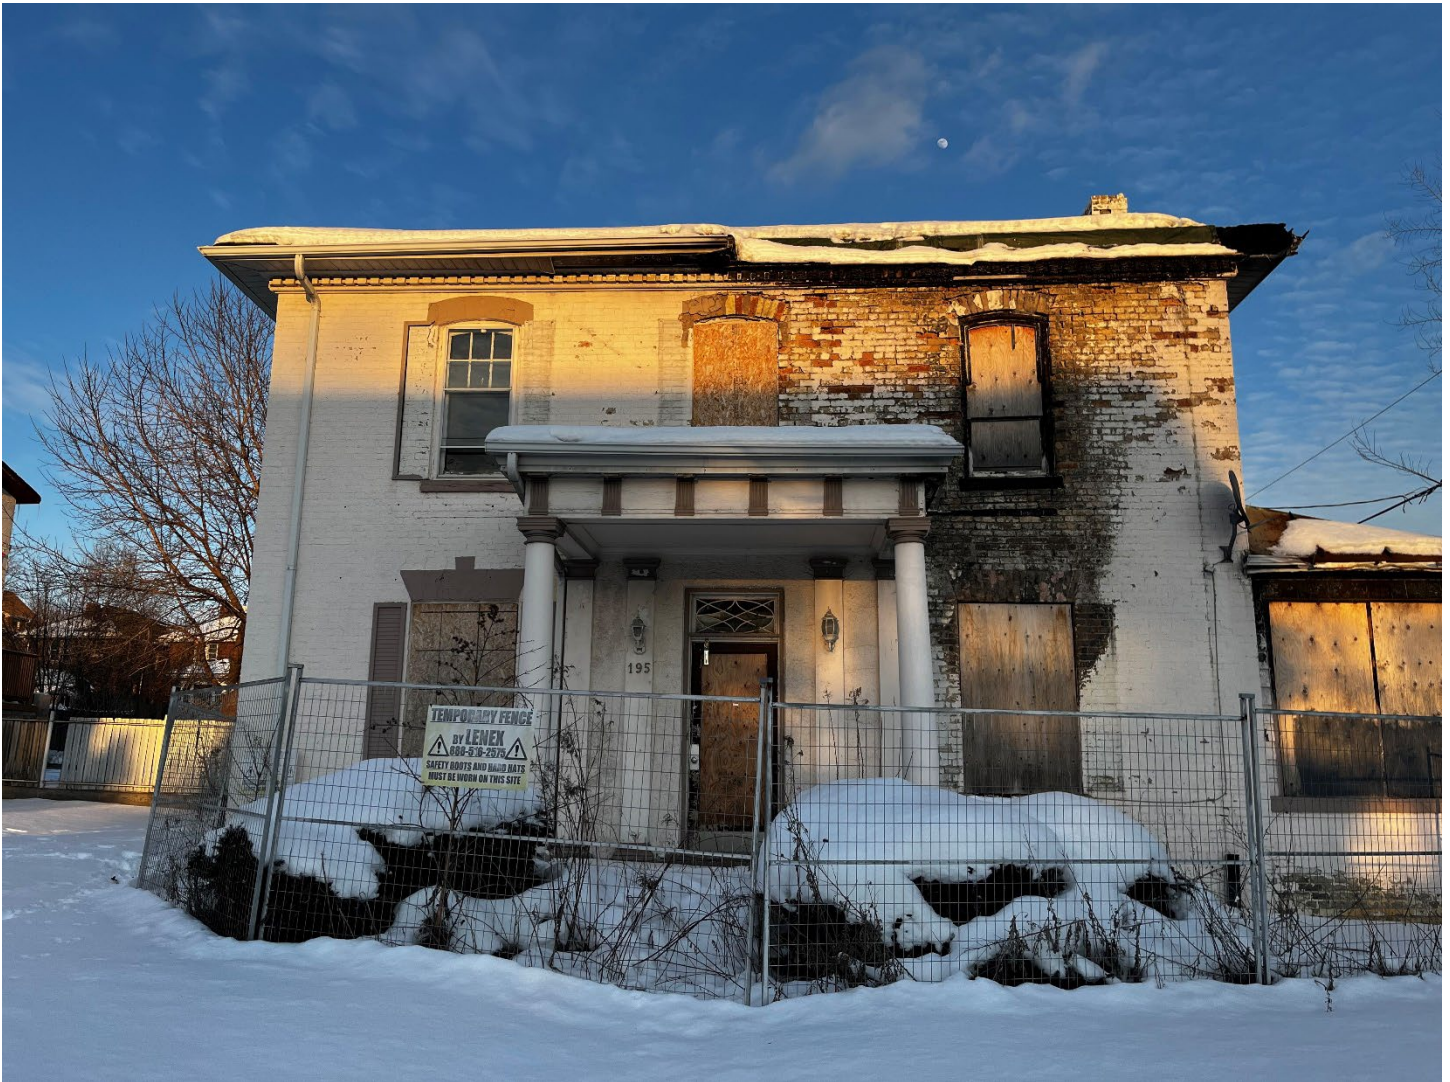
Figure 10 - Front of the building showing window treatments, fire damage, and structurally failing porch.

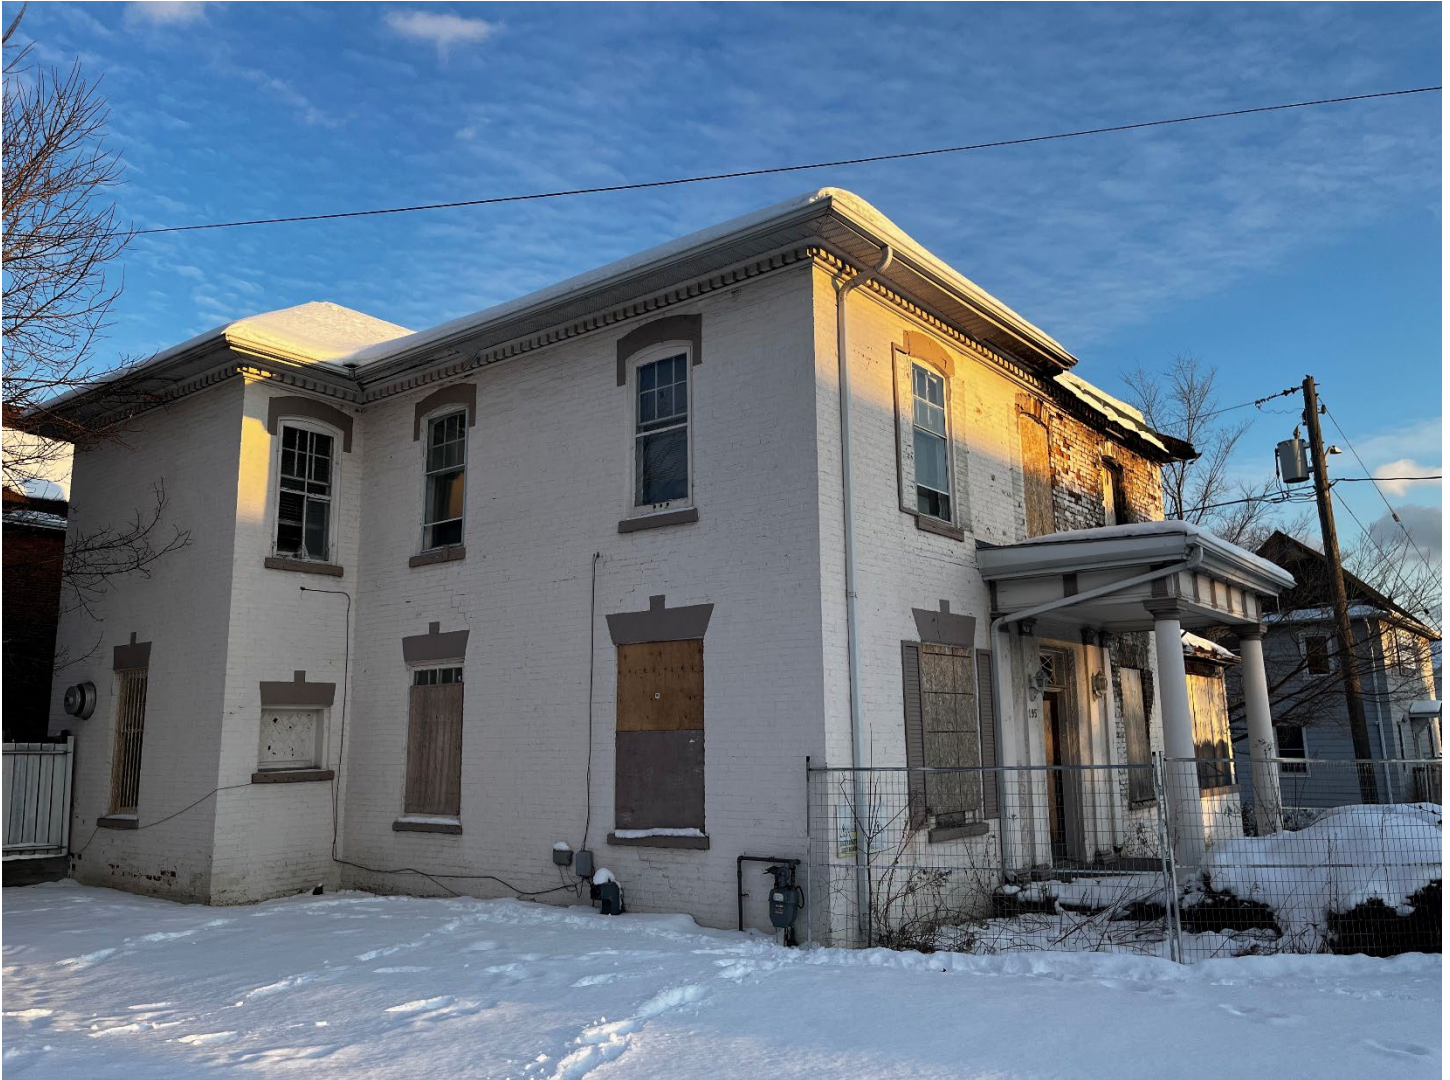
Figure 11 - North West corner of building showing removed or replaced windows.

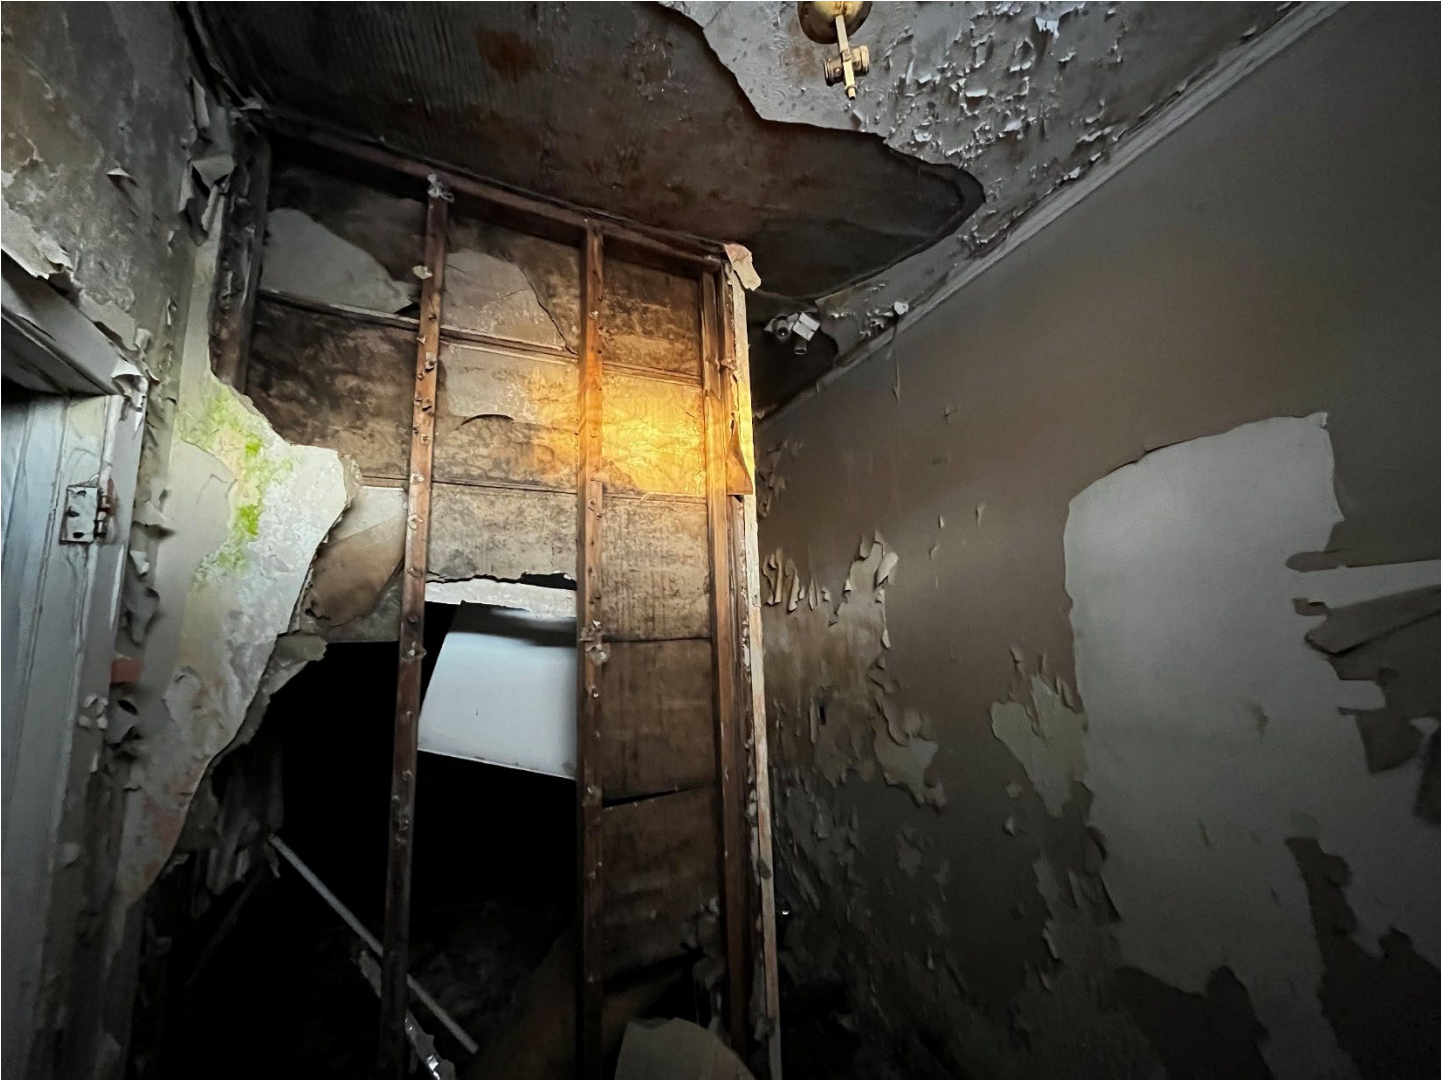
Figure 12 - Interior, showing damage.

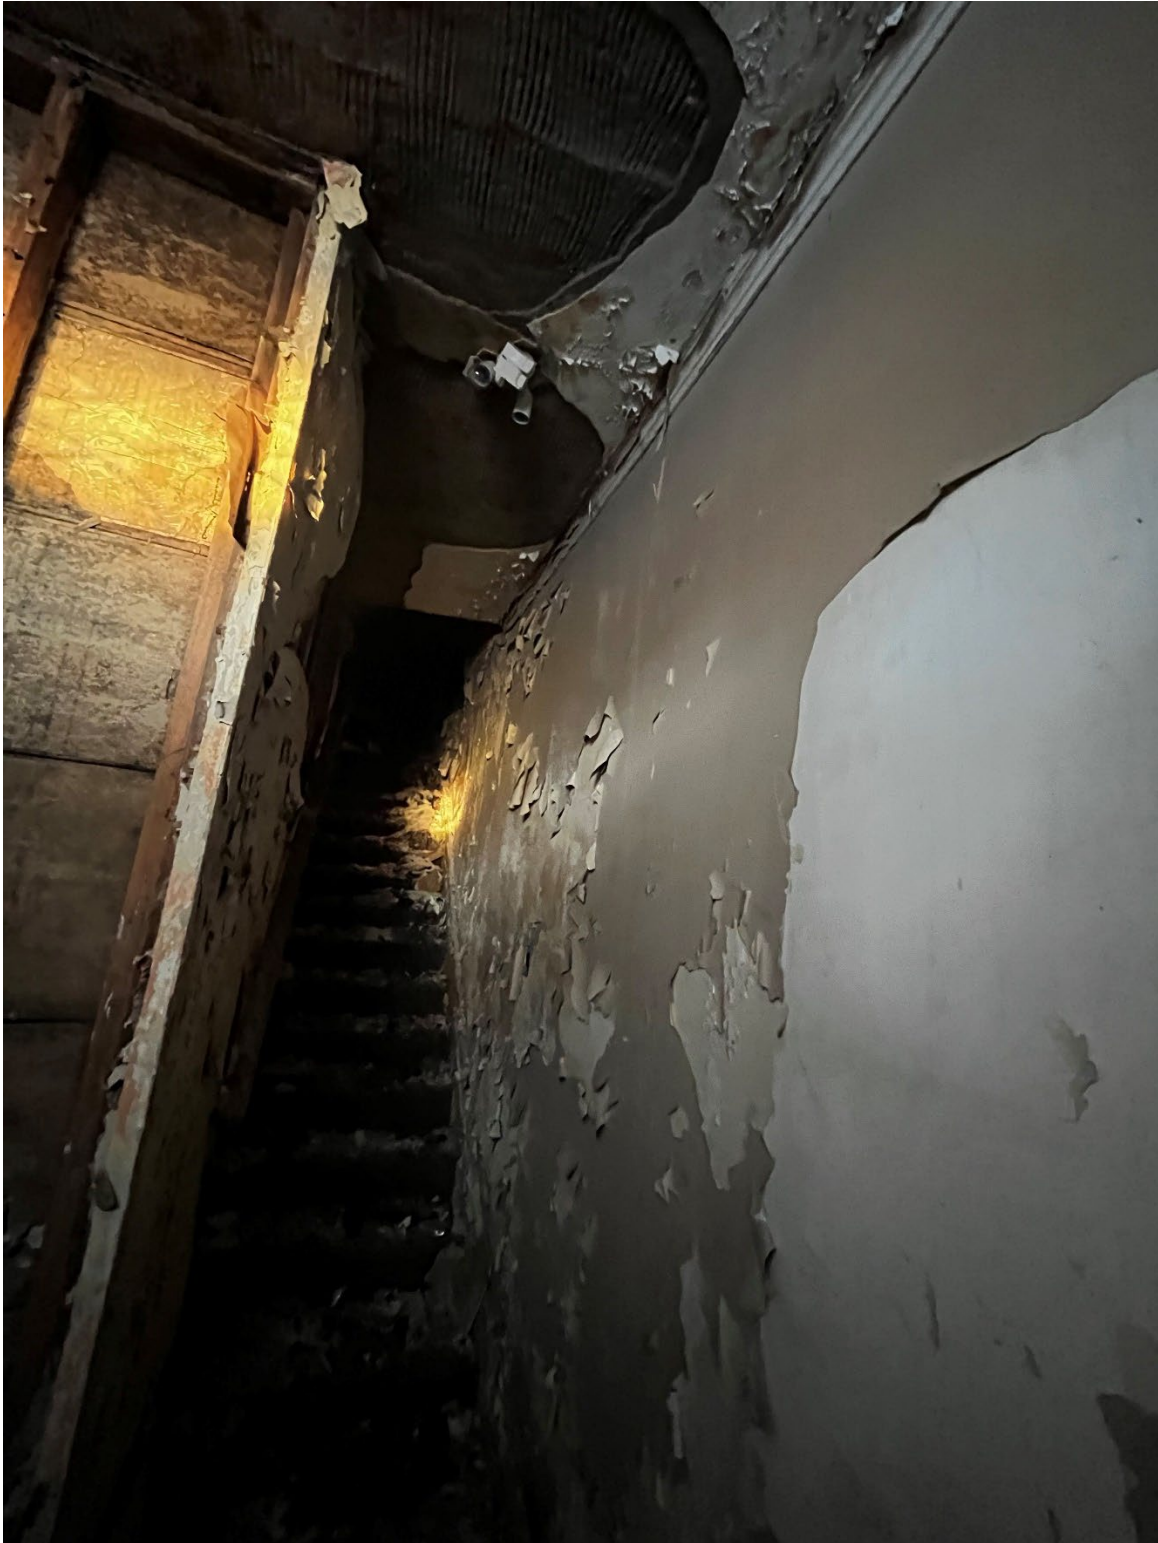
Figure 13 - Staircase showing significant damage.
