Economic and Development Services Committee – April 17, 2023

Application for Demolition of 195 Simcoe Street North under Section 34, Part IV of the Ontario Heritage Act (File: 12-04-0319) (Ward 4)

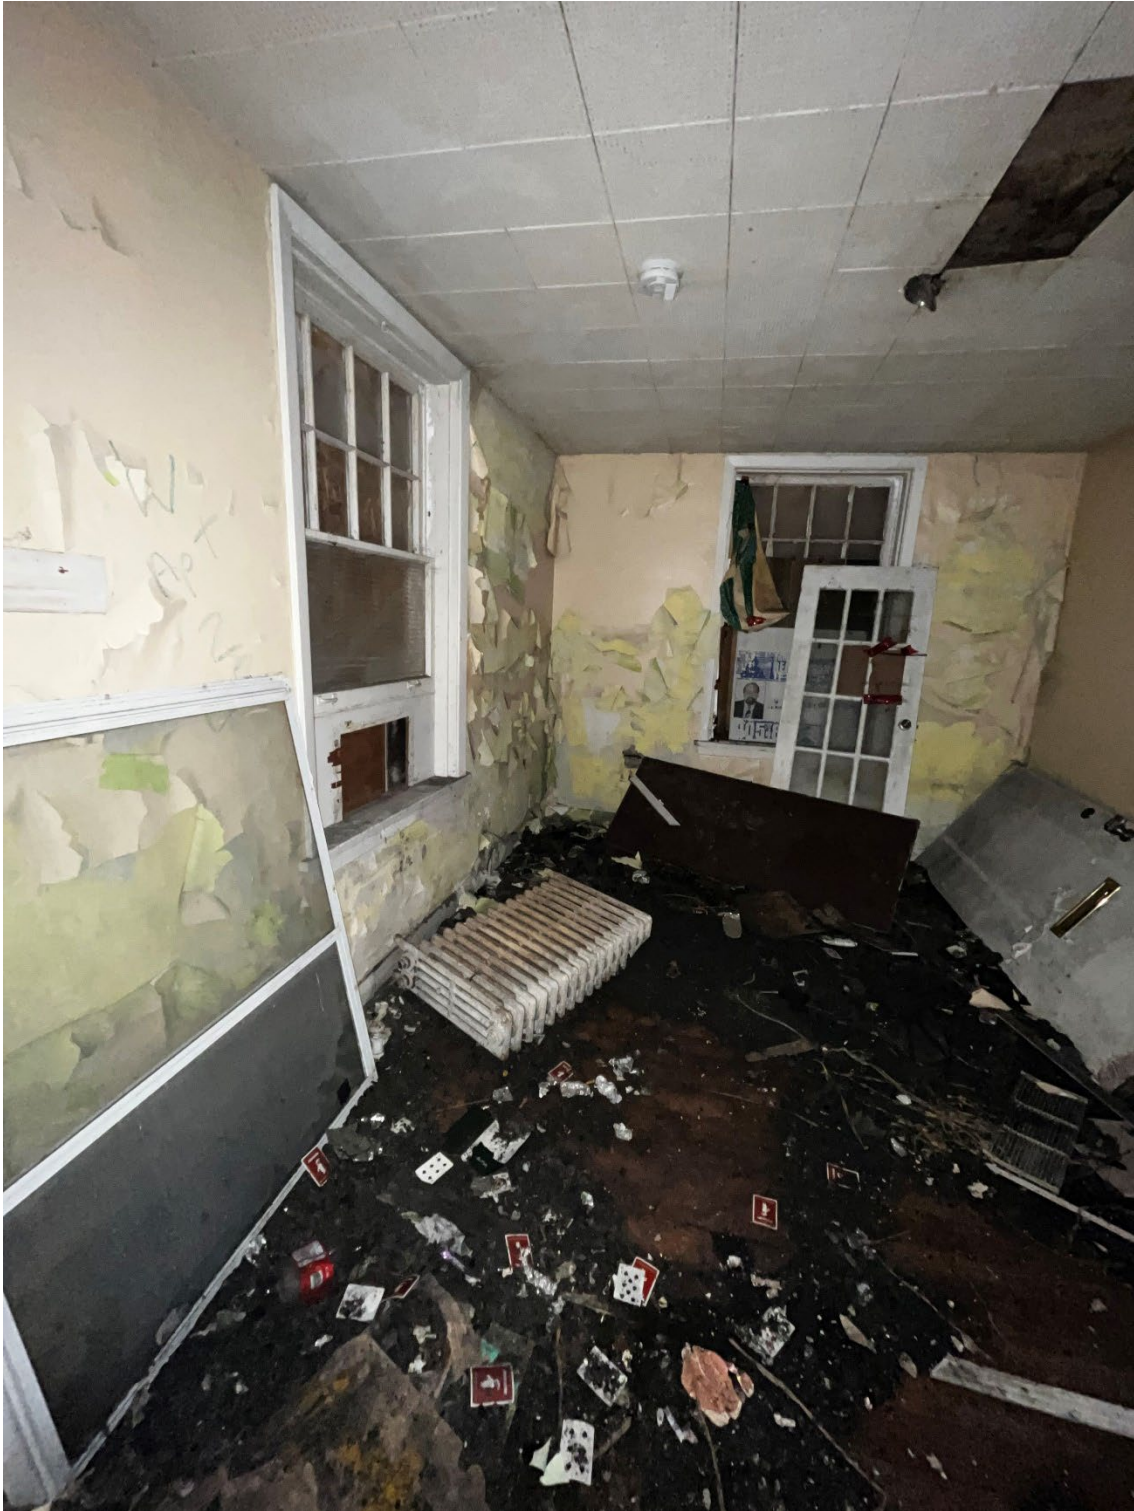
Figure 14 - Showing significant damage

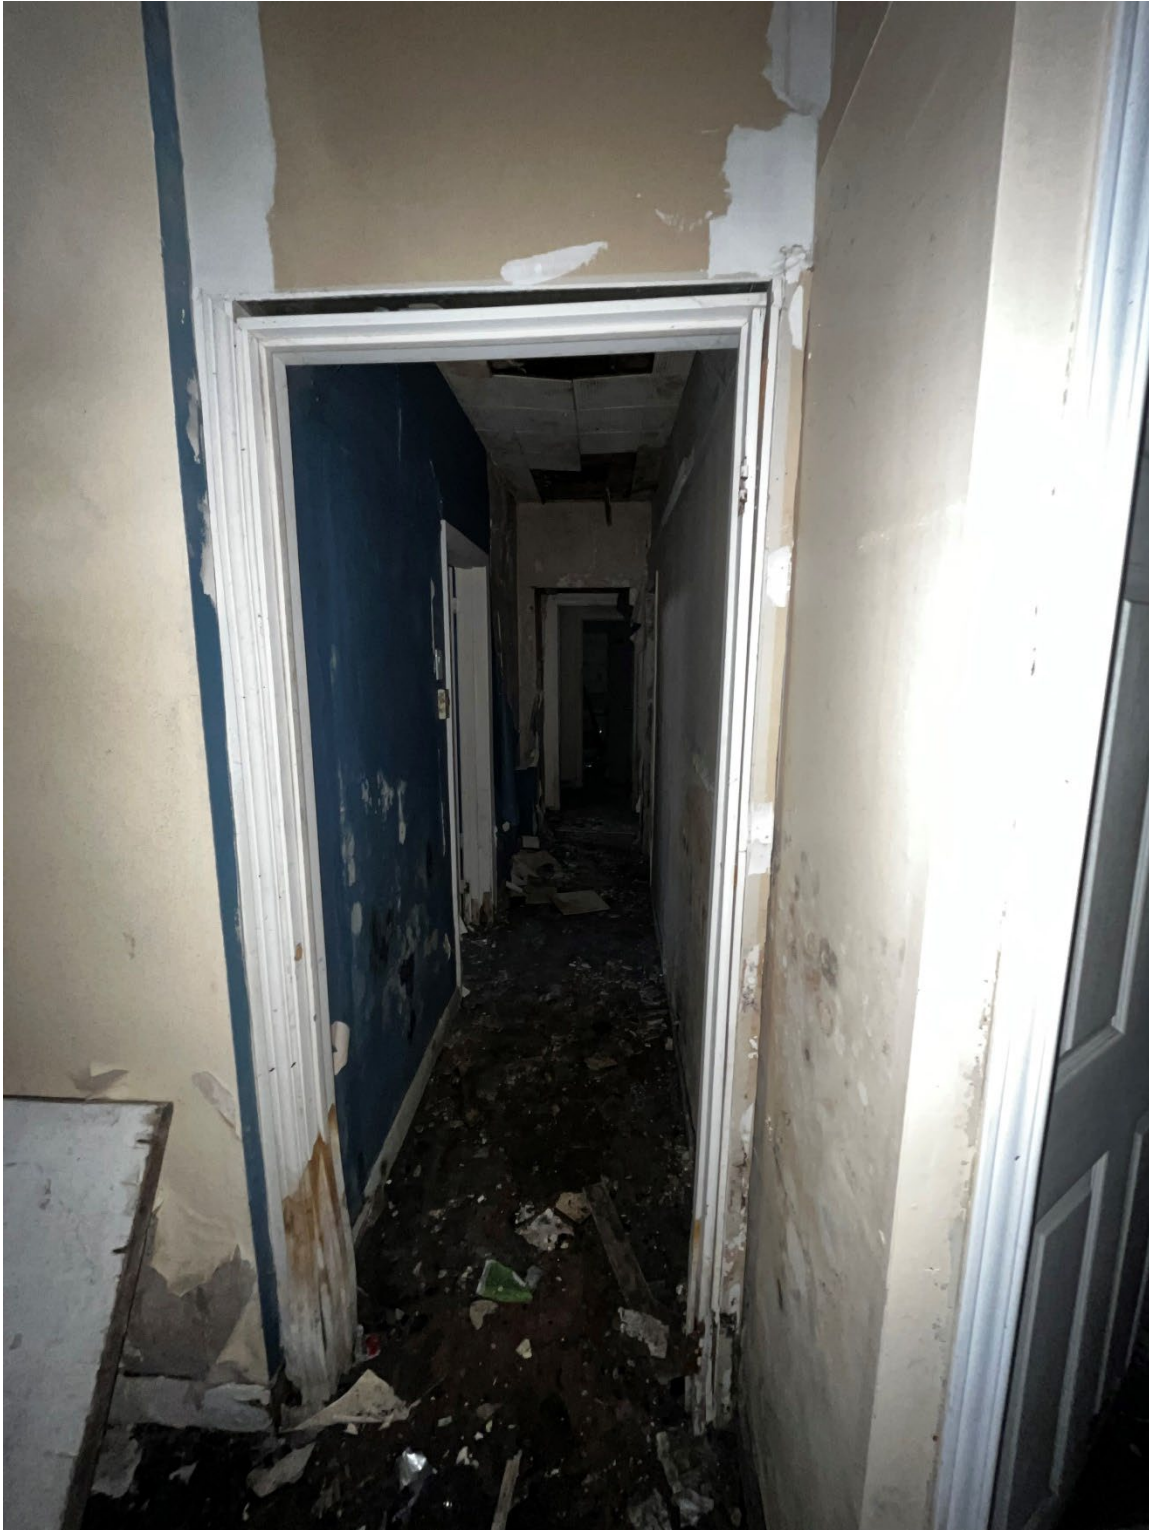
Figure 15 - Showing significant damage

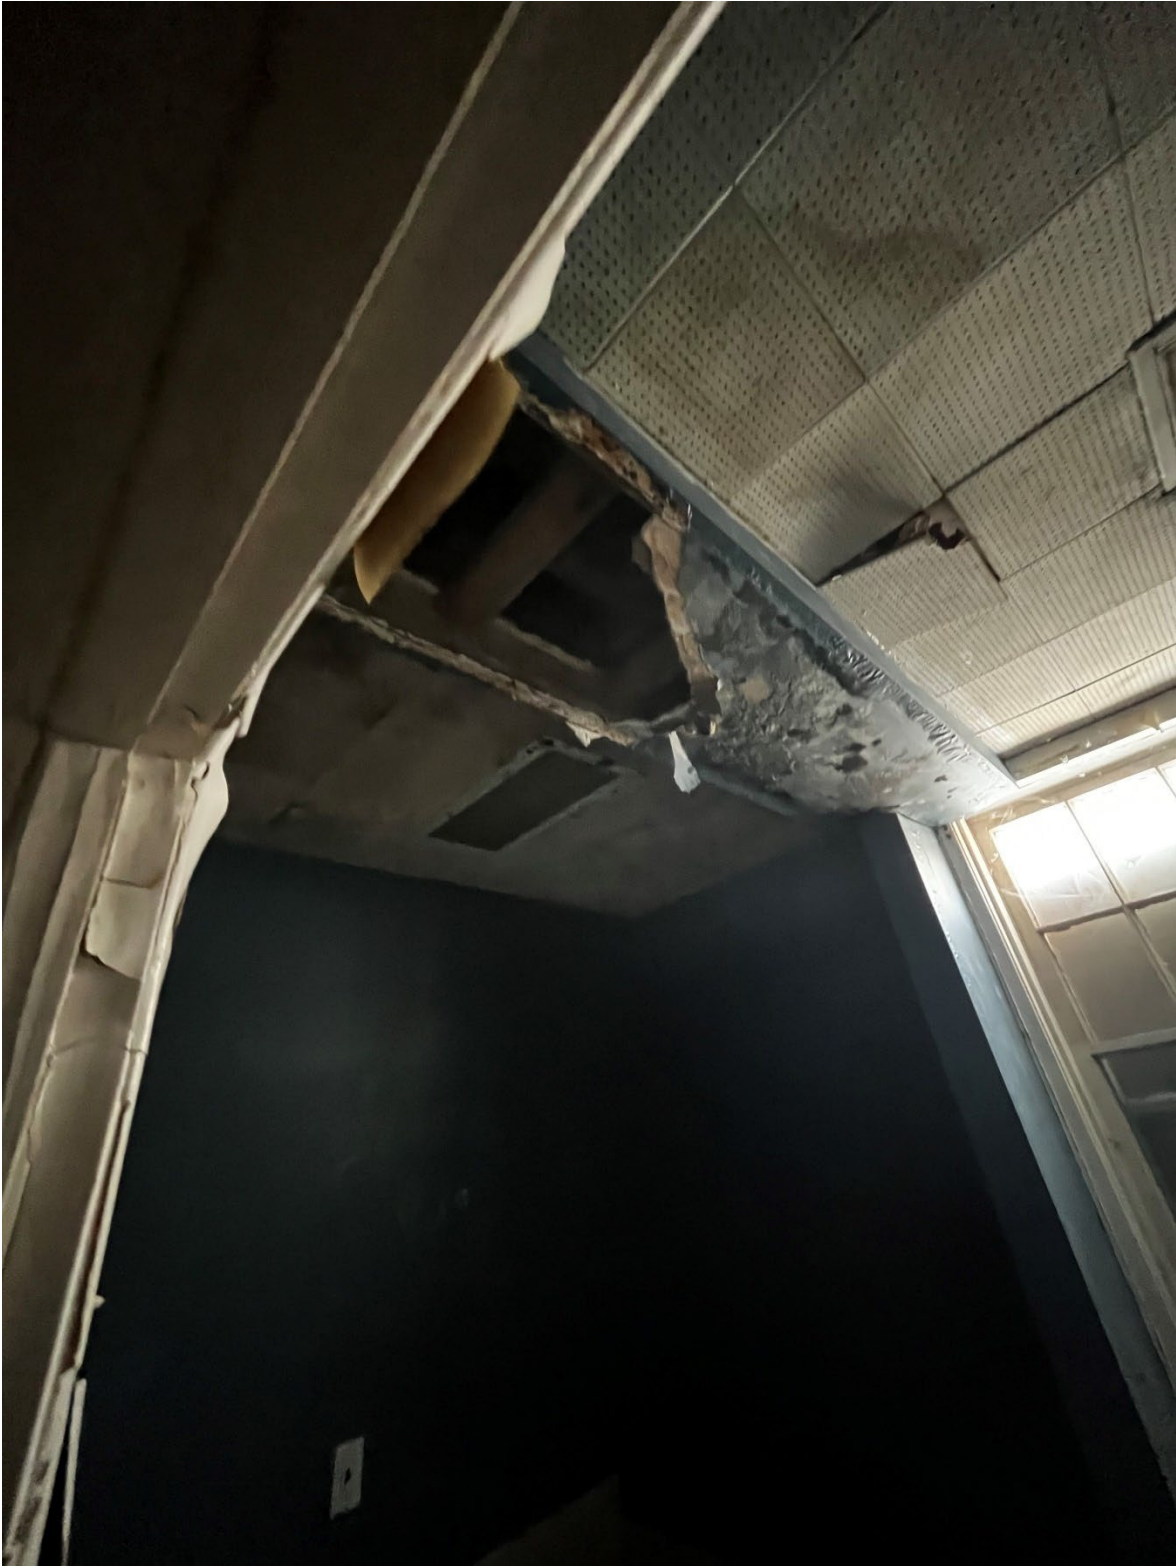
Figure 16 - Showing significant damage.

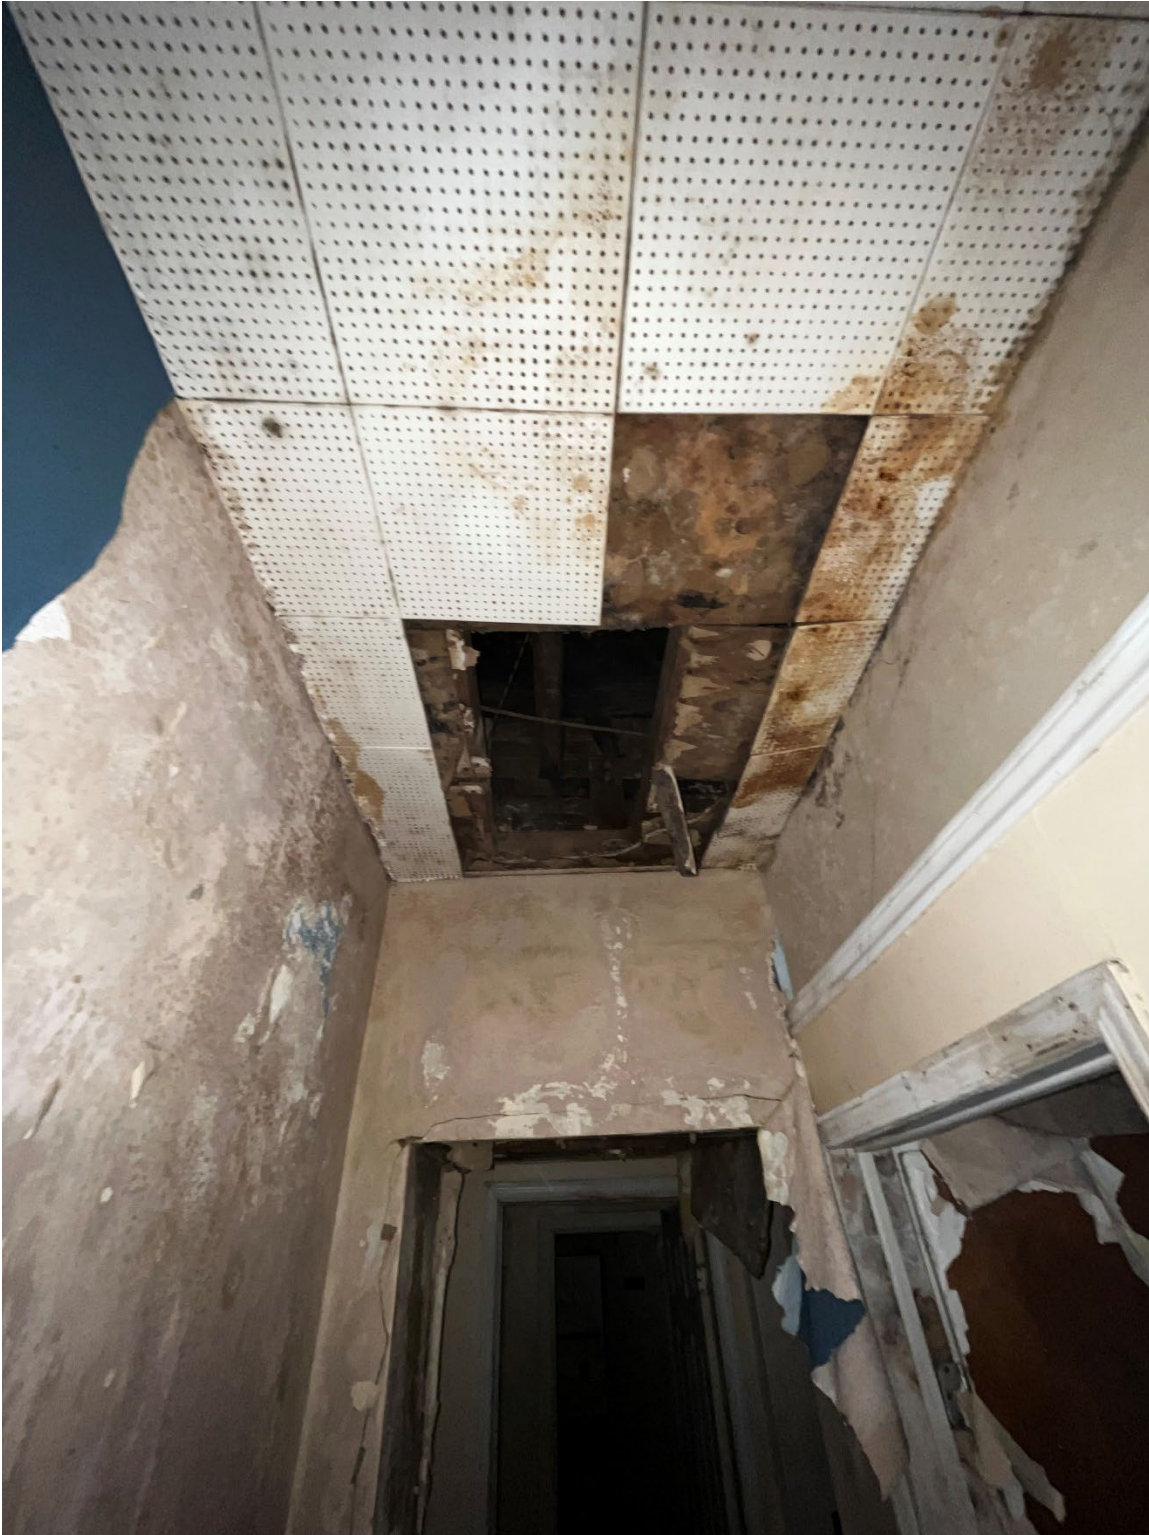
Figure 17 - Showing significant damage.

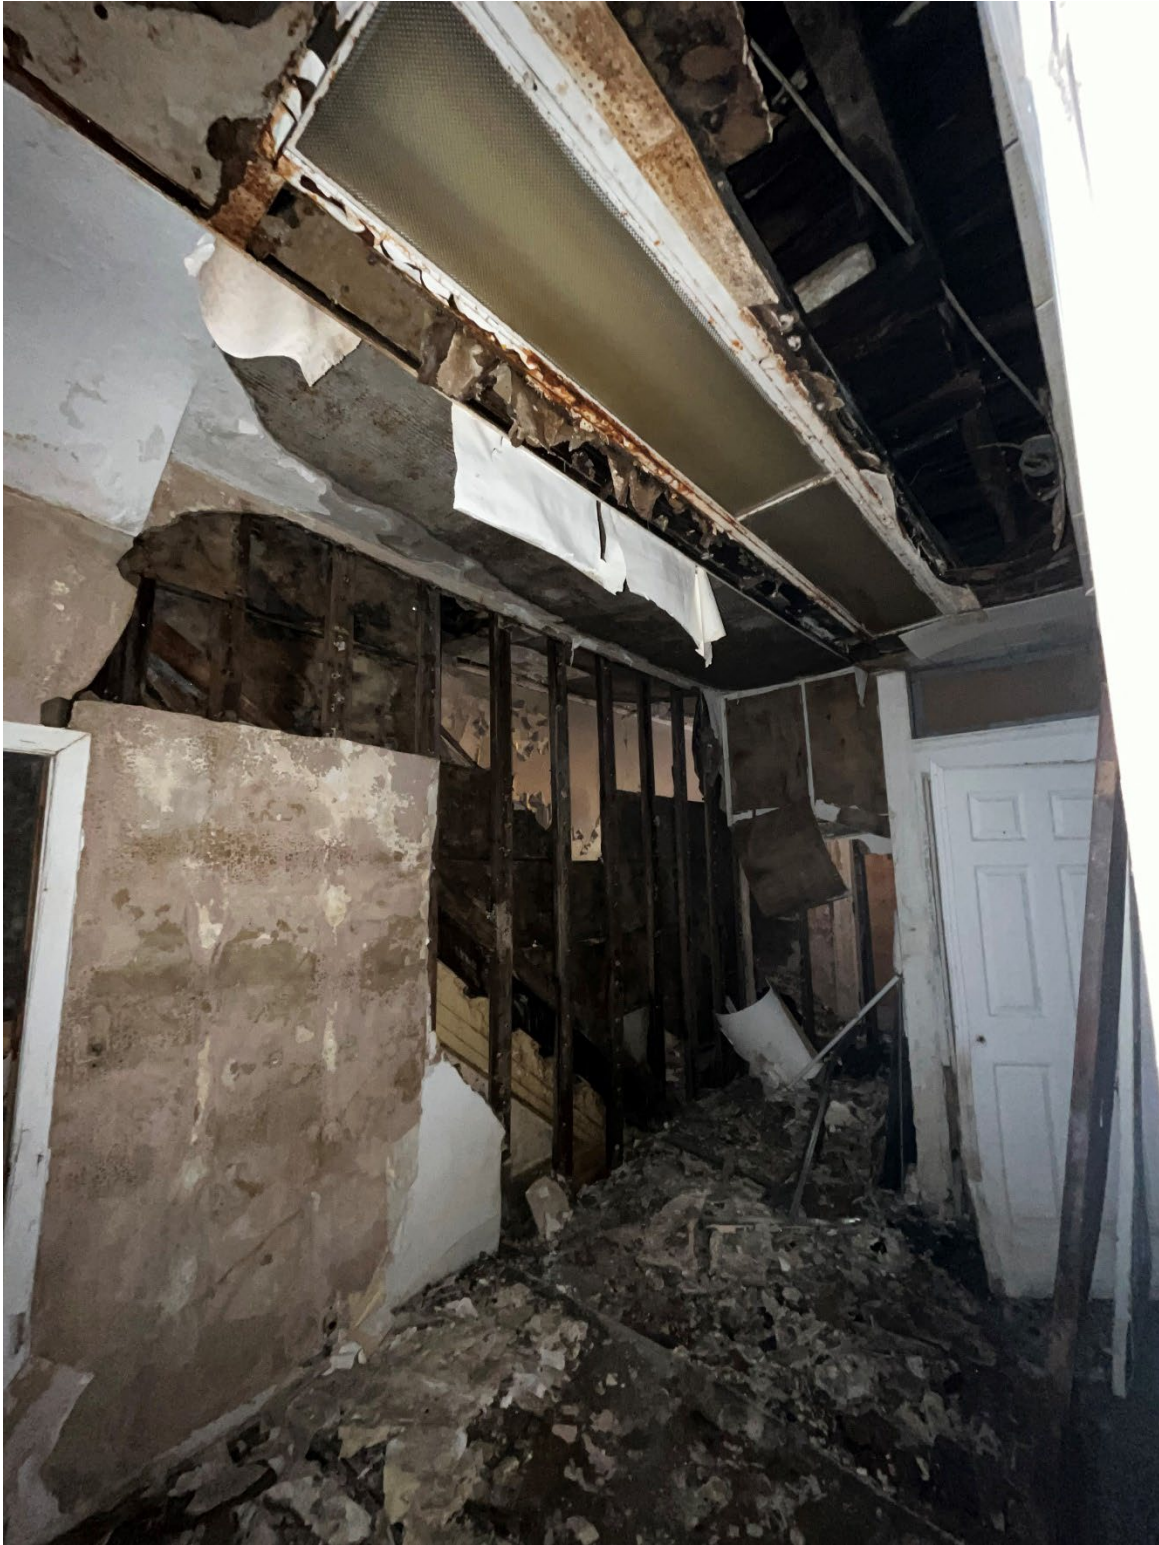
Figure 18 - Showing Significant Damage

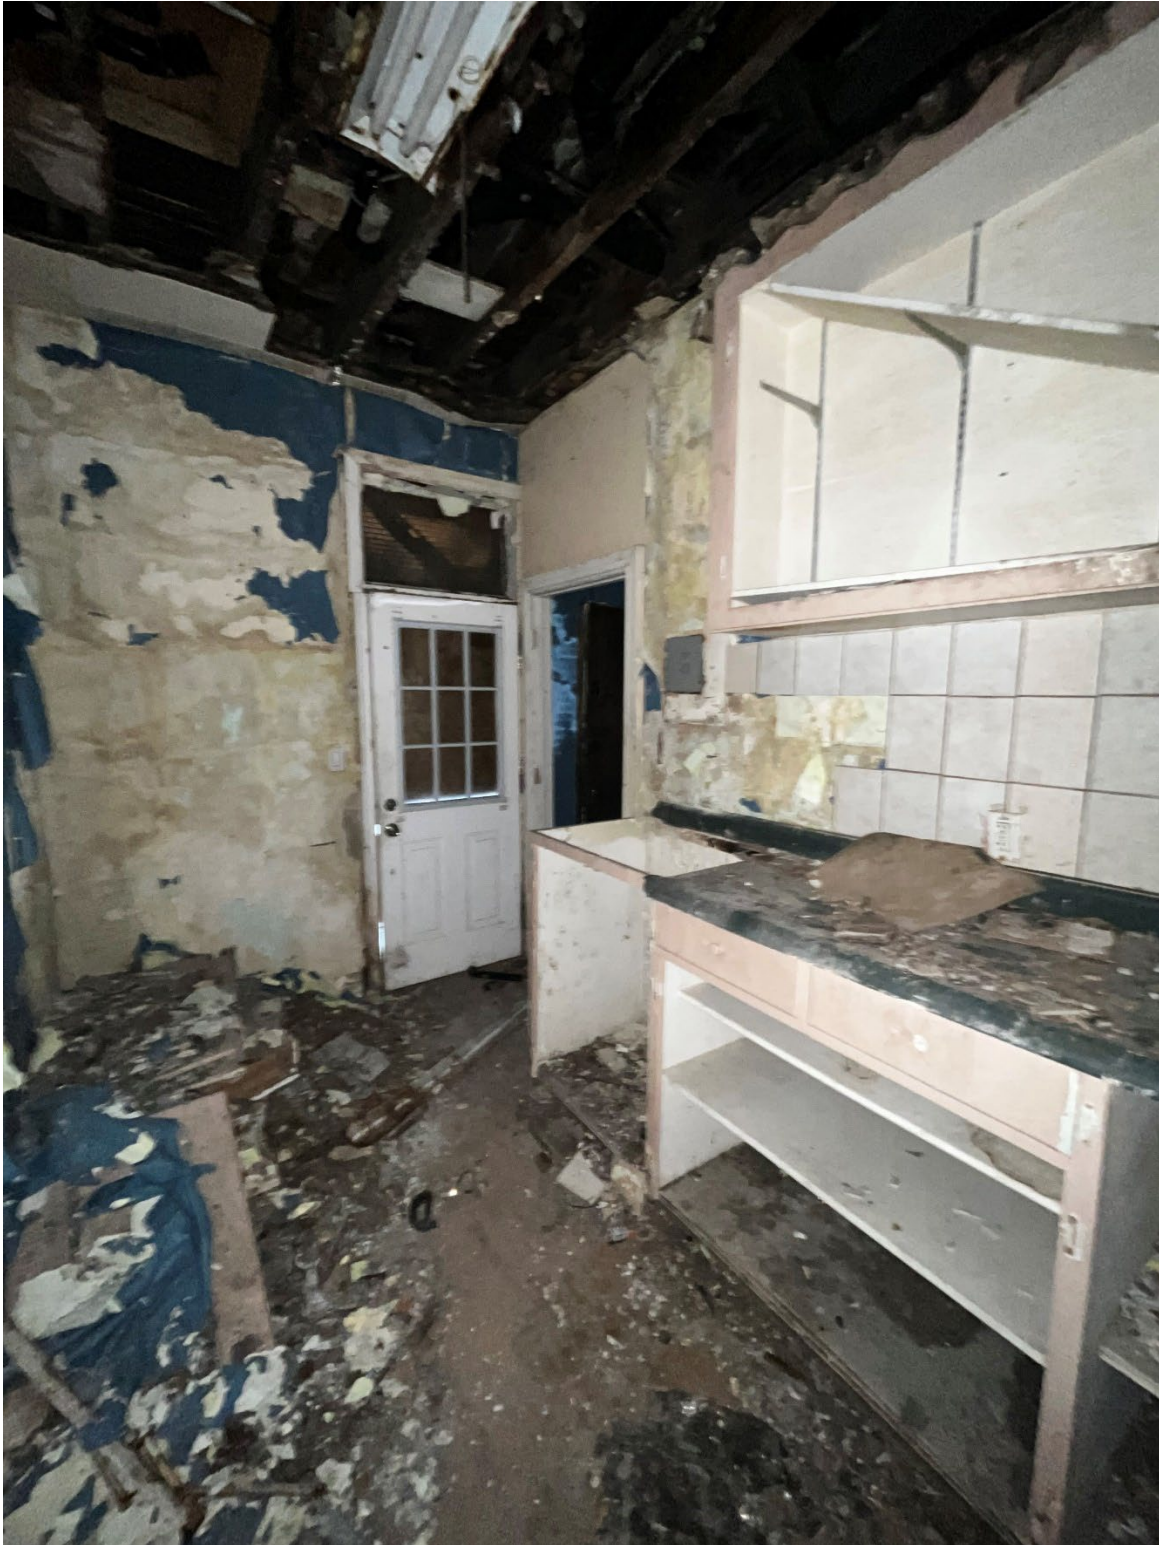
Figure 19 - Showing significant damage.

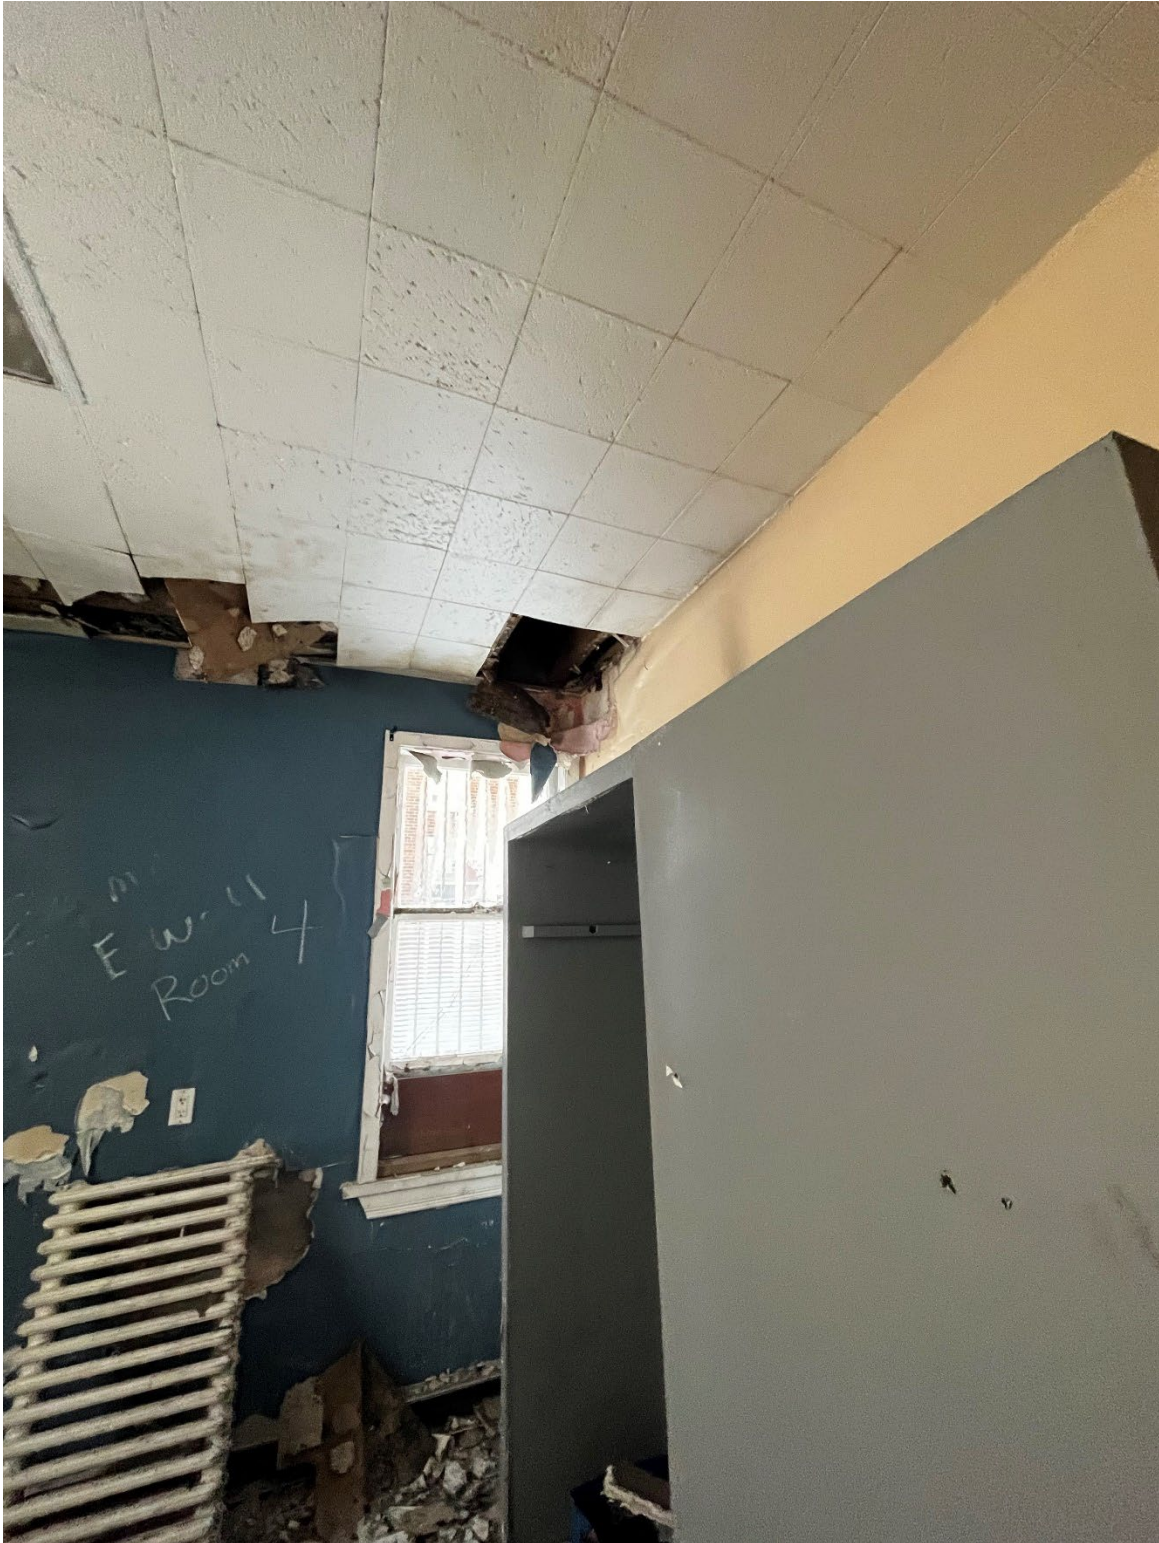
Figure 20 - Showing significant damage.

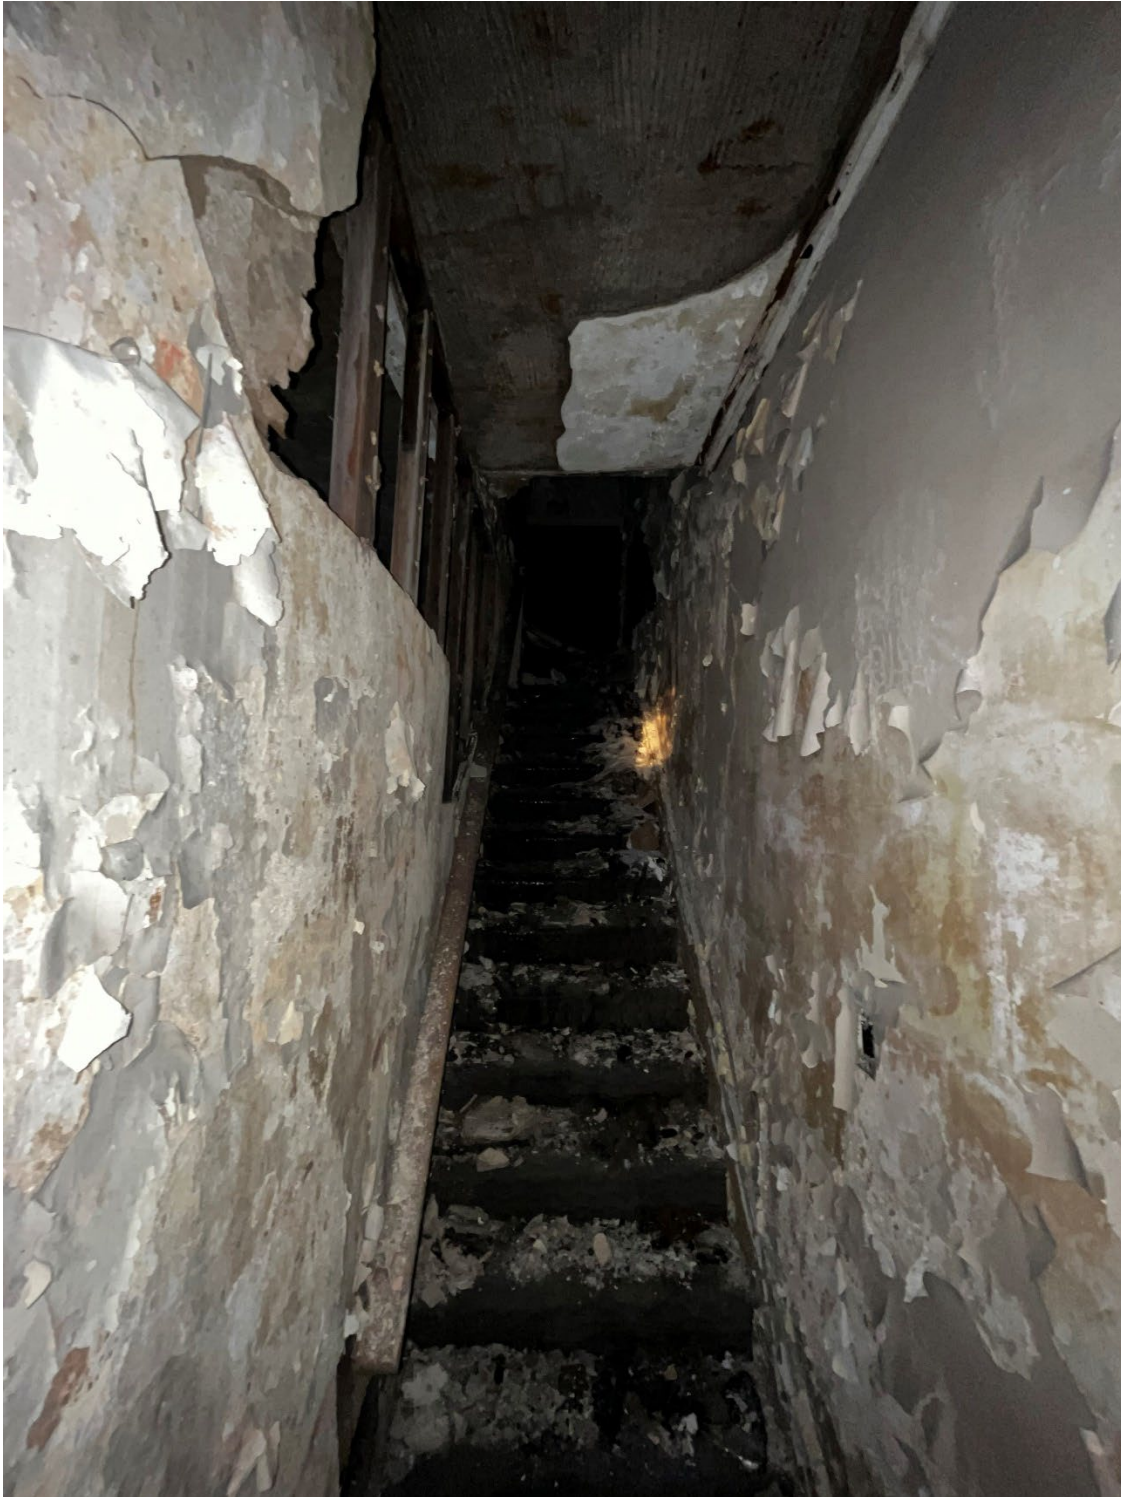
Figure 21 - Showing significant damage and staircase damaged by fire.

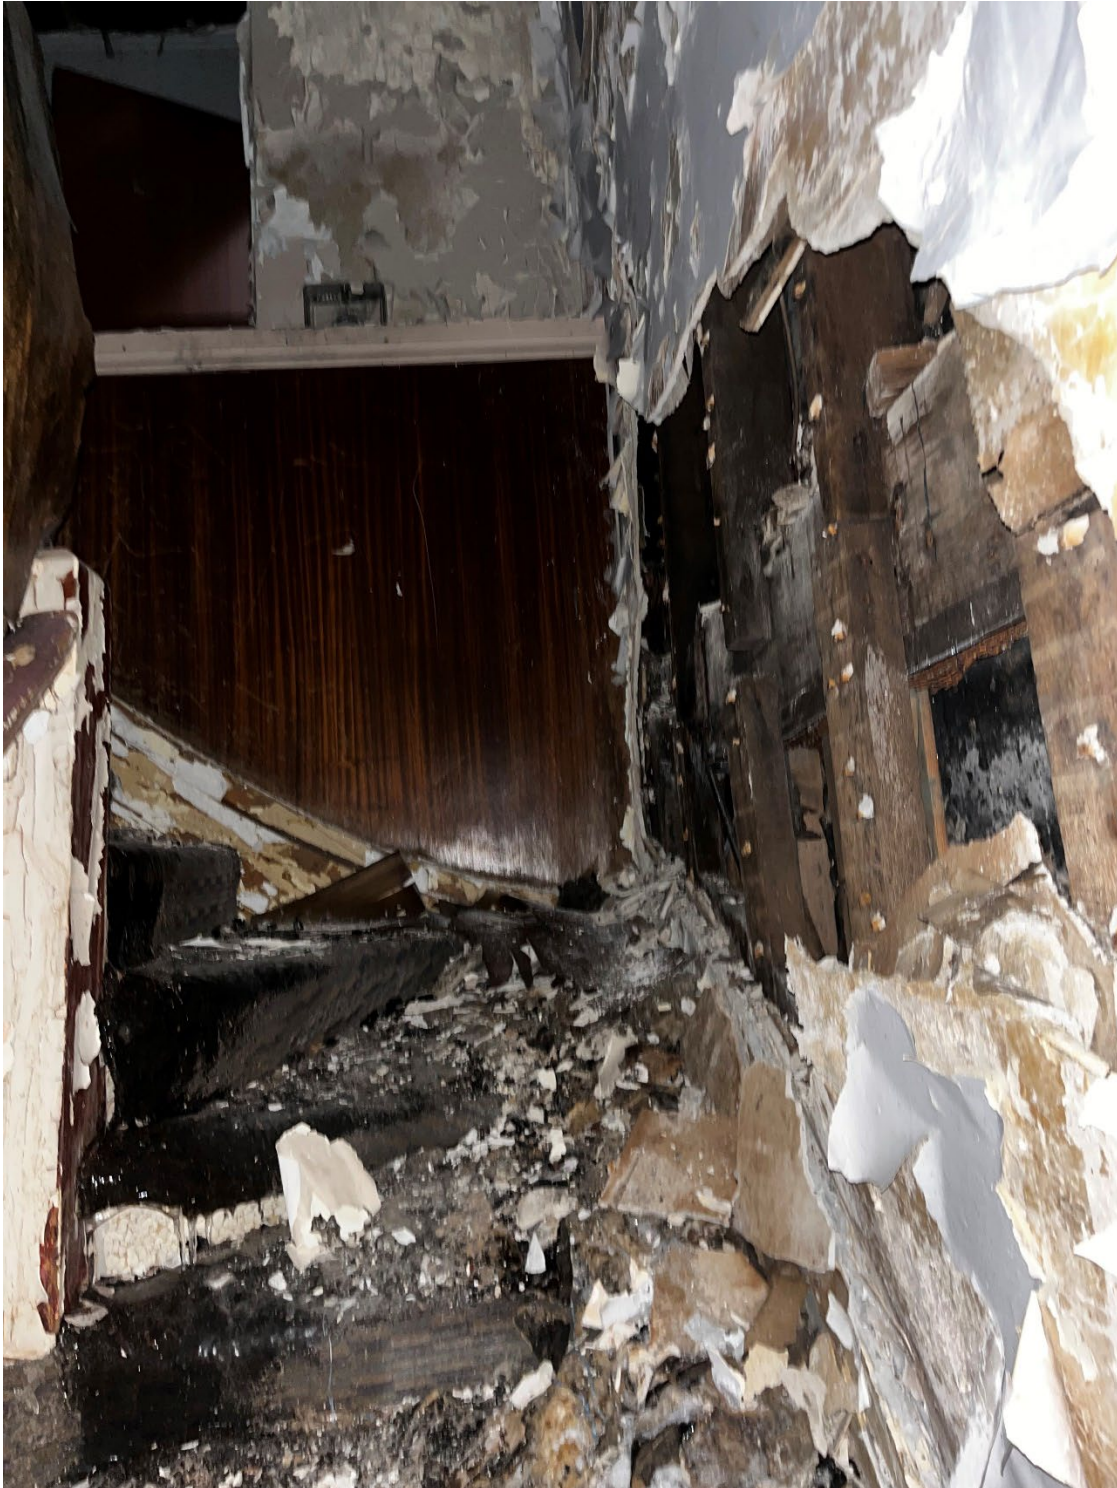
Figure 22 - Showing significant damage where fire spread through wall.

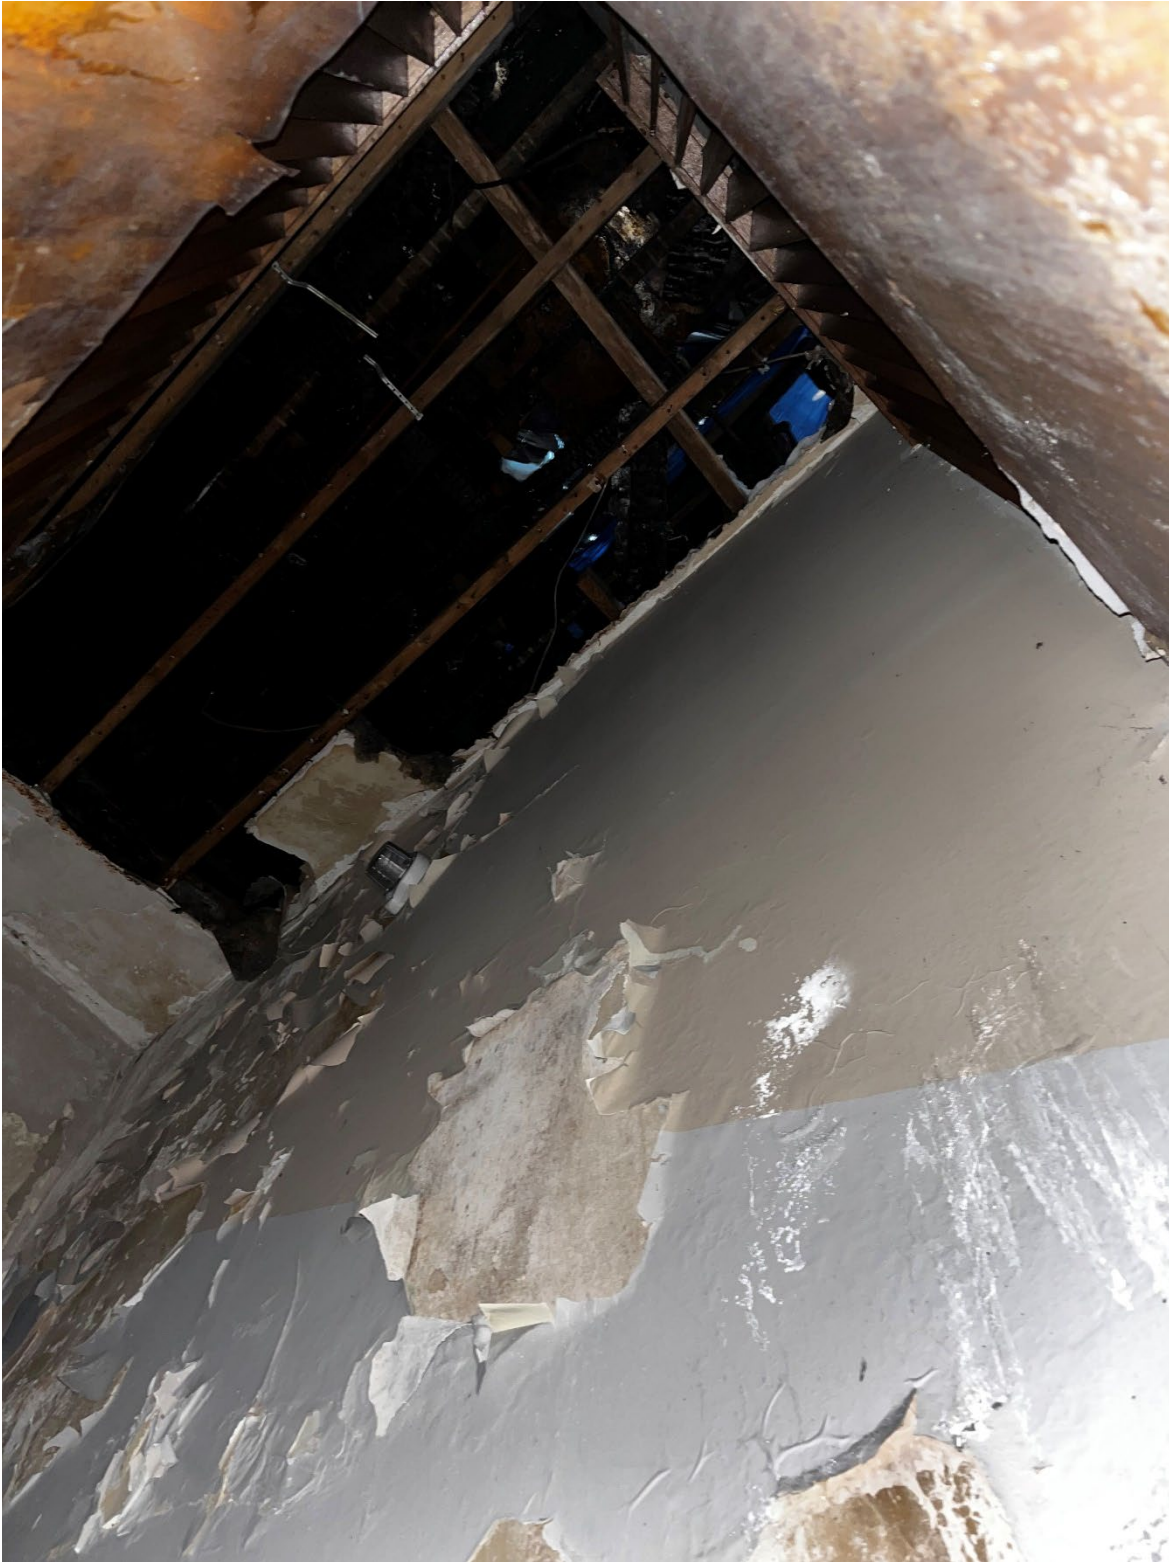
Figure 23 - Showing significant damage where fire caused structural failing of roof.

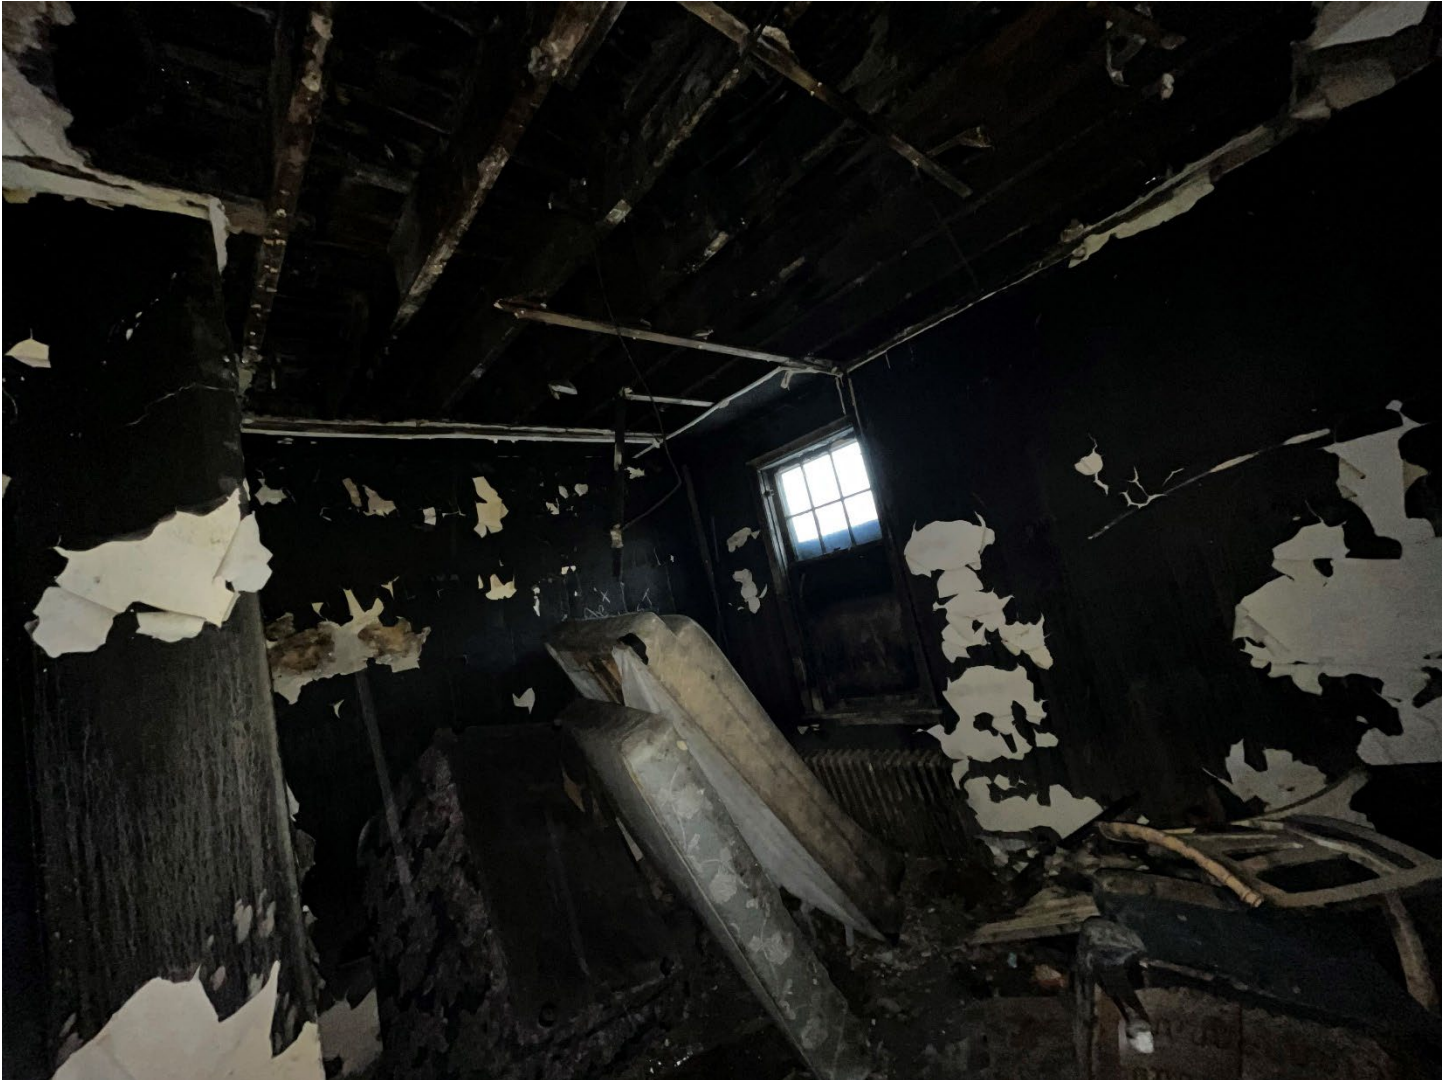
Figure 24 - Showing extent of fire damage, interior black from fire and burn.

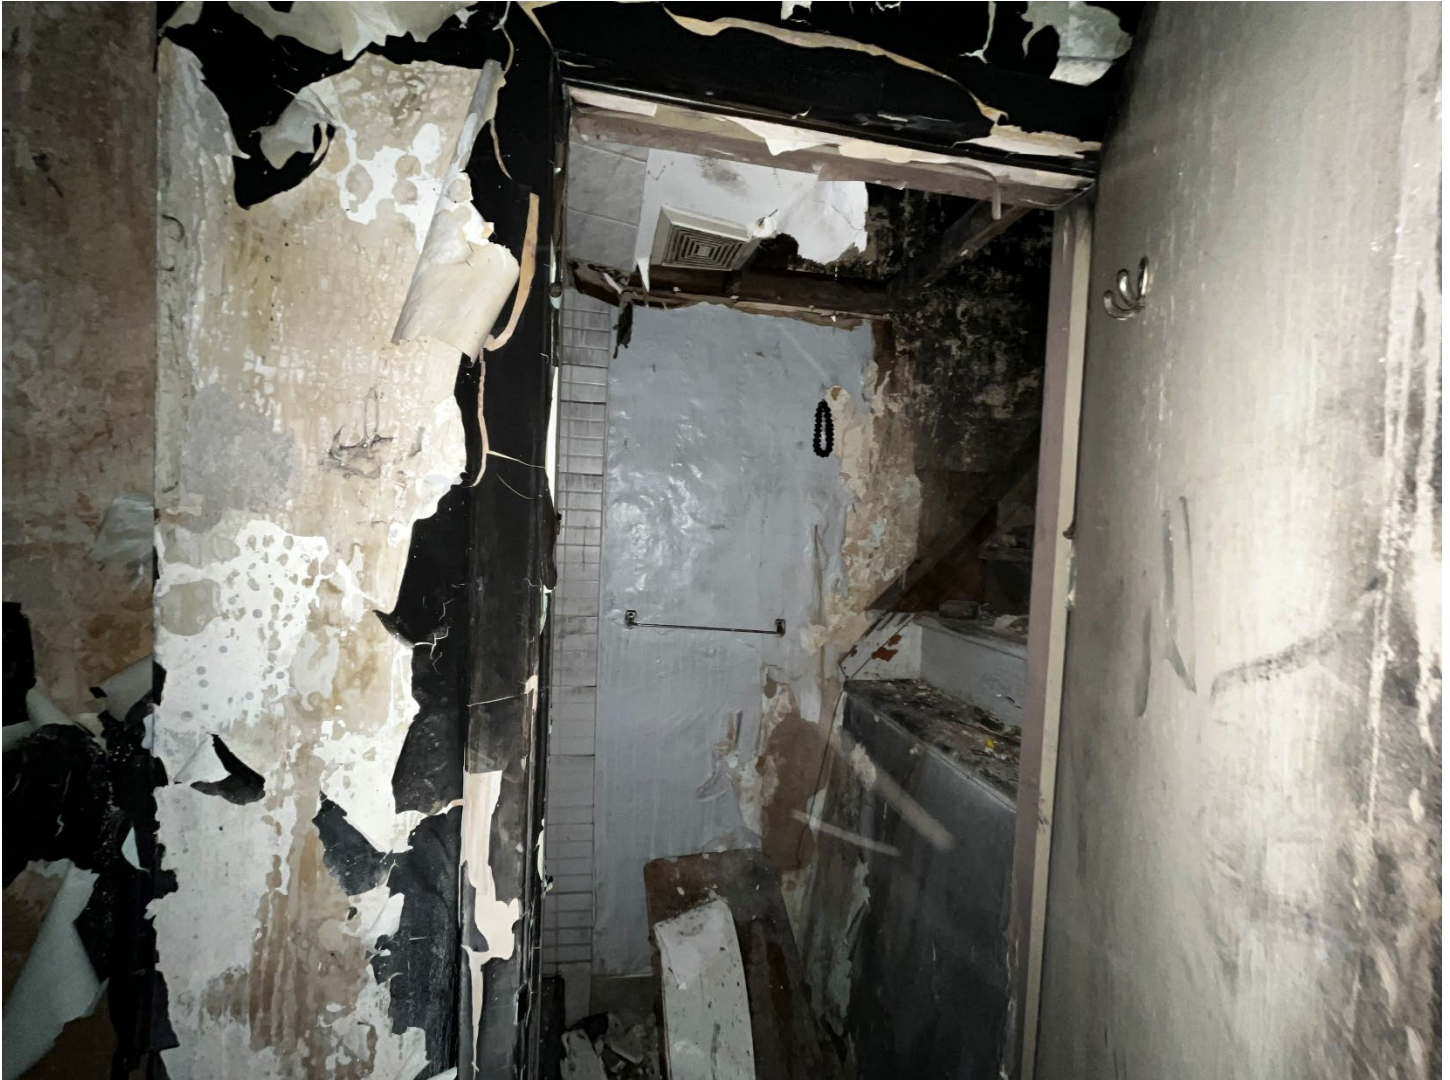
Figure 25- Showing extent of fire damage, interior black from fire and burn.

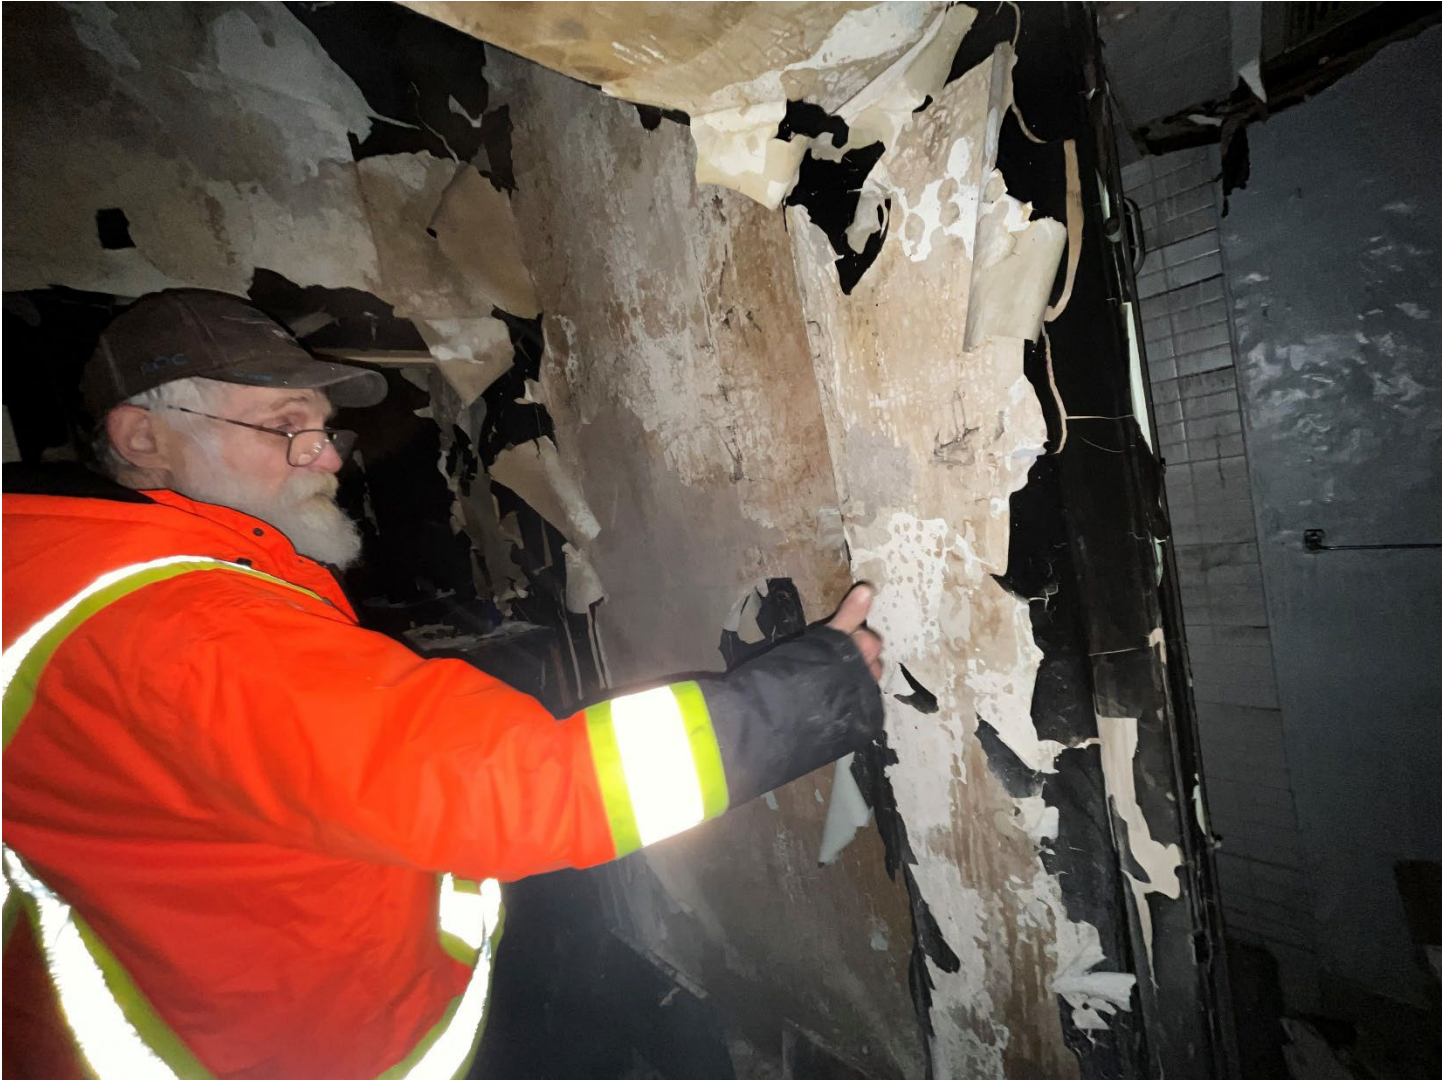
Figure 26- Showing extent of fire damage, interior black from fire and burn.
