Economic and Development Services Committee – April 17, 2023

Application for Demolition of 195 Simcoe Street North under Section 34, Part IV of the Ontario Heritage Act (File: 12-04-0319) (Ward 4)

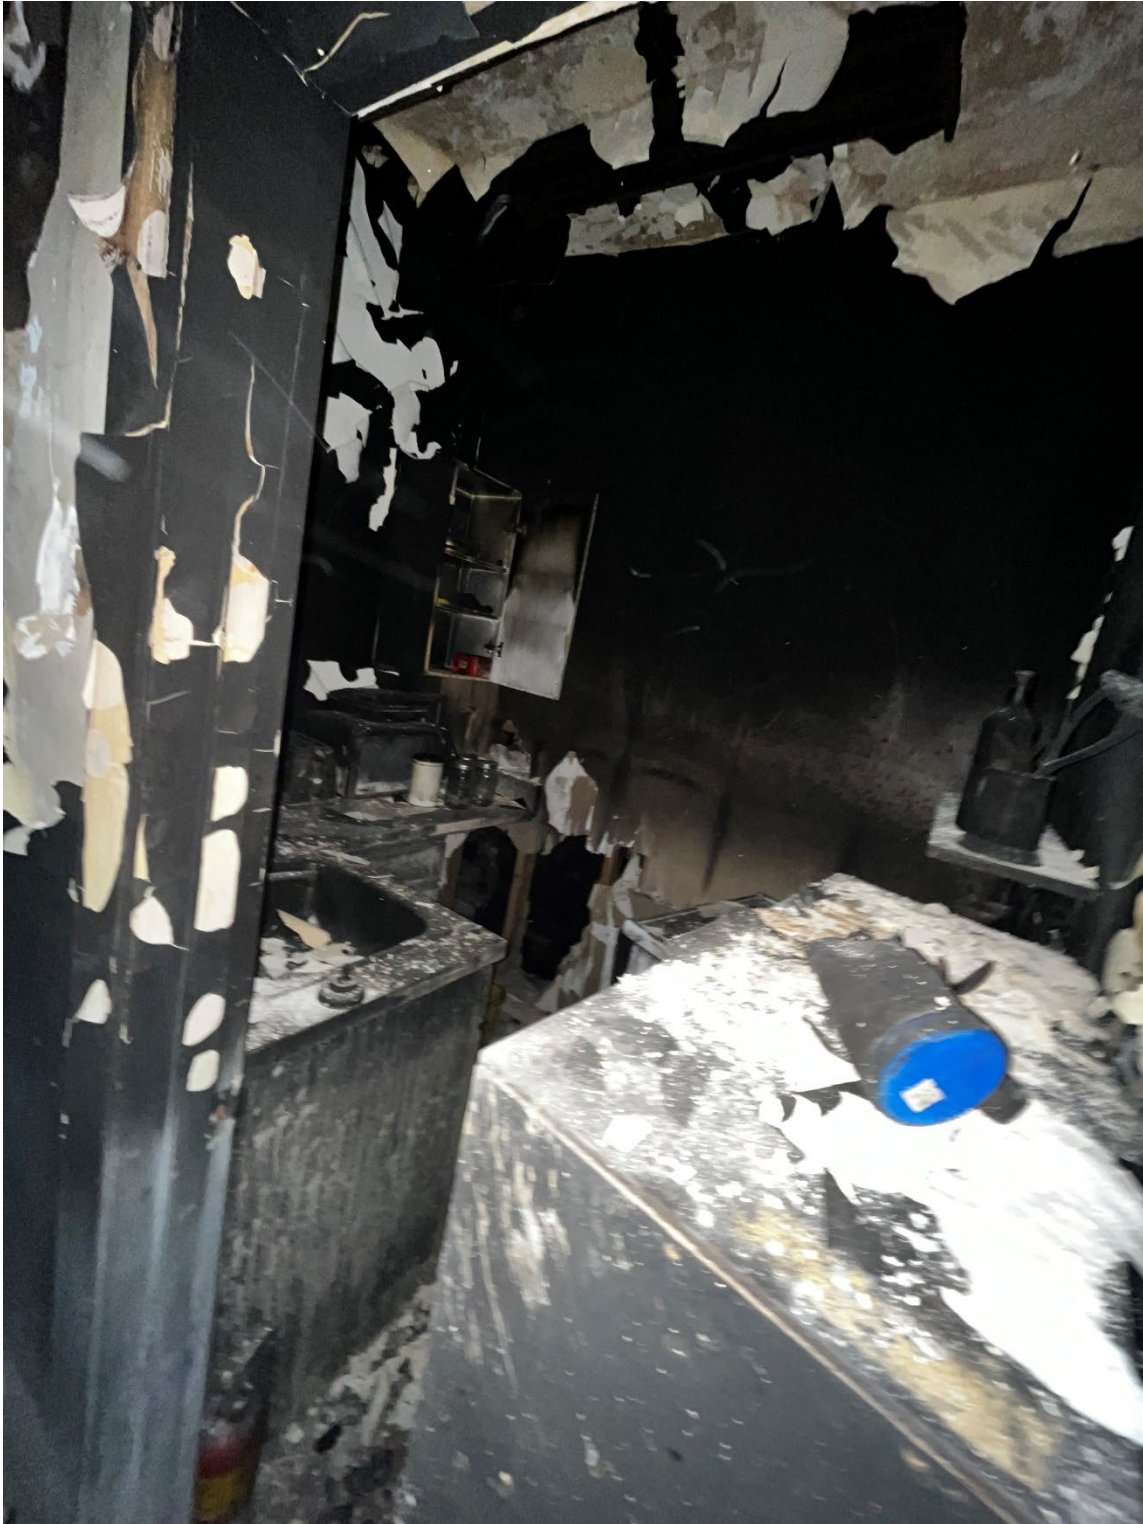
Figure 27 - Showing extent of fire damage, interior black from fire and burn.

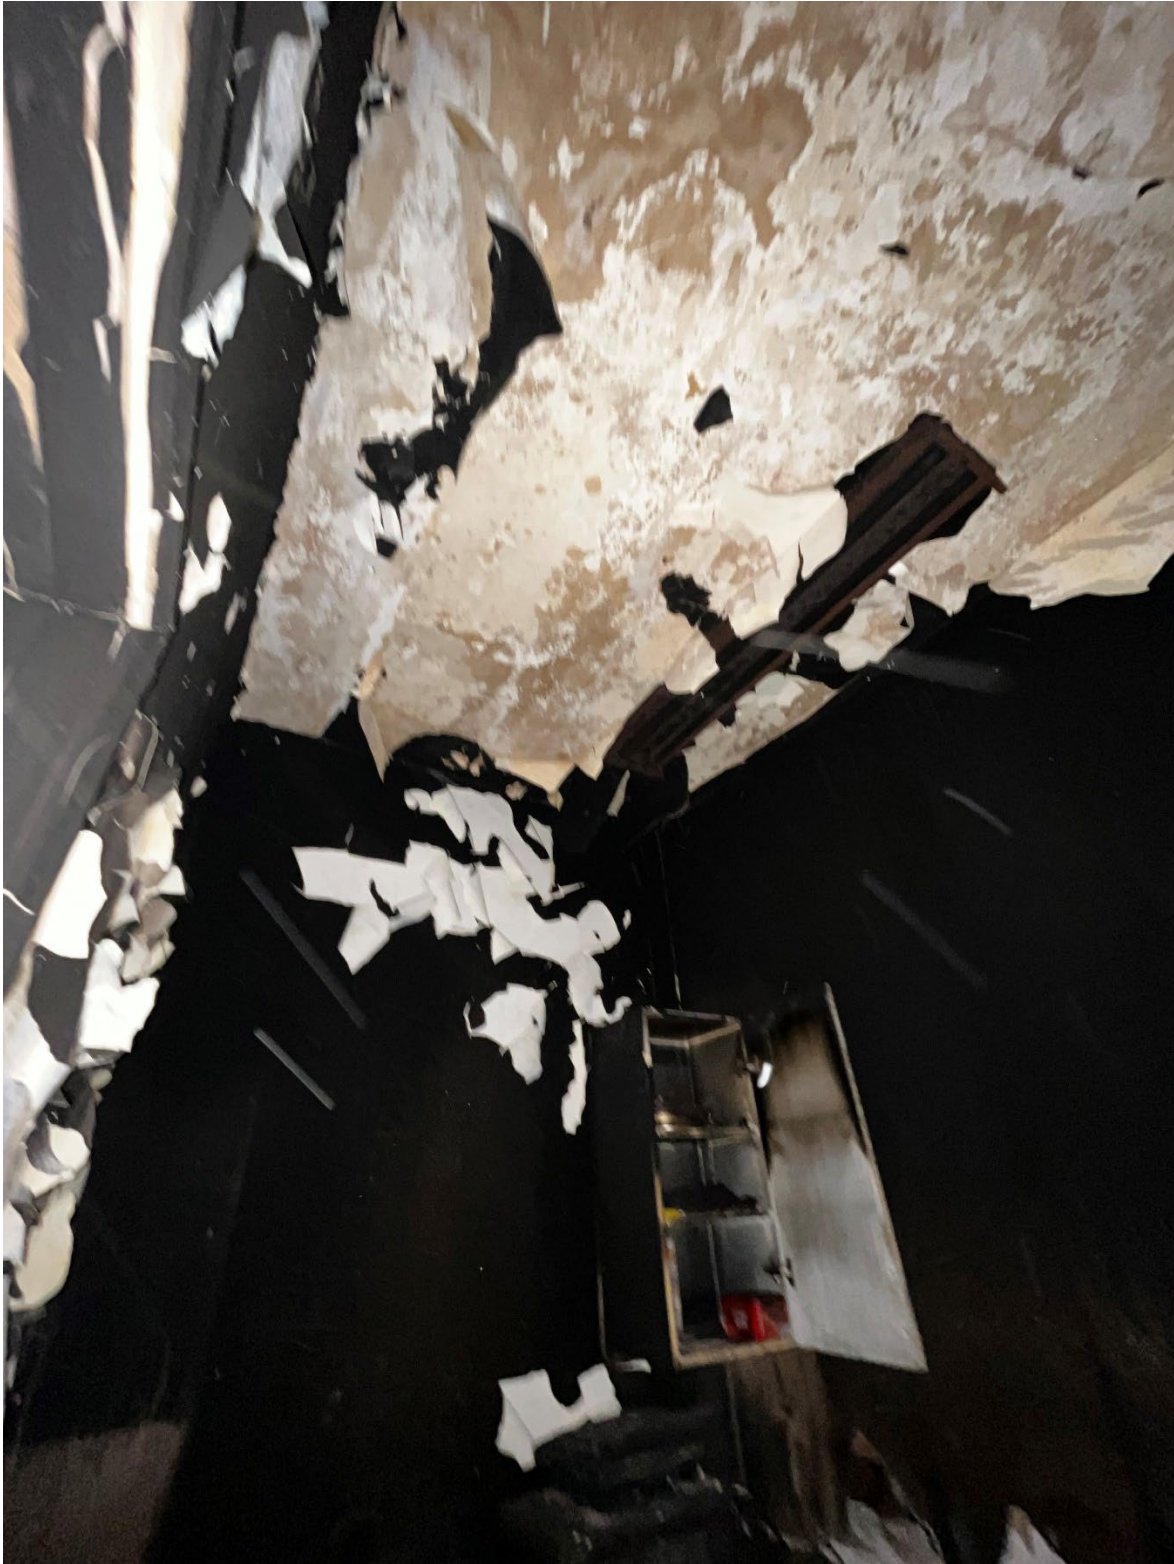
Figure 28 - Showing extent of fire damage, interior black from fire and burn.

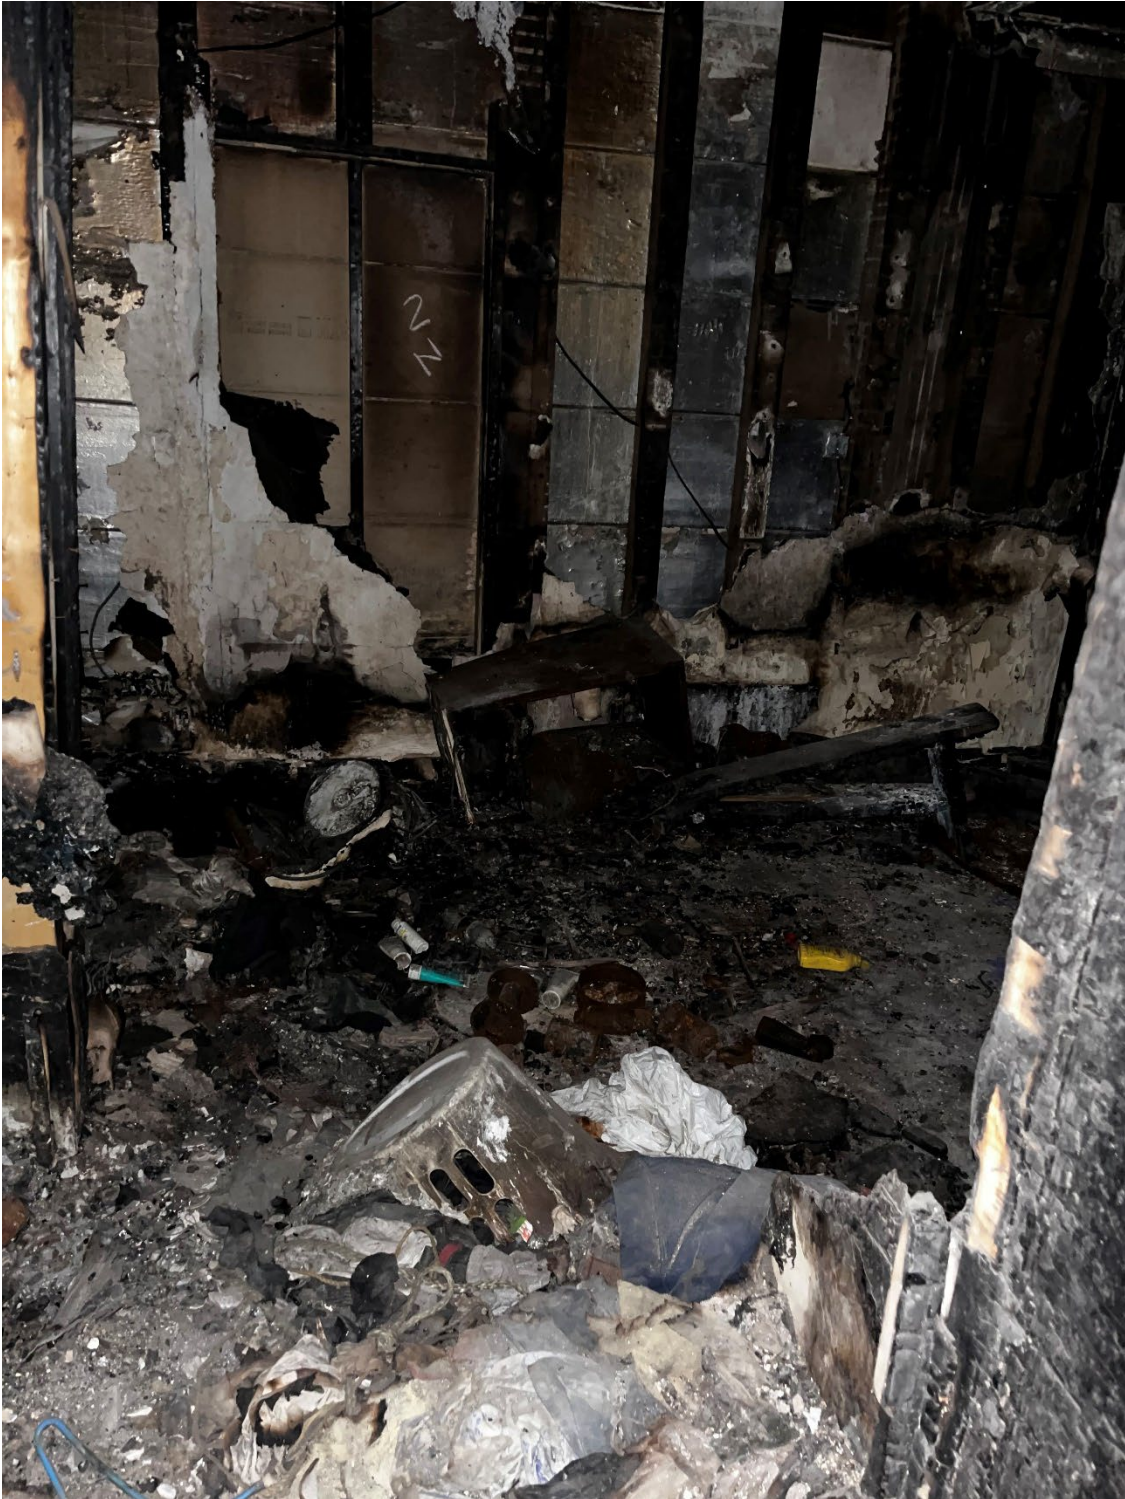
Figure 29- Showing extent of fire damage, interior black from fire and burn.

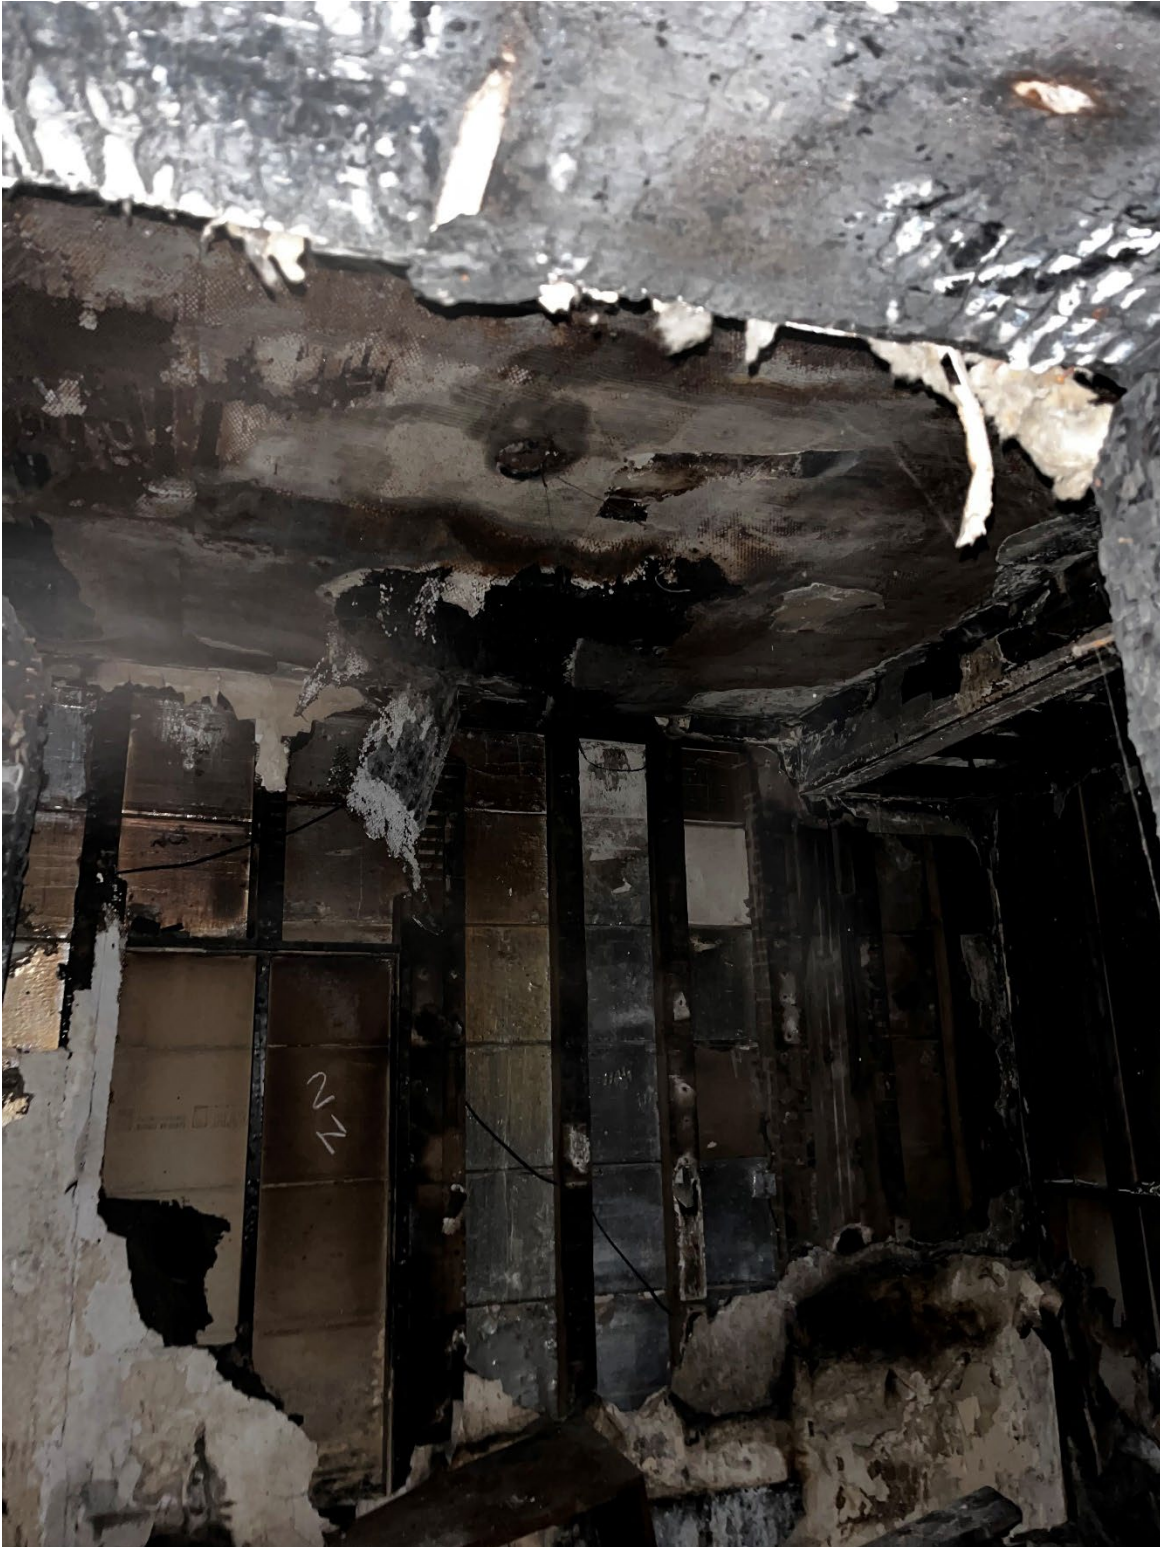
Figure 30 - Showing extent of fire damage, interior black from fire and burn.

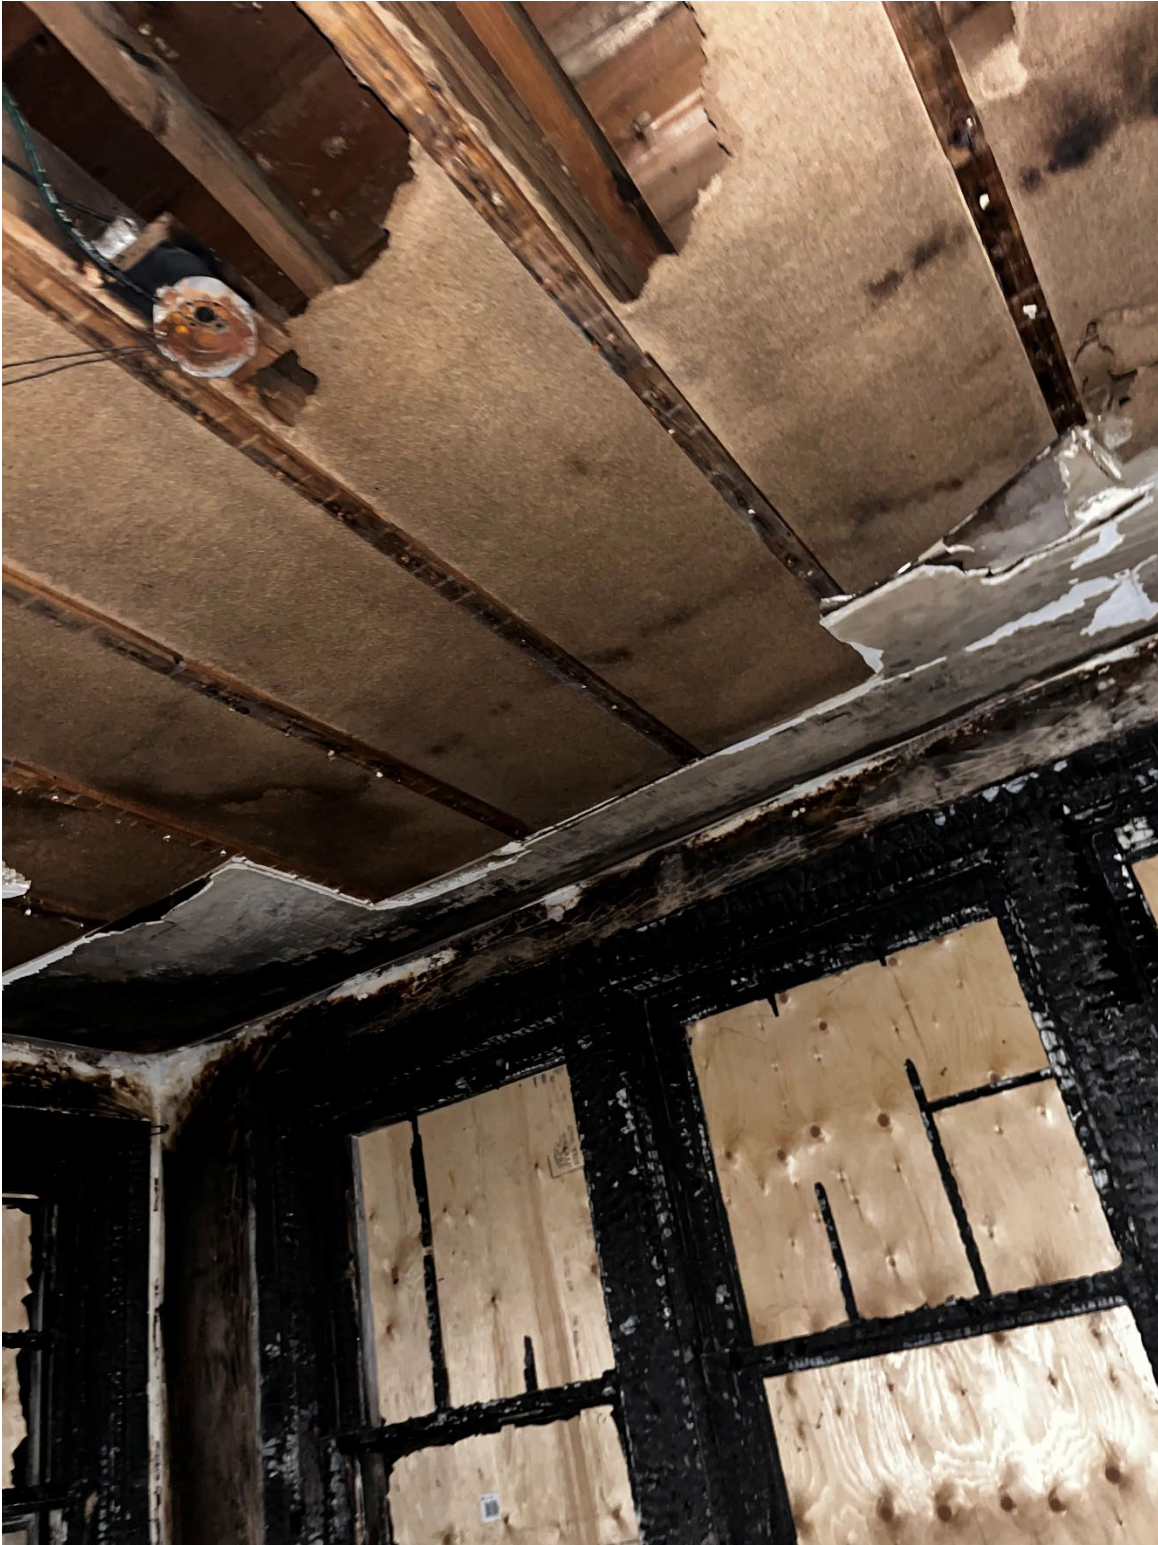
Figure 31 - Showing extent of fire damage, interior black from fire and burn.

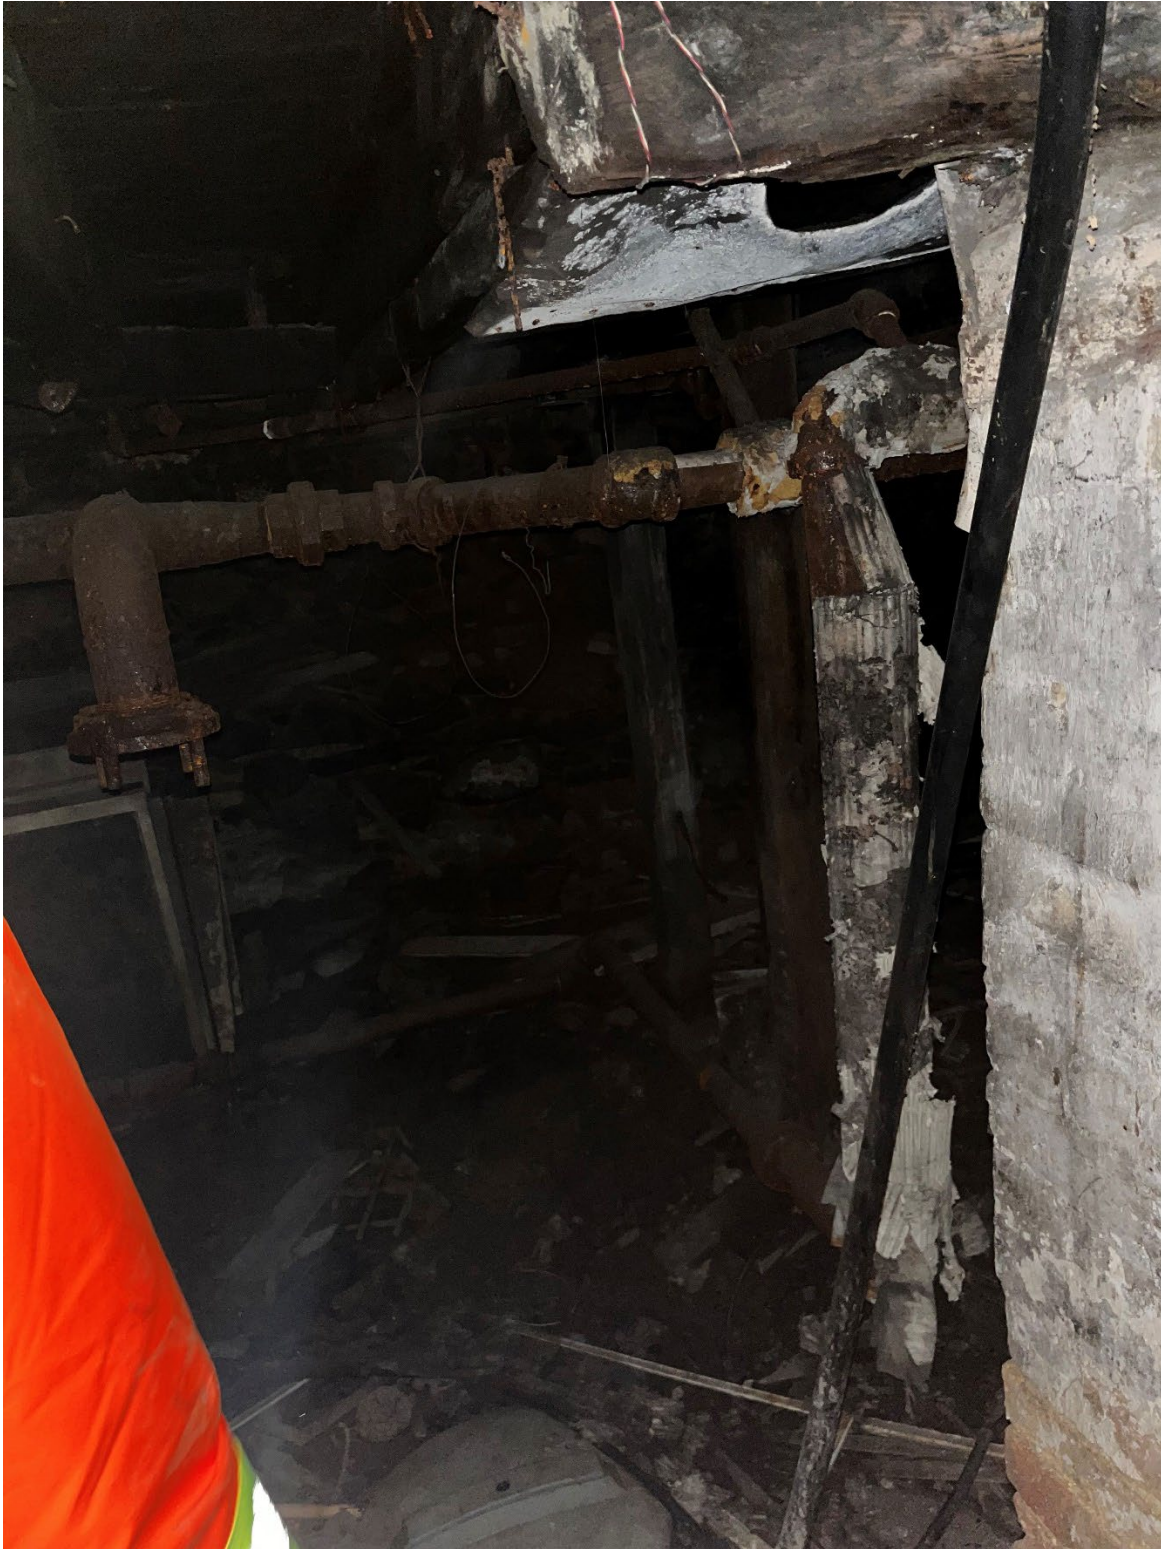
Figure 32 - Basement water system, showing damage and vandalism from arsonist.

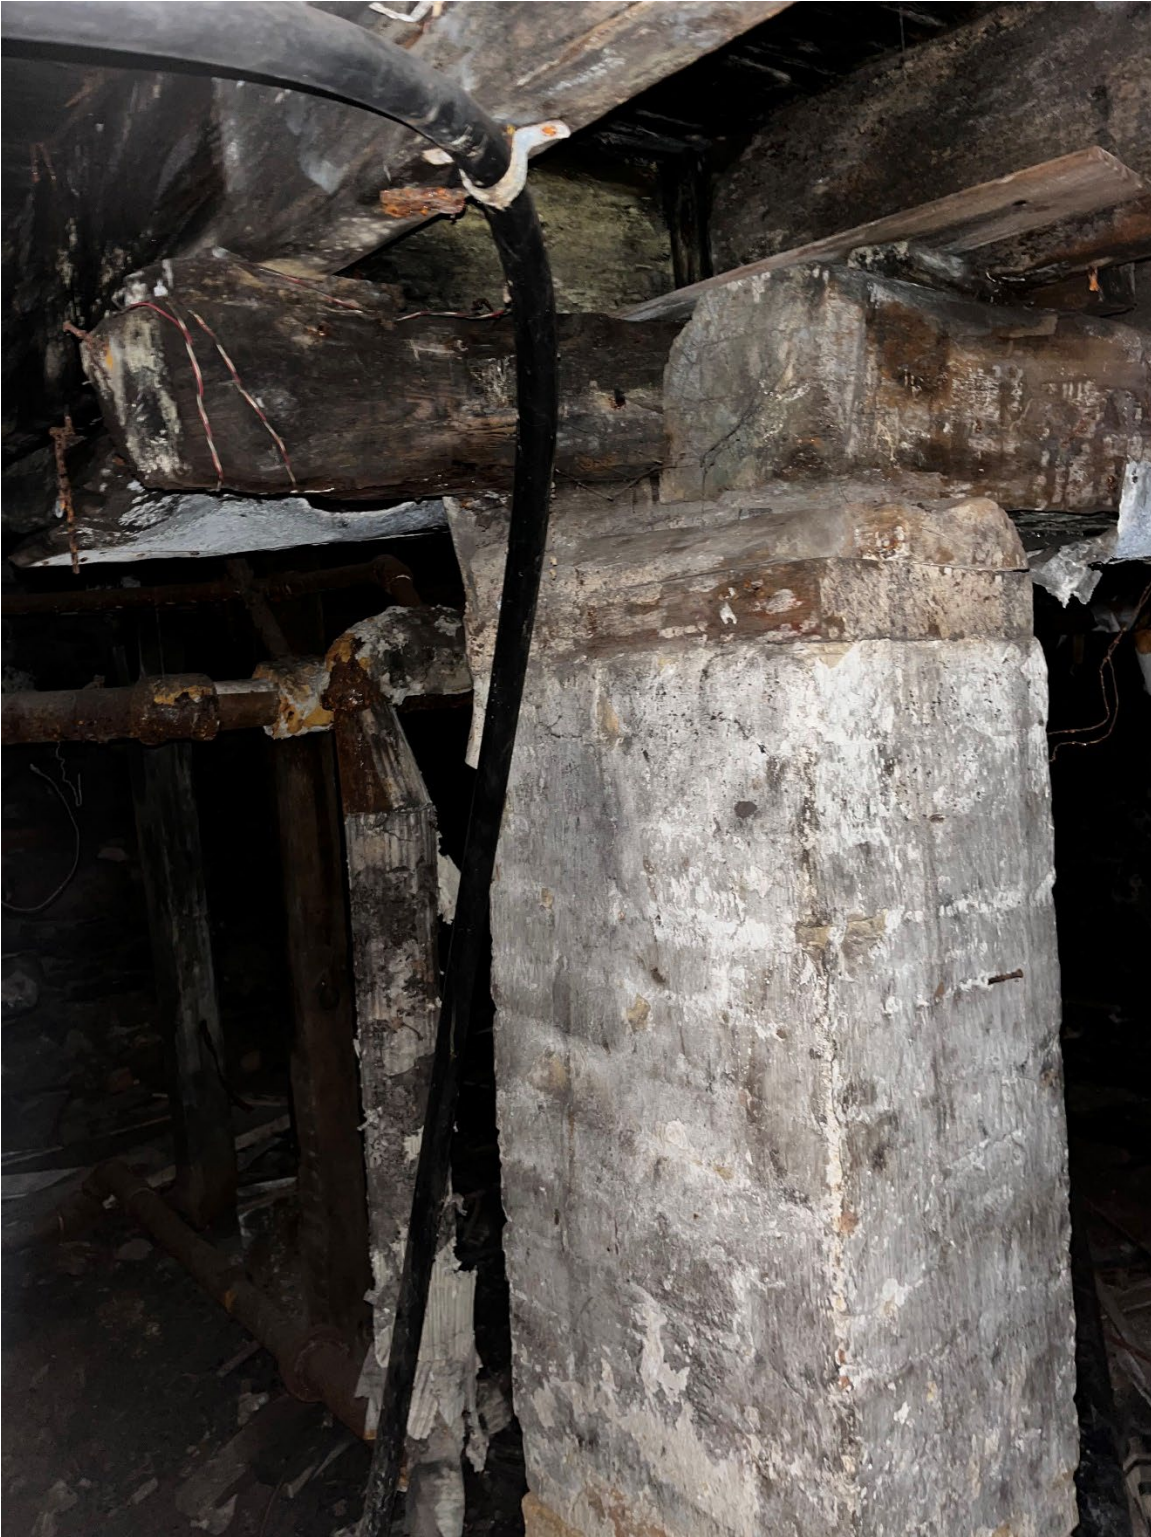
Figure 33 - Existing building foundation, with original wood beams, damaged from fire.
