Report Number: ED-23-155

Subject: Farewell Park and Knights of Columbus Pedestrian Structure
MS-4-2023

Subject: Farewell Park and Knights of Columbus Pedestrian Structure MS-4-2023
Address: 725 King Street East
Ward: Ward 3
File: 03-05

**Re: Structural Integrity Assessment of Farewell Park Pedestrian Footbridge Over Harmony Creek
(Site # MS-4-2023)**

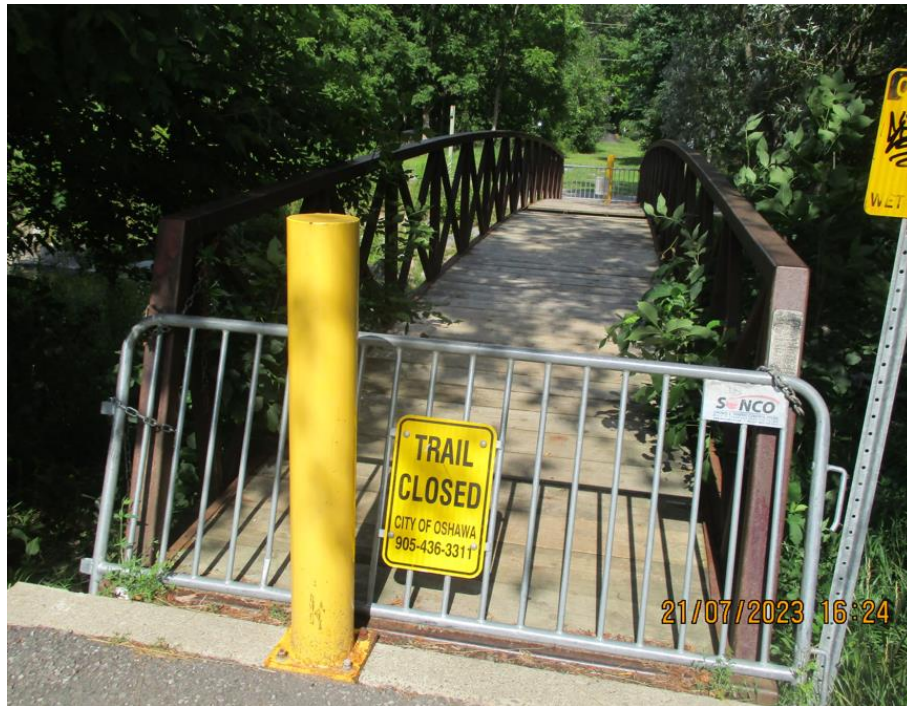
The bridge has recently been closed to the public due to safety concerns (exact date of closure is unknown) (**Figure 2**). At the time of previous biennial inspection (2021) the bridge was open to the public. Nonetheless, the findings of the OSIM inspection report (TSI Inc, 2021) highlighted the urgent need for bridge replacement (proposed time frame 1-5 year) due to the overall poor condition of the bridge and severe corrosion, perforation and localized failure of certain bridge deck elements at the time.

Figure 2: Bridge Closed to the Public

Based on the noted current condition of the bridge, its re-opening to the public is NOT recommended.

Further, the barriers installed in place may not be deemed sufficiently deterrent for certain public deciding to cross the bridge ignoring the restrictive railings and posting installed and hence may result in further liability facing the City. Ongoing deterioration of the bridge superstructure may also result in deleterious debris entering the waterway. It is highly recommended that the existing bridge superstructure should be removed from the site to mitigate any further liability towards the City.

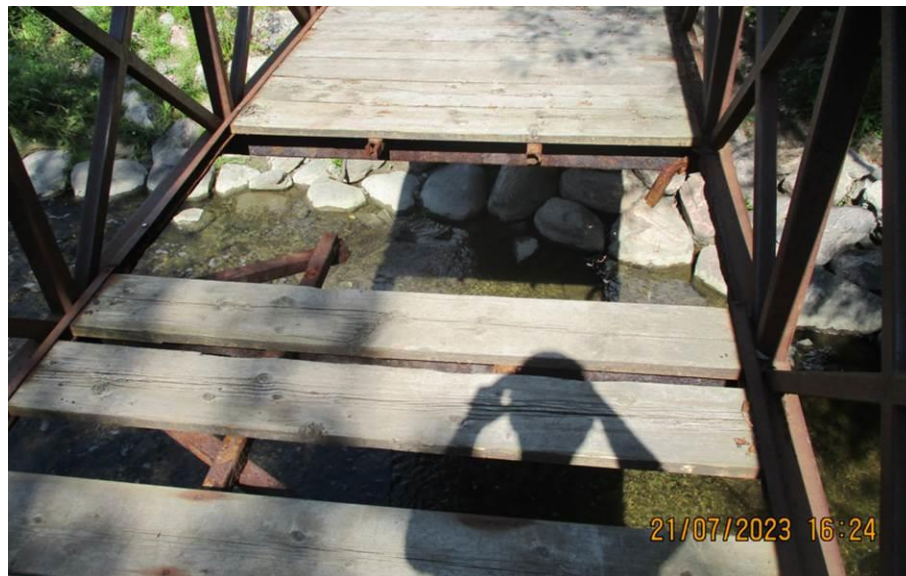
Upon completion of the close-up (enhanced) inspection of the bridge, it was noted that certain areas of the deck (full width) have completely failed due to severe corrosion of steel superstructure elements (main beams, transverse beams, diagonal bracings). It was further noted that the plank insert section of the peripheral stringers are also fully perforated, thus resulting in a lack of any support for certain planks and unsafe support for the rest. **Figures 3 to 7** below further illustrate some of the noted deficiencies.

Figure 3: Localized Failure of Bridge Deck Framing and Loss of Planks due to Severe Corrosion- Deck-top View

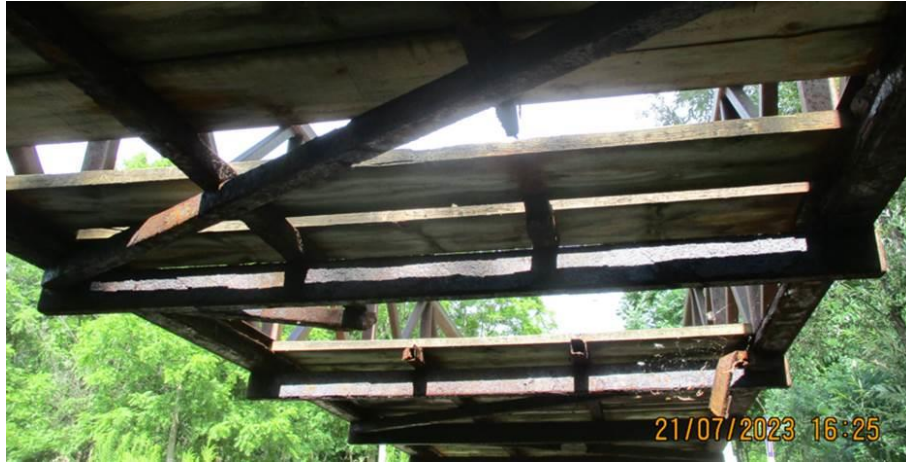
Figure 4: Localized Failure of Bridge Deck Framing and Loss of Planks due to Severe Corrosion- Soffit View

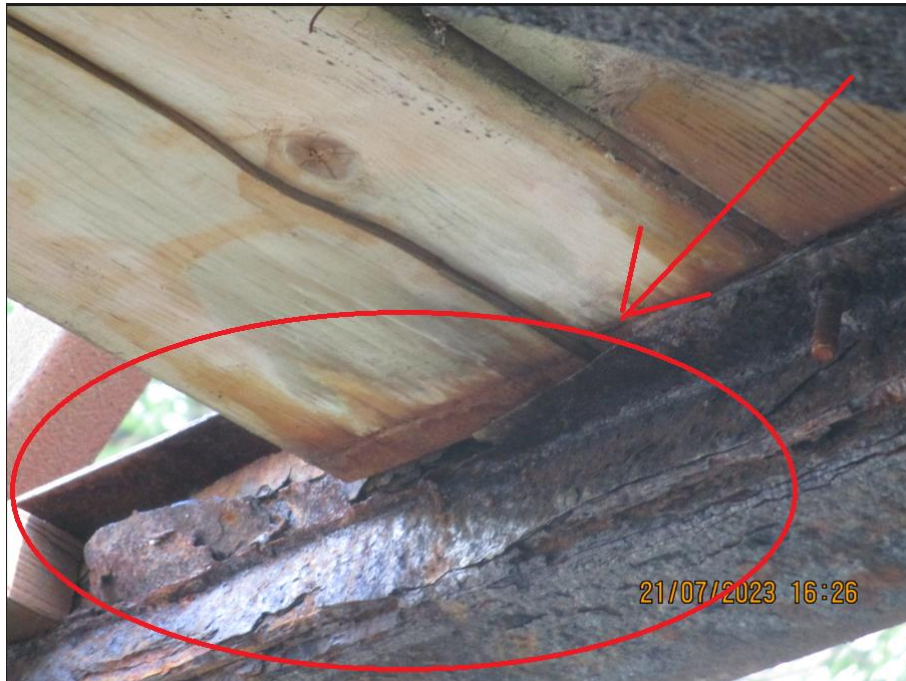
Figure 5: Severe Corrosion and Failure of Plank Insert Support at Peripheral Stringers

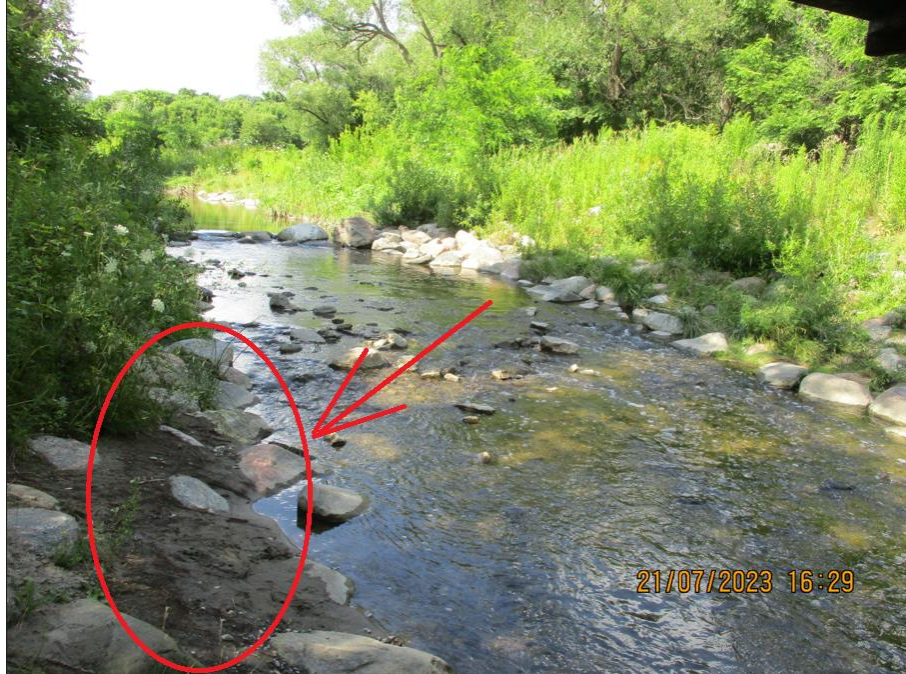
Figure 6: Medium Erosion along Riverbank

The existing foundation system (side abutments) were found to be in an overall good condition and the new bridge superstructure could therefore be designed (in theory) to be installed on the existing foundation system. Having said that, the City may need to retain a Consulting Engineer to design the new structure based on the implications of the new Code released by CSA. The new design may require undertaking a drainage study and topographic/bathymetric survey to ensure new structure will be compliant with the new Code requirements and the noted medium embankment erosion at the site is addressed properly at the time.

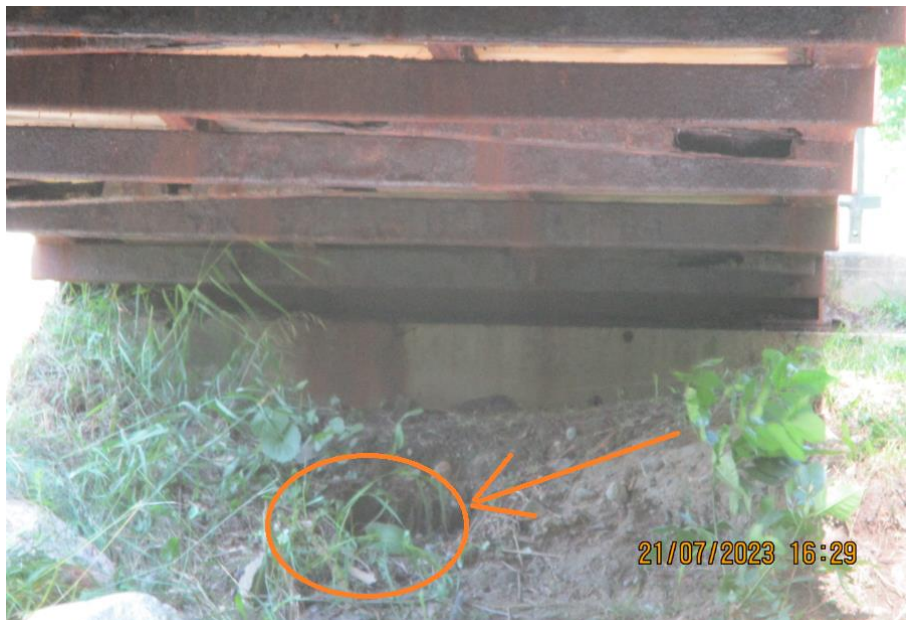
Figure 7: Medium to Severe Erosion along Riverbank (Abutment Embankment)
