Report Number: SF-24-16

Subject: Update Regarding Questions Related to the Link 3 Recreation Trail

# HARMONY CREEK TRAIL EXTENSION

**CITY OF OSHAWA - ESTERBROOK TO CONLIN TRAIL  
TREE INVENTORY AND ASSESSMENT REPORT**  
OSHAWA, ON

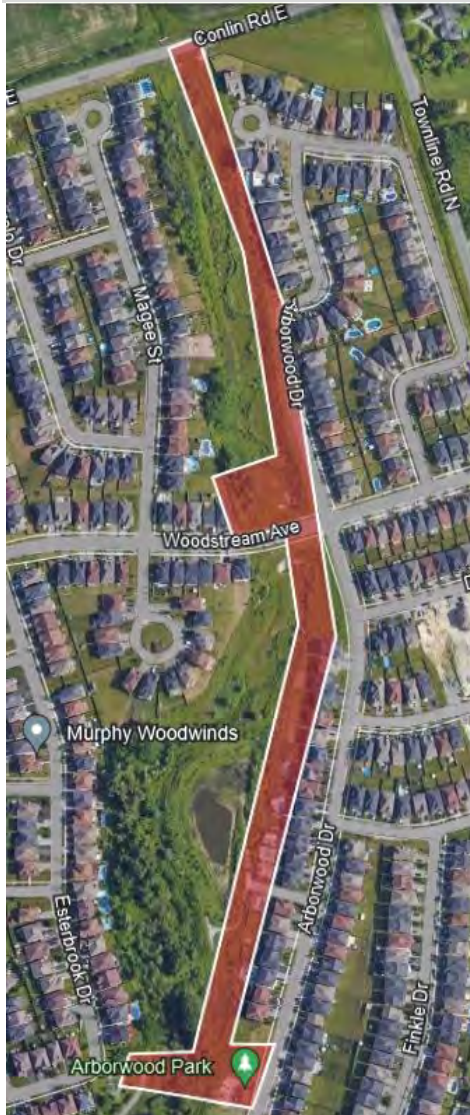
**FIGURE 1 – STUDY AREA**

Schollen & Company Inc. was retained by the City of Oshawa to complete an inventory of the trees that are contained within, and located immediately surrounding the proposed recreational trail from Esterbrook Drive to Conlin Road East, west to Arborwood Drive. The Study Area is a greening area within a residential zone, with streams connecting the ponds and swamp from the north to the south. The greening area is split by east-west Woodstream Ave.

The subject lands that comprise the Study Area encompass approximately 3.2 hectares. The inventory has been prepared in support of an application for planning approvals to facilitate the redevelopment of the site.

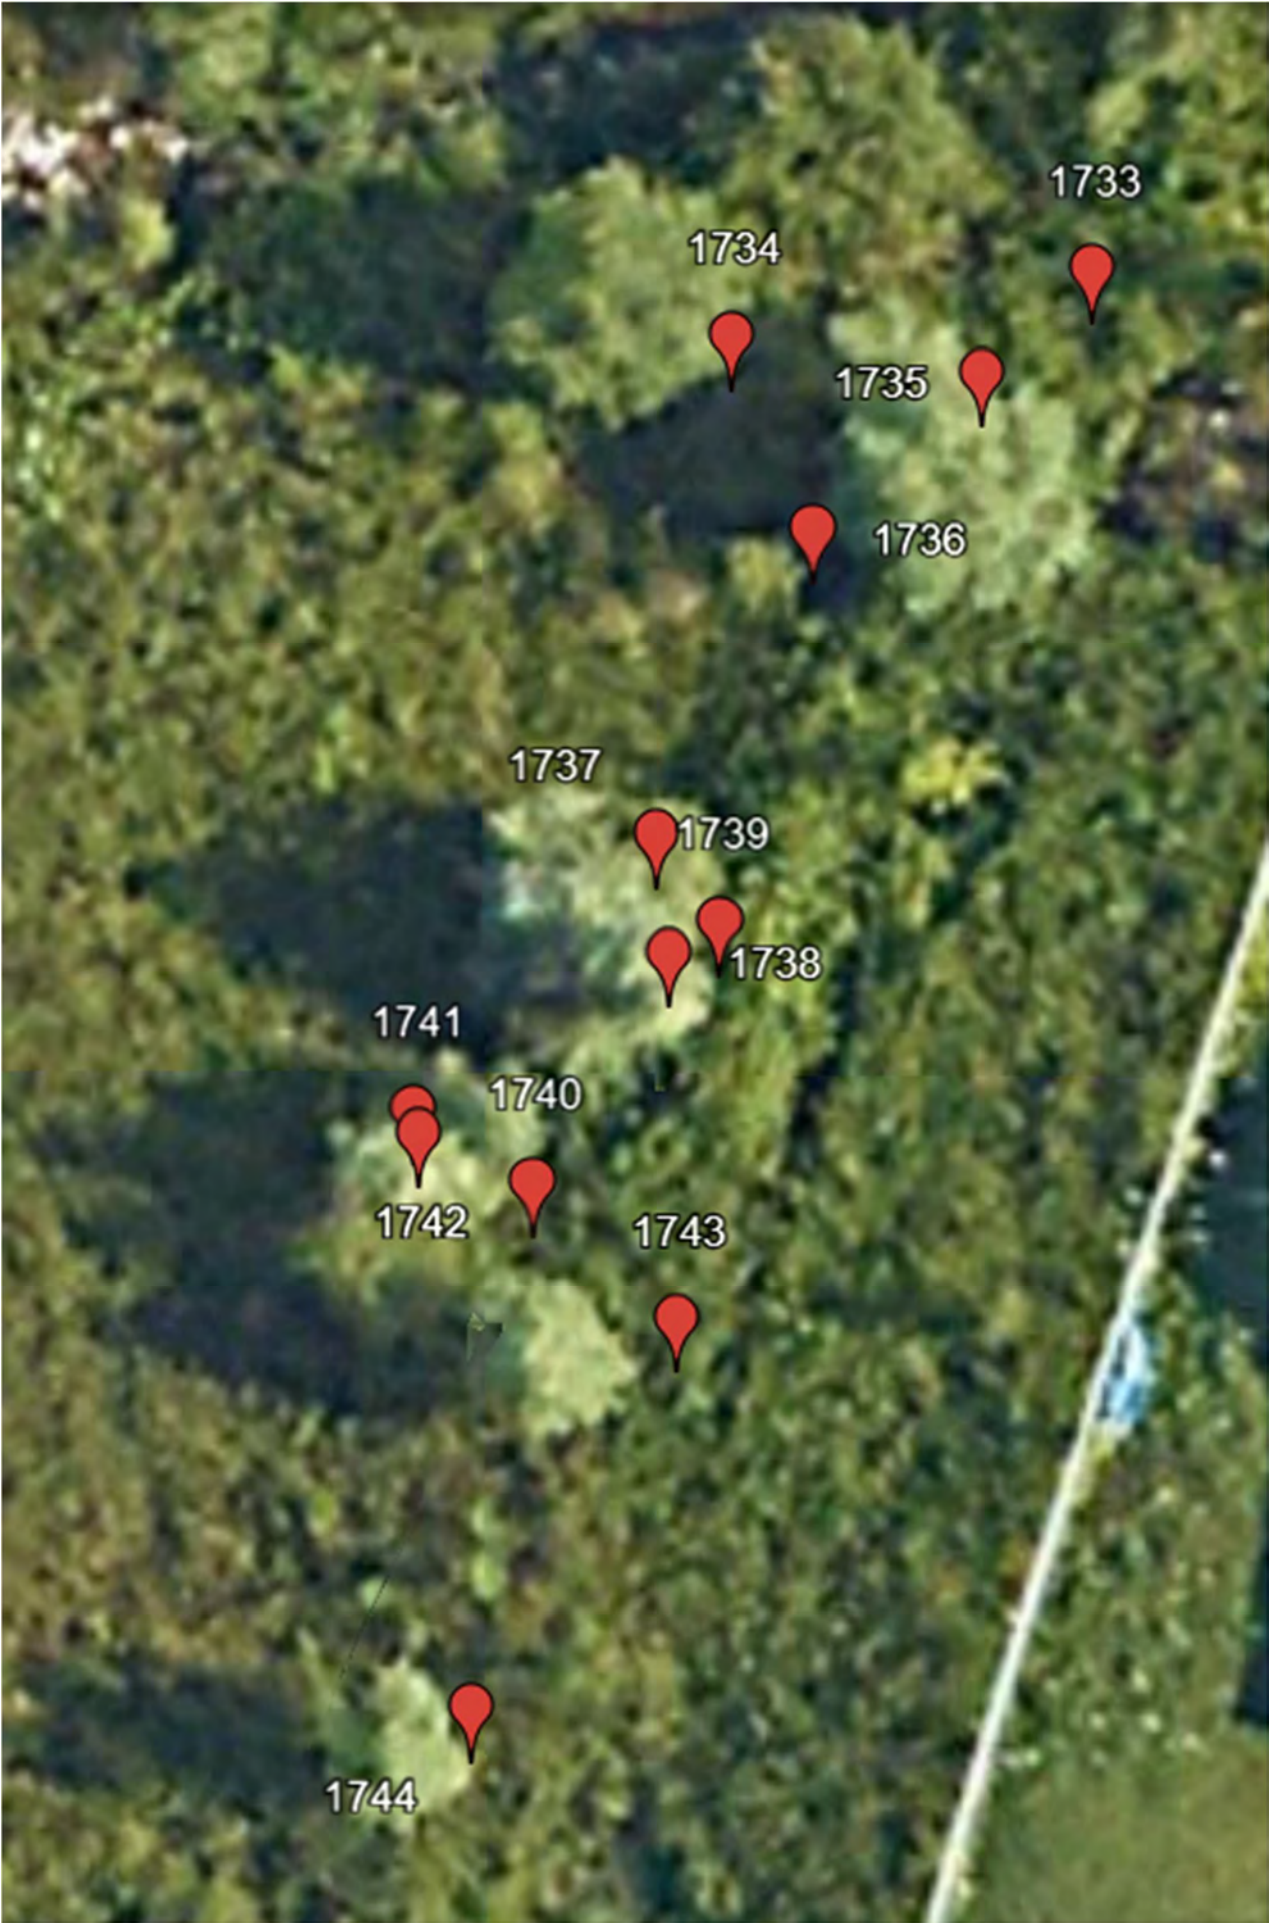
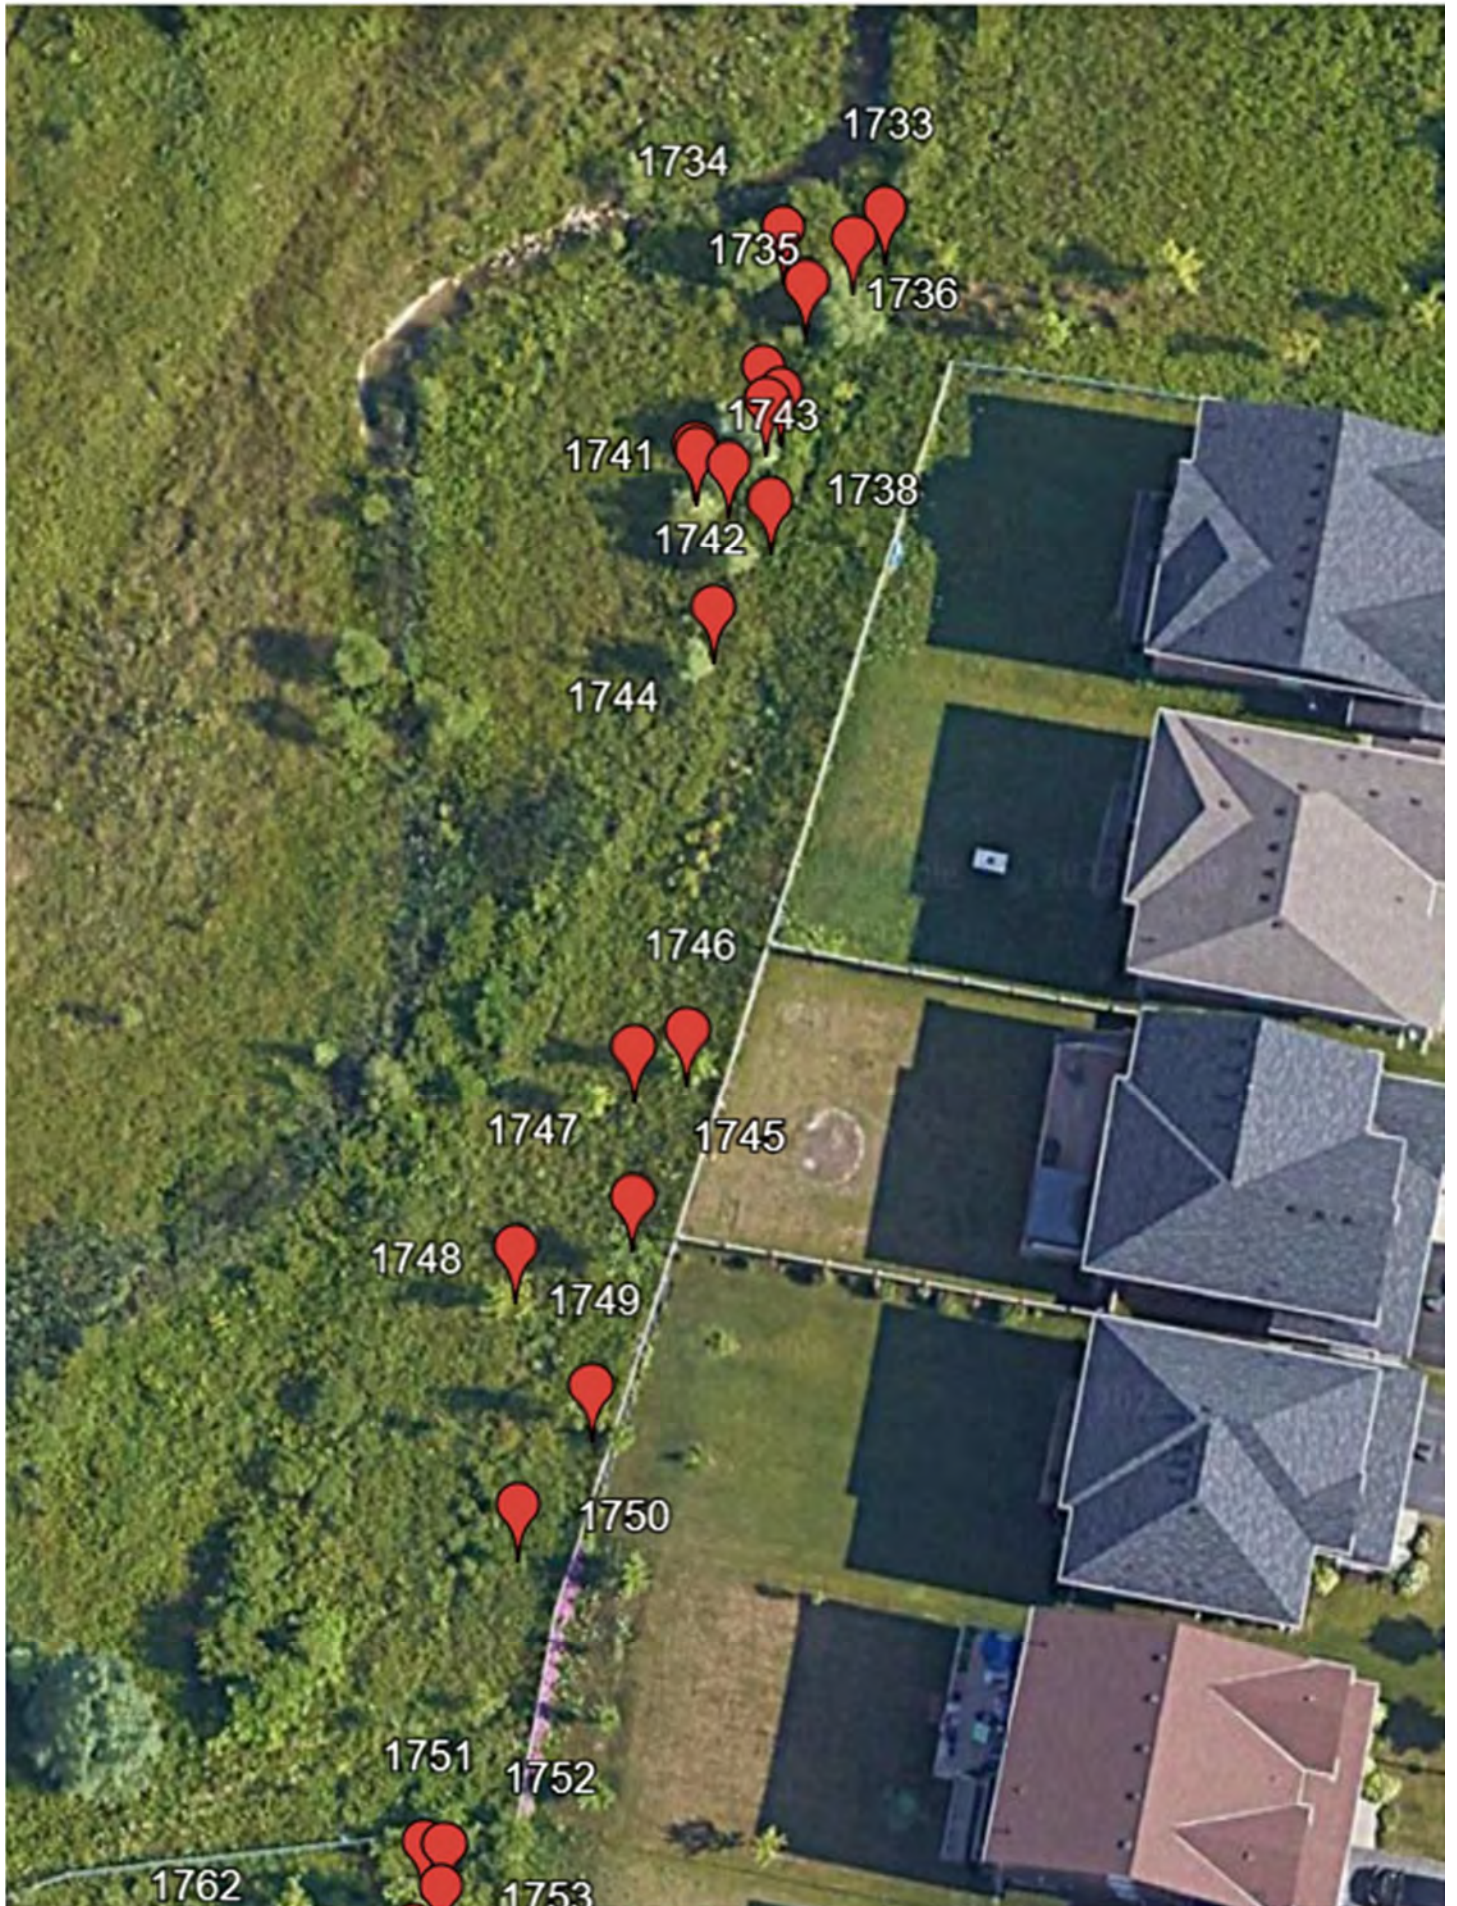
Tree Inventory and Assessment Plans (TI-)

A survey of the Study Area was provided that illustrates the location of trees in relation to existing buildings, structures, roads and property boundaries. This survey was utilized to create the Tree Inventory Plans TI-01 through TI-10. The Tree Inventory Plans identify each tree that was inventoried.

The following summary of the assessment describes the findings of the inventory. Refer to the corresponding drawings, Tree Inventory Plans TI-01 through TI-10 for an illustration of the location of the existing trees. Refer to the Tree Inventory & Assessment Matrix for the condition related to each tree.
