Report Number: DS-22-51

Subject: Results of Staff Investigation regarding a Water Drainage Issue
at 903 Black Cherry Drive

Item: DS-22-51
Attachment 2

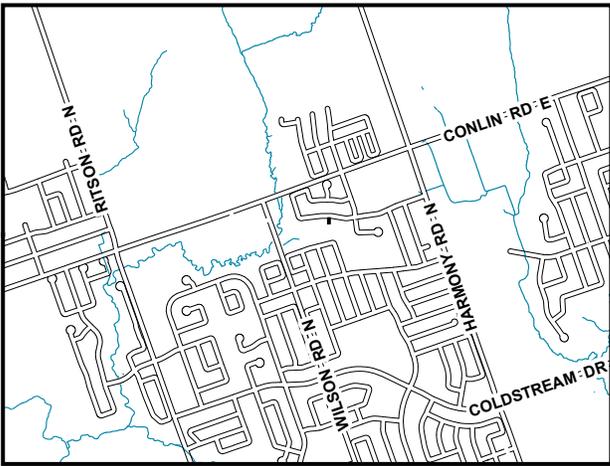
Attachment 2 is an exhibit showing the location of 903 Black Cherry Drive and surrounding contextual elements including the location of Boreholes 7 and 9 from a Geotechnical Investigation dated May 10, 1995 prepared by Golder Associates Ltd. on behalf of the subdivider, FKT Co-Tenancy.

The Geotechnical Investigation dated May 10, 1995 prepared by Golder Associates Ltd. indicates the location of boreholes (see Attachment 2). As noted in the Geotechnical Report, Boreholes 7 and 9 had the shallowest groundwater table. When considering the

underlying soil condition is water bearing sand, it is staff's opinion that groundwater and not surface water is the likely cause of the issues experienced by the pool.
